DOT HS 813 287

**Special Crash Investigations:
On-Site Reported Air Bag Non-
Deployment Crash Investigation;
Vehicle: 2007 Volkswagen GTI;
Location: Florida;
Crash Date: March 2017**

Special Crash Investigations
On-Site Reported Air Bag Non-Deployment Crash Investigation
Office of Defects Investigation
Case Number: CR17017
Vehicle: 2007 Volkswagen GTI
Location: Florida
Crash Date: March 2017

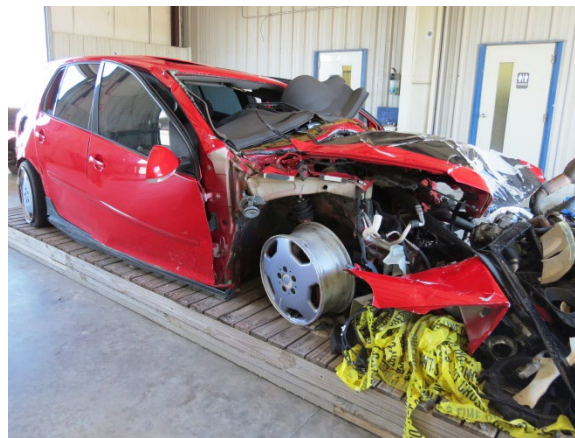
The 2007 Volkswagen GTI (Figure 6) was identified by the Vehicle Identification Number WVWHV71K77Wxxxxxx. It was a 4-door hatchback with front wheel drive, powered by a 2.0-liter, inline, 4-cylinder gasoline engine. The electronic odometer reading could not be obtained during the vehicle inspection due to complete disintegration of the instrument panel during the crash. The Volkswagen had a center-console-mounted shift lever for its 6-speed automatic transmission. It had a 258 cm (101.6 in) wheelbase and a curb weight of 1,406 kg (3,100 lb). Due to vehicle damage, the SCI investigator had no access to the vehicle's VIN placard. Gross vehicle weight rating and tire information specific to this vehicle remain unknown. At the time of the SCI inspection, the Volkswagen was equipped with four tires of size P205/40R17. Specific tire data were as follows:

Figure 6. Front-right oblique view of the 2007 Volkswagen GTI at the time of the SCI vehicle inspection

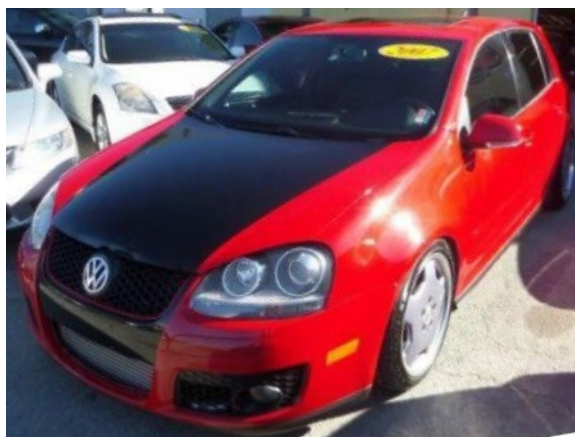
Figure 7. Front-left oblique view of the 2007 Volkswagen GTI when listed for sale in 2015 (image obtained from a commercially available vehicle history report)

The Volkswagen was then offered for sale in January 2015. Records indicate that it remained listed for sale during 2015 before being sold in Florida at auction in December 2015. At the time, its odometer reading was noted as 180,247 km (112,000 mi). Figure 7 shows a left front oblique view of the Volkswagen from its classified sale listing in March 2015. This and other images were categorized in the commercially obtained vehicle history report. Aside from the incident crash, there were no other crashes or other damage reports in the Volkswagen's documented history.
