DOT HS 813 300

**Special Crash Investigations:
On-Site Air Bag Non-Deployment
Crash Investigation;
Vehicle: 2008 Chevrolet Malibu;
Location: New York;
Crash Date: September 2017**

Special Crash Investigations
On-Site Air Bag Non-Deployment Crash Investigation
Office of Defects Investigation
Case Number: CR18019
Vehicle: 2008 Chevrolet Malibu
Location: New York
Crash Date: September 2017

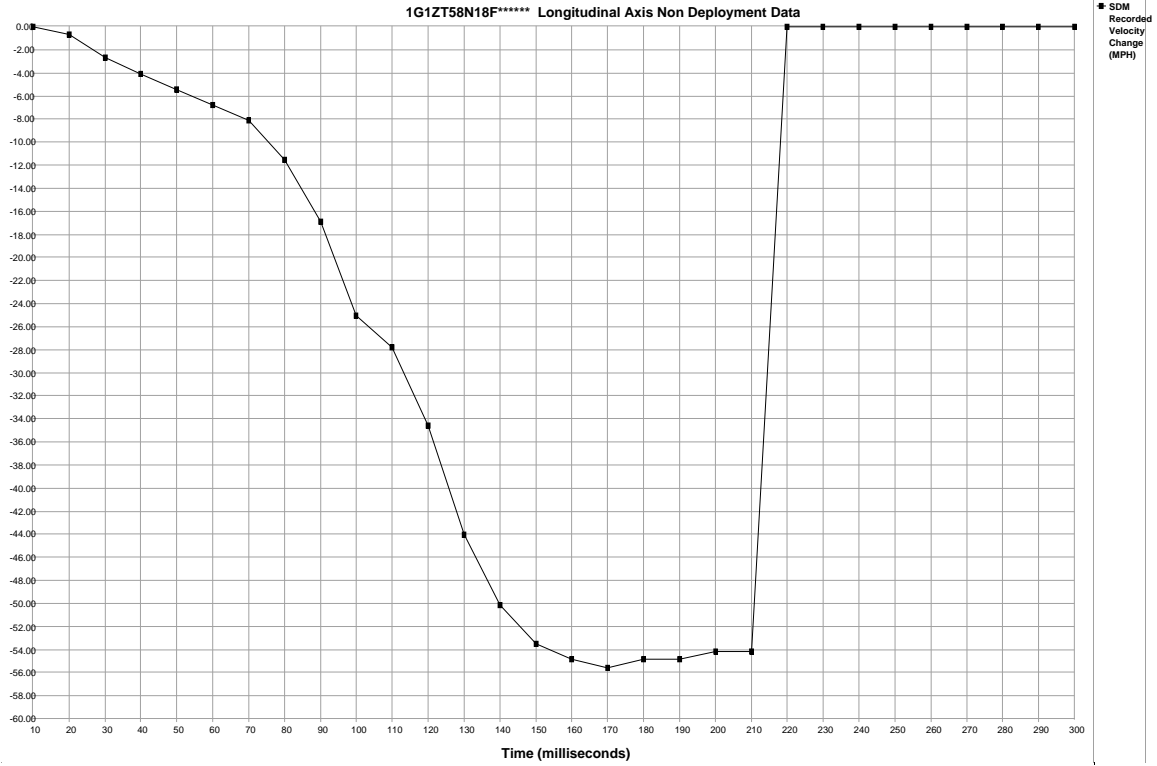
Time (milliseconds)	10	20	30	40	50	60	70	80	90	100	110	120	130	140	150
SDM Longitudinal Axis Recorded Velocity Change (MPH)	0.00	-0.68	-2.71	-4.07	-5.42	-6.78	-8.13	-11.52	-16.94	-25.07	-27.79	-34.56	-44.05	-50.15	-53.54
Time (milliseconds)	160	170	180	190	200	210	220	230	240	250	260	270	280	290	300
SDM Longitudinal Axis Recorded Velocity Change (MPH)	-54.89	-55.57	-54.89	-54.89	-54.22	-54.22	0.00	0.00	0.00	0.00	0.00	0.00	0.00	0.00	0.00

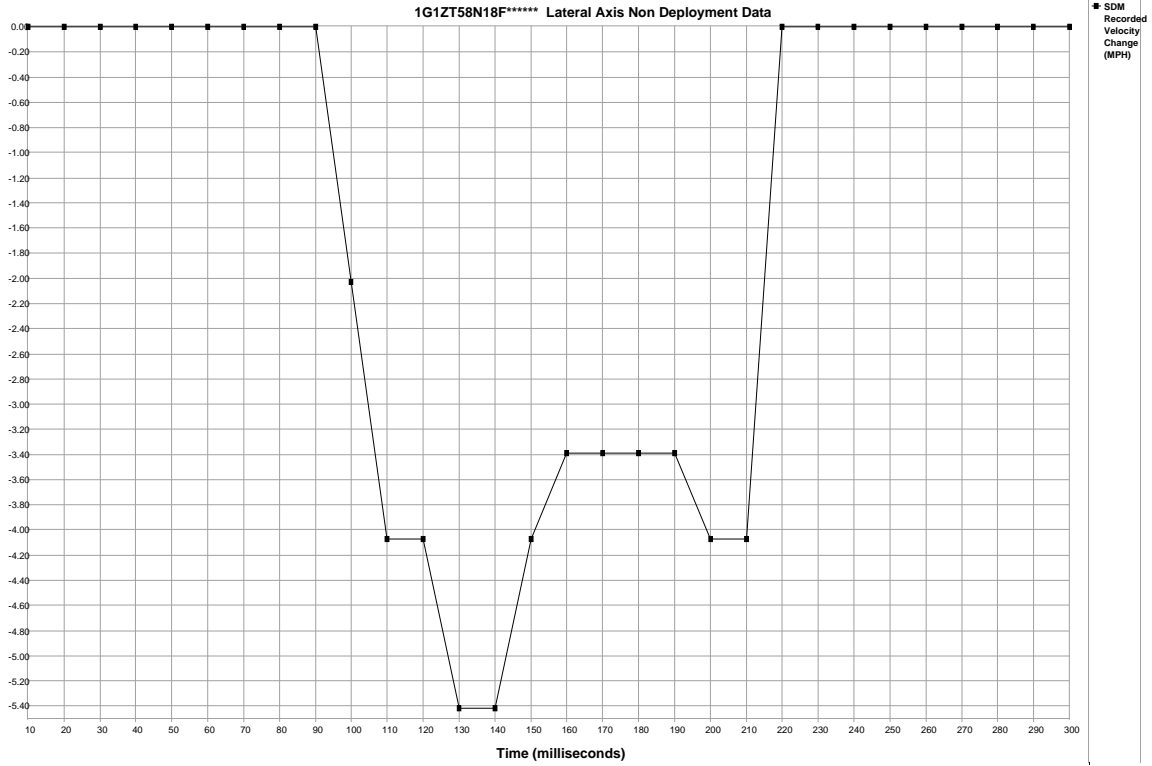
Time (milliseconds)	10	20	30	40	50	60	70	80	90	100	110	120	130	140	150
SDM Lateral Axis Recorded Velocity Change (MPH)	0.00	0.00	0.00	0.00	0.00	0.00	0.00	0.00	0.00	-2.03	-4.07	-4.07	-5.42	-5.42	-4.07
Time (milliseconds)	160	170	180	190	200	210	220	230	240	250	260	270	280	290	300
SDM Lateral Axis Recorded Velocity Change (MPH)	-3.39	-3.39	-3.39	-3.39	-4.07	-4.07	0.00	0.00	0.00	0.00	0.00	0.00	0.00	0.00	0.00
