DOT HS 813 349

**Special Crash Investigations:  
On-Site Reported Driver Manual  
Restraint System Malfunction  
Crash Investigation;  
Vehicle: 2018 Honda Civic EX;  
Location: Florida;  
Crash Date: January 2020**

**Special Crash Investigations  
On-Site Reported Driver Manual Restraint System  
Malfunction Crash Investigation  
Office of Defects Investigation  
Case Number: CR20008  
Vehicle: 2018 Honda Civic EX  
Location: Florida  
Crash Date: January 2020**

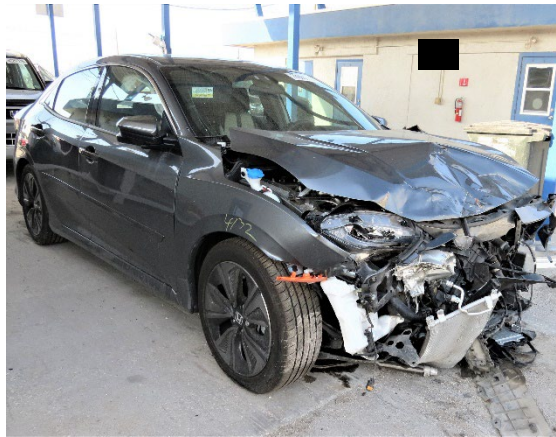
*Figure 1. Right front oblique view of the Honda*

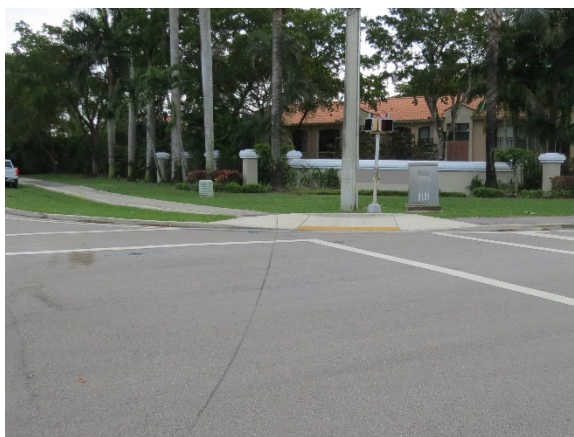
The Lexus was redirected toward the southwest by the impact. A dark tire mark on the roadway surface from the Lexus' left front tire showed its trajectory from initial impact. The front tires/wheels overrode the curb at the southwest corner of the intersection as the Lexus departed the roadway and entered the grassy roadside. It continued through the roadside and struck a large palm tree with the center aspect of its front plane. This tree impact was located approximately 31.0 m (101.7 ft) from the initial point of impact. The Lexus came to final rest with its front against the base of the palm tree. Figure 5 shows the trajectory of the Lexus into the roadside and the struck palm tree in the far center.

*Figure 5. Southwest-facing view of the Lexus' trajectory into the roadside toward the palm tree impact*

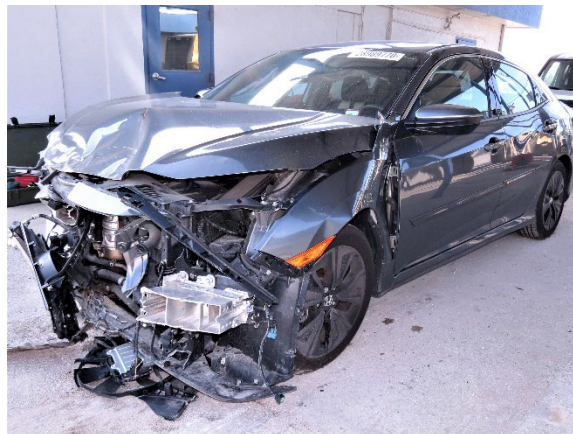
The 2018 Honda Civic (Figure 6) was manufactured in April 2018 and identified by the VIN SHHFK7H56JUxxxxxx. The electric odometer was inoperable at the time of SCI inspection, however, the driver stated during interview that the Honda's odometer reading at the time of the crash was 24,544 km (15,251 miles). The Honda was a front-wheel drive platform with the EX trim package. It was powered by a 1.5-liter, inline 4-cylinder gasoline engine linked to an automatic transmission, with power-assisted 4-wheel disc brakes with antilock. The gross vehicle weight rating (GVWR) was 1,795 kg (3,957 lb), with gross axle weight ratings (GAWR) of 955 kg (2,105 lb) front and 850 kg (1,874 lb) rear. The manufacturer's recommended tire size was P215/50R17, with recommended cold tire pressures of 220 kPa (32 PSI) for all four axle positions. At the time of the SCI inspection, the Honda had Michelin Primacy MXM4 tires of the recommended size at all four axle positions. All four tires had at least 3 mm (4/32 in) of tread, remained inflated, and were not damaged or restricted in relation to the crash.

*Figure 6. Left front oblique view of the 2018 Honda Civic during the SCI vehicle inspection*

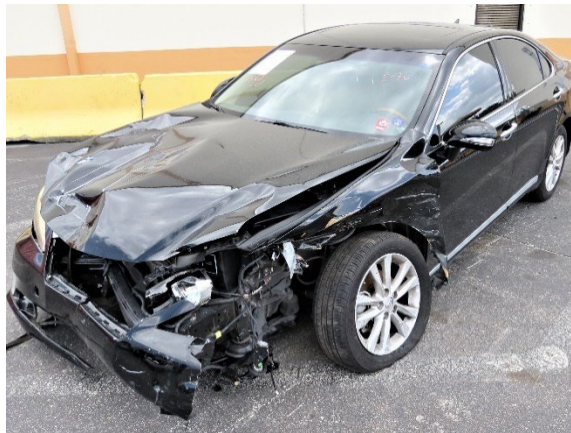
*Figure 19. Front left oblique view of the Lexus at the time of the SCI inspection*
