DOT HS 813 350

**Special Crash Investigations:
On-Site Seat Belt Pretensioner Fire
Investigation;
Vehicle: 2016 Infiniti QX60;
Location: South Carolina;
Crash Date: October 2019**

Special Crash Investigations
On-Site Seat Belt Pretensioner Fire Investigation
Office of Defects Investigation
Case Number: CR19034
Vehicle: 2016 Infiniti QX60
Location: South Carolina
Crash Date: October 2019

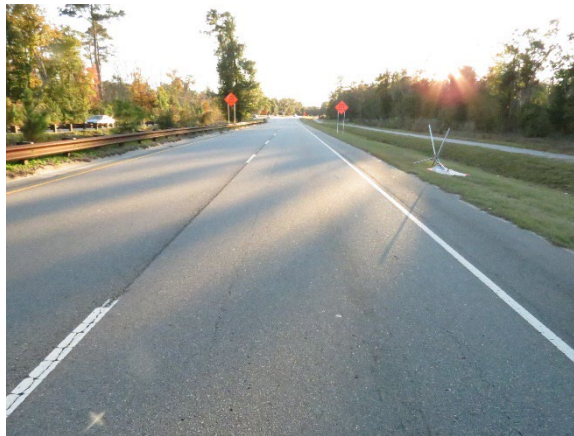
Figure 3. South-facing view along the roadway in the area of the crash. Image taken from the right lane for safety reasons.

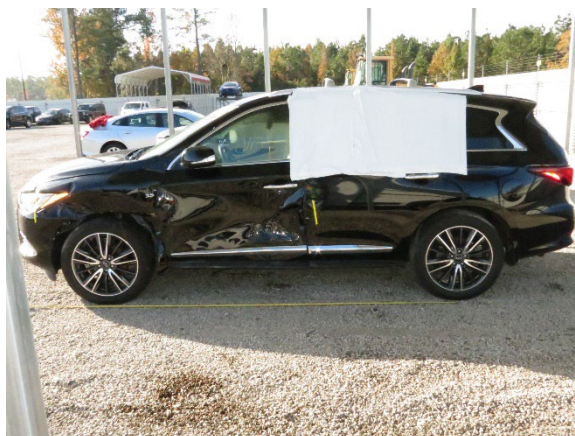
Figure 4. Left side view of the Infiniti

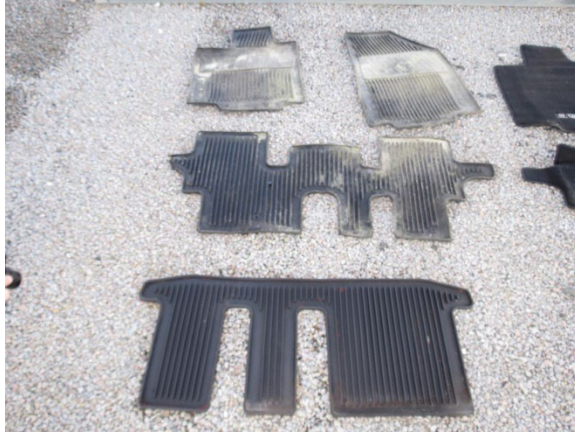
At initial inspection the vehicle's floor mats were found stacked together on the third row seat. Each row had an OEM carpeted mat and a rubber weather-proof mat. Each set of mats were contoured to fit the floor/seat configuration at the appropriate row (Figures 8 and 9). The carpet mat was placed on top of the rubber weather-proof mat. It was observed that the carpeted floor mats were in good condition and were absent of any fire damage.

Figure 8. View of the Infiniti's OEM rubber floor mat

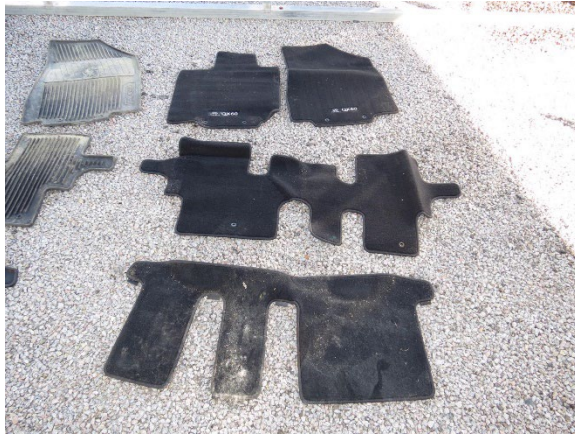
Figure 9. View of the Infiniti's OEM carpeted floor mats

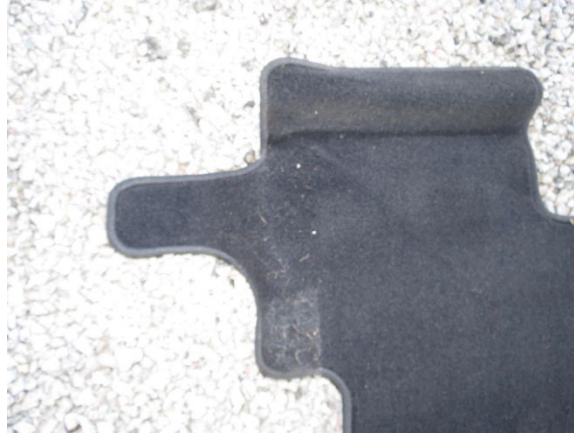
Fire damage was present at the left end of the second row rubber mat. A 6 cm (2.4 in) long section of the mat at its extreme left end was consumed by the fire (Figure 10). This section would have been positioned adjacent to the B-pillar. The carpeted mat directly on top of the consumed section had no observable damage (Figure 11).

Figure 11. View of the Infiniti's undamaged OEM second row carpeted floor mat

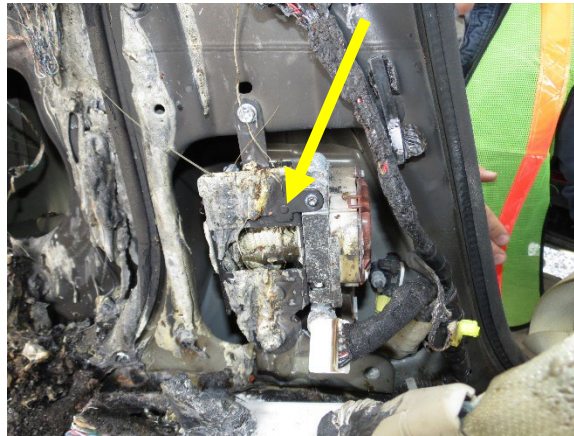
The retractor pretensioner was removed from its mounted location in the pillar (Figures 15 and 16). The retractor pretensioner was a ball-and-tube design manufactured by Takata and identified by the following nomenclature.

Figure 15. Image showing the mounting location of the Infiniti's left retractor pretensioner (yellow arrow)

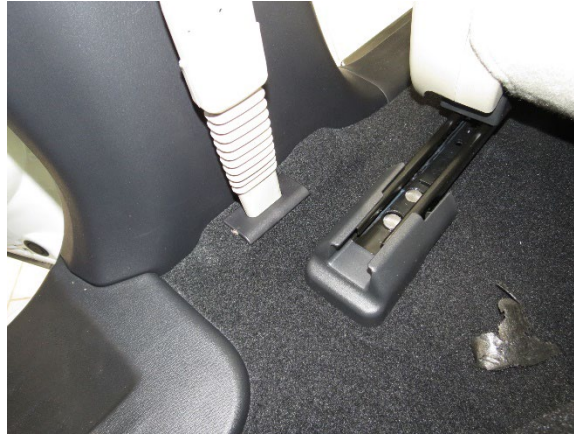
The driver's lower anchor pretensioner was located to the left of the driver's outer seat track, beneath the carpet. It was mounted with a longitudinal orientation and actuated in a forward direction, which compressed the convoluted sleeve at the seat belt's anchor. The pretensioner was positioned in a tray, surrounded by polystyrene foam and secured to the floor. For reference, the position of the lower anchor location in an exemplar vehicle is shown in Figure 21 and the unactuated right lower anchor pretensioner from the involved Infiniti is shown in Figure 22. The right lower anchor pretensioner was removed during the SCI inspection for comparison purposes.

Figure 21. Interior view of the left lower anchor pretensioner location in an exemplar Infiniti

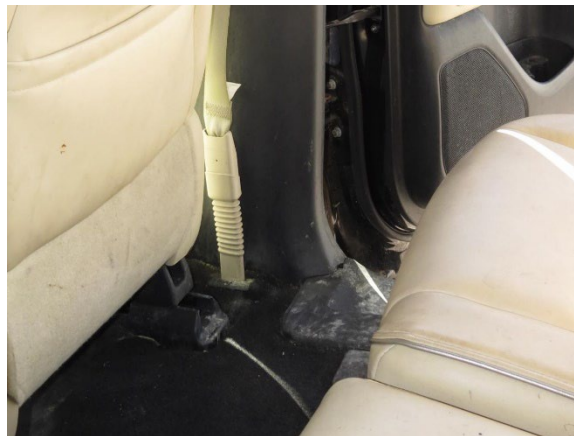
Figure 22. Interior image showing the right lower anchor pretensioner prior to its removal from the involved Infiniti

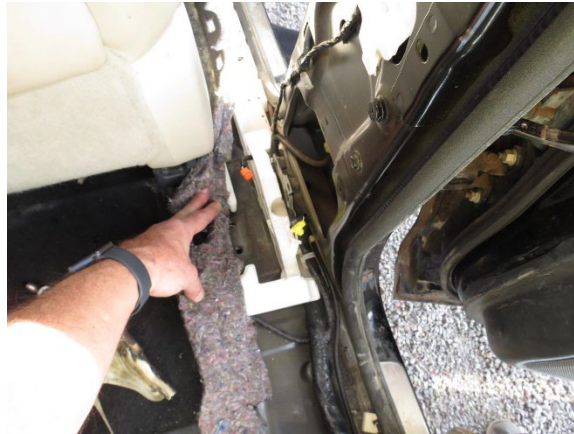
The mounted location of the right lower anchor pretensioner is shown in Figure 23.

Figure 23. Interior view of the Infiniti's right lower anchor pretensioner location
