DOT HS 813 364

**Special Crash Investigations:
On-Site Air Bag Non-Deployment
Crash Investigation;
Vehicle: 2016 Ford Explorer Police
Interceptor;
Location: Louisiana;
Crash Date: April 2017**

Special Crash Investigations
On-Site Air Bag Non-Deployment Crash Investigation
Office of Defects Investigation
Case Number: CR17007
Vehicle: 2016 Ford Explorer Police Interceptor
Location: Louisiana
Crash Date: April 2017

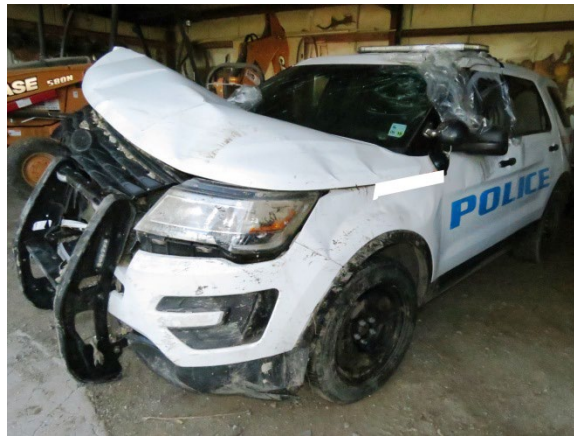
This report documents the on-site investigation of the non-deployment of the air bag systems in a 2016 Ford Explorer Police Interceptor (Figure 1) during a multi-event, rollover crash. Further interest was the potential carbon monoxide (CO) exposure of the Ford's 36-year-old unbelted female driver. At the time of the case assignment, the Ford Explorer was not under recall; however, NHTSA had a Preliminary Evaluation #PE16-008 in response to consumer reports of exhaust fumes entering the interiors of model year (MY) 2011 to 2015 Ford Explorers. As the SCI investigation proceeded, the Preliminary Evaluation was elevated to an Engineering Analysis #EA17-002 and expanded to cover the model years 2011 to 2017.

Figure 1. Oblique view of the 2016 Ford Explorer Police Interceptor at the time of the SCI inspection

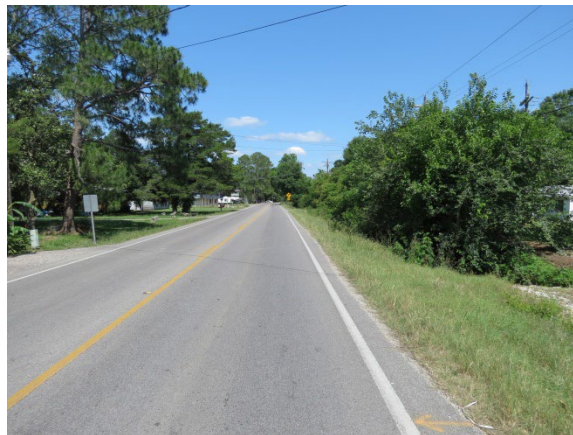
Figure 2. Eastbound trajectory view of the Ford in the area of the crash

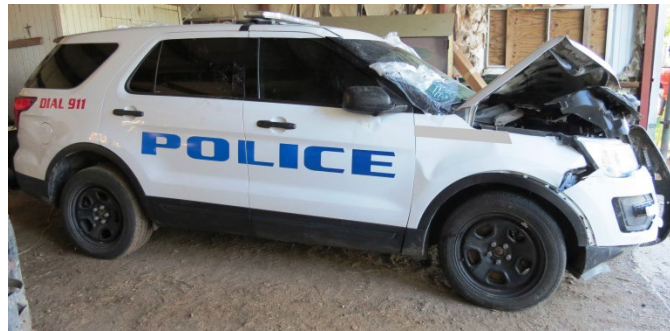
The 2016 Ford Explorer Police Interceptor (Figure 5) was manufactured in March 2016 and was identified by the VIN 1FM5K8AR4GGxxxxxx. Its electronic odometer reading obtained during the SCI vehicle inspection was 14,709.9 km (9,140.3 mi). The all-wheel-drive Ford was powered by a 3.7-liter, V-6 flex-fuel (unleaded gasoline/E-85) internal combustion engine. It had a steering column-mounted shift lever for its 6-speed automatic transmission. The Ford had a 287 cm (113.0 in) wheelbase with a gross vehicle weight rating of 2,877 kg (6,342 lb). The front and rear gross axle weight ratings were 1,452 kg (3,200 lb) and 1,520 kg (3,350 lb), respectively. Its curb weight as an incomplete vehicle (before installation of emergency warning lights, communications, and other law enforcement equipment), was 2,146 kg (4,731 lb). The manufacturer's recommended tire size was P245/55R18, with recommended cold tire pressures of 250 kPa (36 PSI) for all four axle positions. The Ford had Goodyear Eagle RS-A tires of the recommended size at all four axle positions. Specific tire data measured at the time of the SCI inspection were as follows.

Figure 5. Right plane view of the 2016 Ford Explorer Police Interceptor

Position	Tire Identification Number (TIN)	Measured Tread Depth	Restriction	Damage
LF	M6DX JA2R 2416	6 mm (8/32 in)	No	None
LR	M6DX JA2R 1116	4 mm (5/32 in)	No	None
RR	M6DX JA2R 1116	6 mm (7/32 in)	No	None
RF	M6DX JA2R 1116	5 mm (6/32 in)	Yes	Cut in sidewall

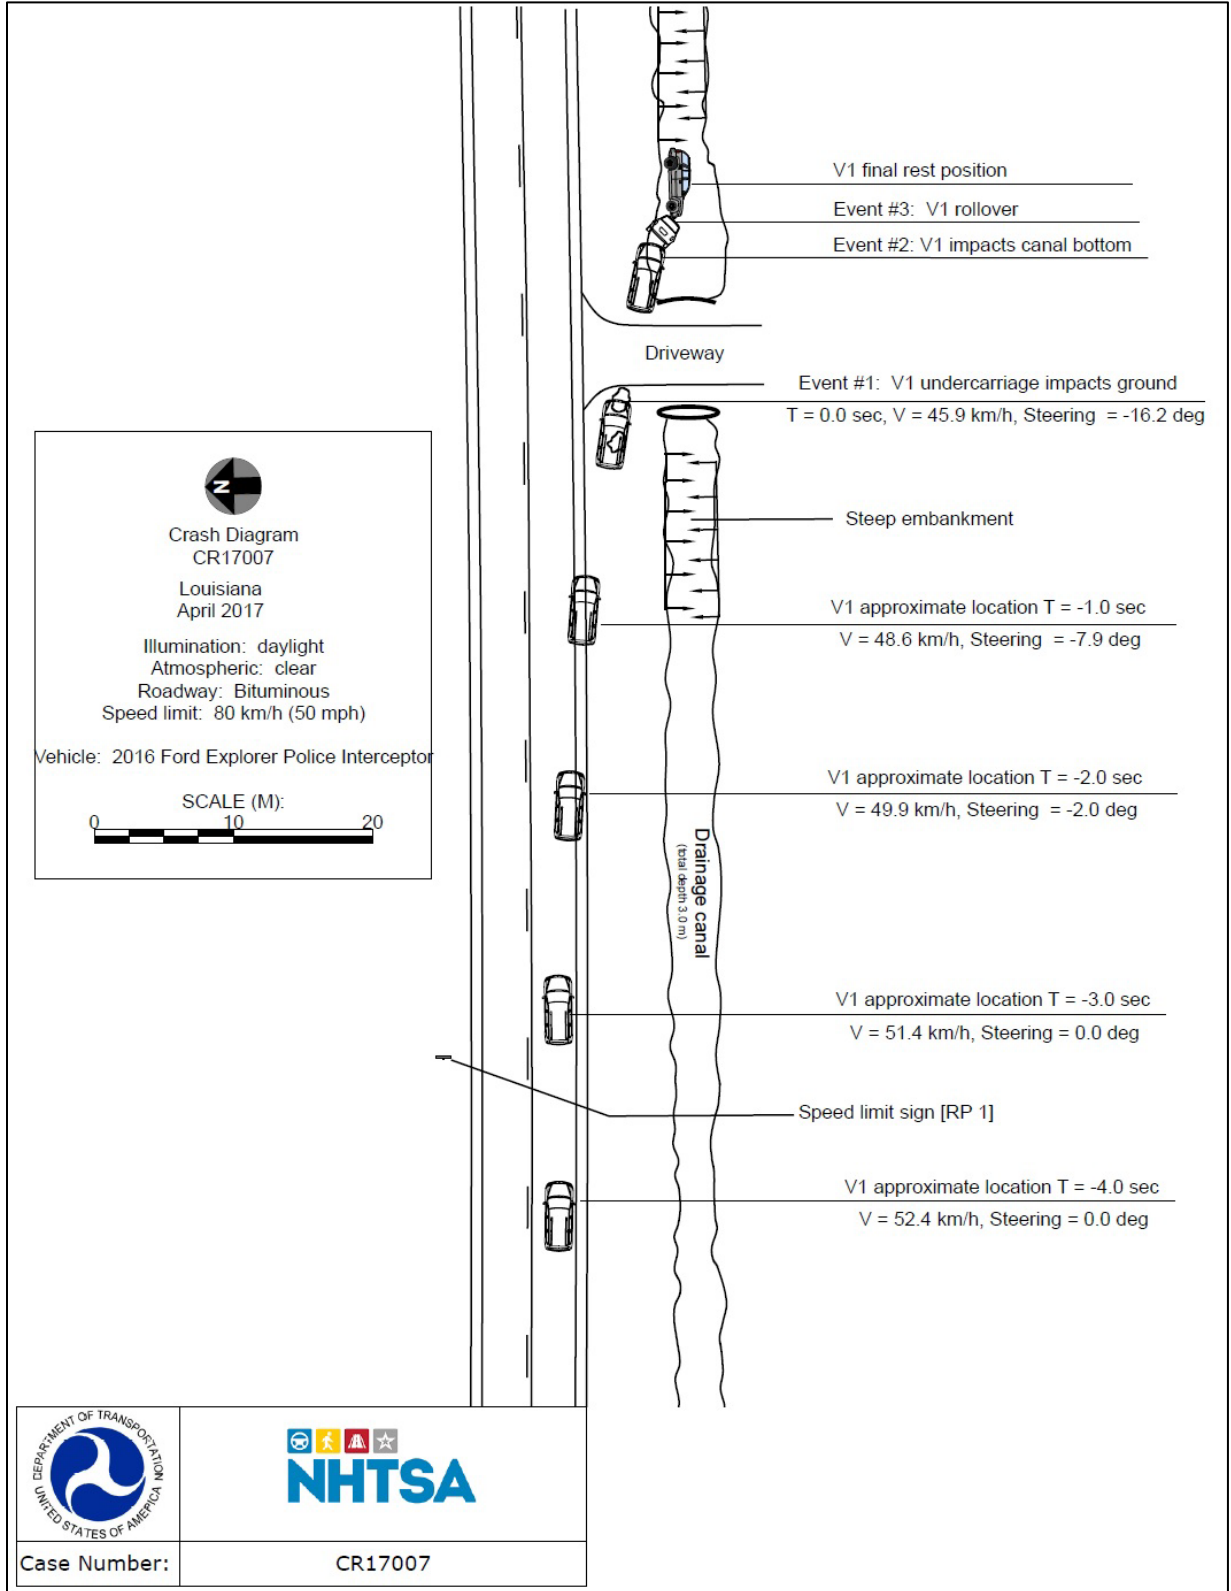
Case Number: CR17007

Crash Diagram
