DOT HS 813 377

**Special Crash Investigations:
On-Site Pretensioner Malfunction
Crash Investigation;
Vehicle: 2021 Hyundai Elantra;
Location: North Carolina;
Crash Date: September 2021**

Special Crash Investigations
On-Site Pretensioner Malfunction Crash Investigation
Office of Defects Investigation
Case Number: CR21023
Vehicle: 2021 Hyundai Elantra
Location: North Carolina
Crash Date: September 2021

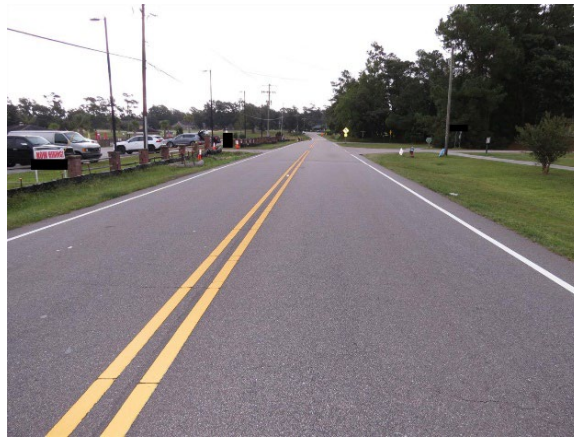
Figure 3. Crash scene eastbound

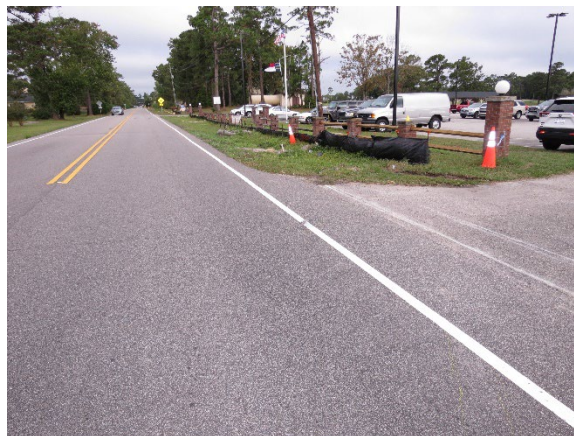
Figure 4. Crash scene westbound, V2 at POI

The crash occurred in the westbound lane where the center/front of the Honda struck right/front of the Hyundai (Event 1). A gouge mark identified the area of the impact near the white fog (Figure 4 above). The supplemental restraint systems in both vehicles actuated/deployed. The force of the impact reversed the momentum of the Hyundai and rotated it 140 degrees counterclockwise. The Hyundai came to rest facing west in the westbound lane approximately 10 m (33 ft) from the point of the impact. The Honda was deflected to its right, departed the road, traveled through the roadside, and struck the second brick pillar supporting the fence (Event 2). The Honda came to rest in contact with the fractured pillar approximately 8.5 m (28 ft) from the vehicle-to-vehicle impact facing north. Its impact with the pillar dislodged a brick into the parking lot where it struck a parked/unoccupied Chevrolet Cruze (Event 3).

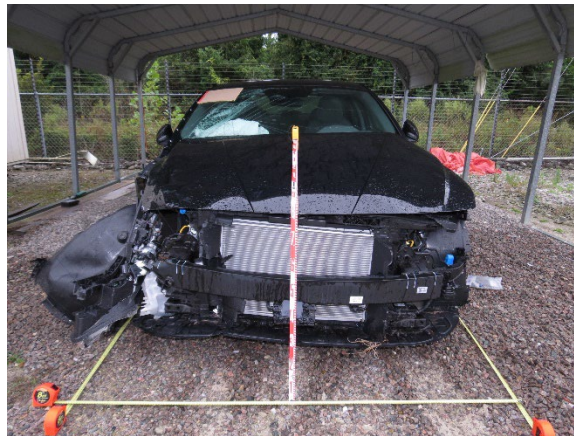
Figure 5. Front view of the 2021 Hyundai Elantra during the SCI vehicle inspection

The front and right planes of the Hyundai were damaged (Figure 5) in the impact (Event 1). The bumper fascia and grille separated in the impact. The direct damage began 52 cm (20.5 in) right of center and extended 8 cm (3.1 in) to the right corner. The damage pattern then wrapped

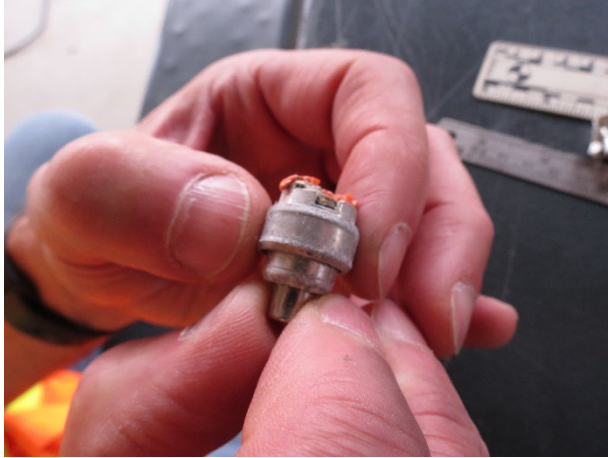
Figure 14. Top view of gas generator

The force of the explosion caused the gas generator to separate from the end cap and hole the B-pillar trim panel. The tube portion of the pretensioner recoiled approximately 10 degrees clockwise (Figure 18) into the B-pillar structure. The back side of the tube contacted the ends of two exposed bolts in the pillar, causing two indents to be formed in the tube structure (Figure 19).
