DOT HS 813 383

**Special Crash Investigations:  
Remote Child Restraint System  
Crash Investigation;  
Vehicle: 2016 Nissan Rogue;  
Location: Maryland;  
Crash Date: November 2019**

**Special Crash Investigations**  
**Remote Child Restraint System Crash Investigation**  
**Office of Defects Investigation**  
**Case Number: CR20015**  
**Vehicle: 2016 Nissan Rogue**  
**Location: Maryland**  
**Crash Date: November 2019**

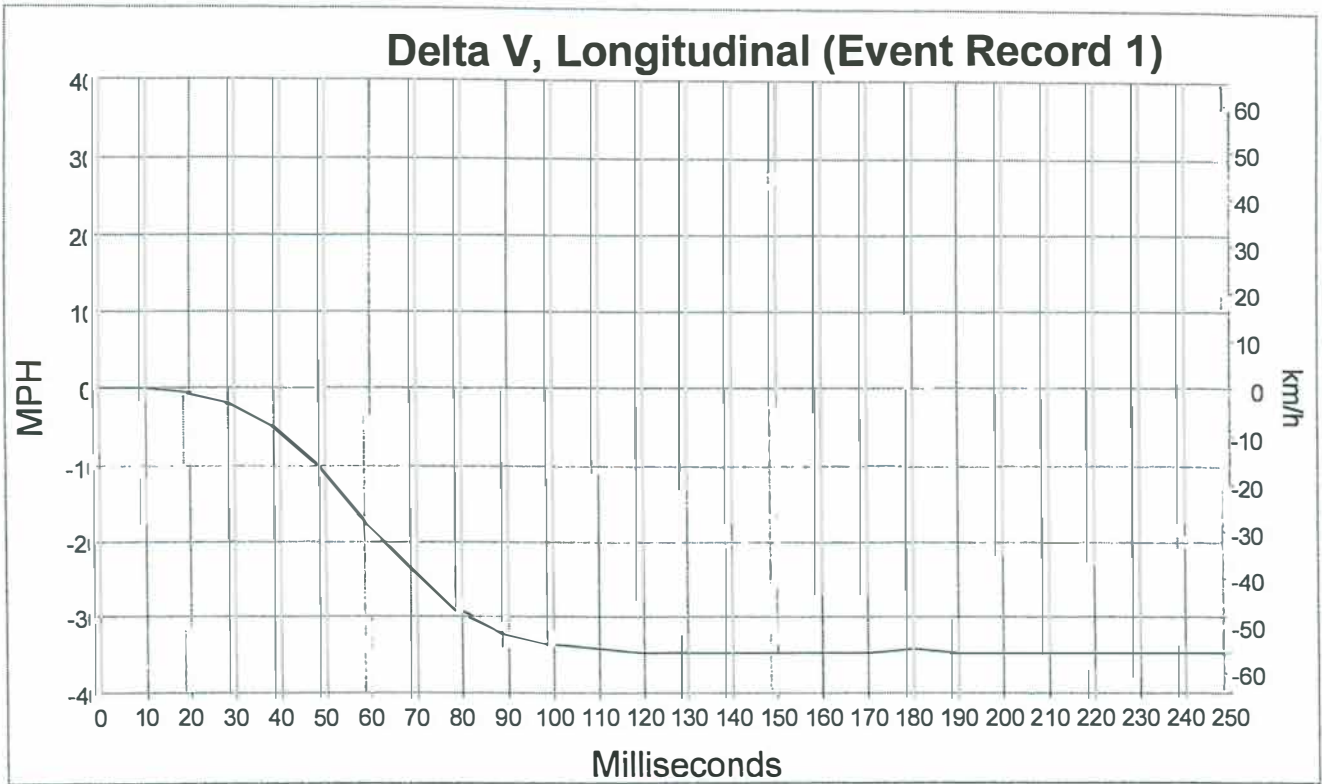
### Longitudinal Delta V (Event Record 1)

At impact with the utility pole, the vehicle experienced a 12 o’clock direction of impact force and underwent a longitudinal velocity change of -56 km/h (-35 mph). The IC air bags deployed as a result of the frontal crash event at 41 msec of AE. The IC air bag deployed between the left aspect of the CRS shell and the door glazing. A vertically oriented abrasion was noted to the shell of the CRS over a label that resulted from IC deployment.
