DOT HS 813 402

**Special Crash Investigations:  
On-Site Semi-Trailer Underride  
Crash Investigation;  
Vehicle: 2019 International Tractor/  
2018 Wabash Semi-Trailer;  
Location: New York;  
Crash Date: February 2020**

**Special Crash Investigations**  
**On-Site Semi-Trailer Underride Crash Investigation**  
**Case Number: CR20009**  
**Vehicle: 2019 International Tractor/2018 Wabash Semi-Trailer**  
**Location: New York**  
**Crash Date: February 2020**

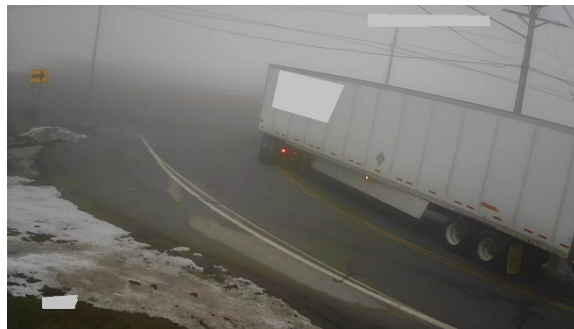
*Figure 4. East-facing surveillance camera view of the International/Wabash stopped at the intersection*

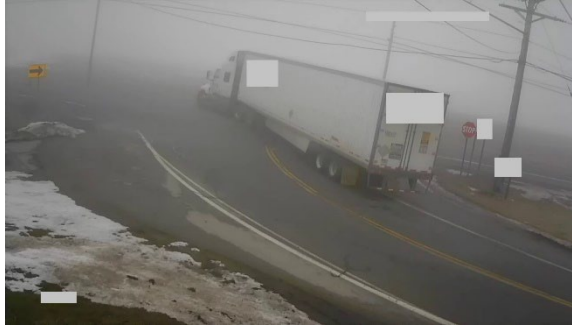
*Figure 5. East-facing surveillance camera view of the International/Wabash as it turned left*

It should be noted that the dense foggy conditions substantially reduced the visibility for both drivers. Further, the white color of the Dodge, the International tractor, and the Wabash trailer would have made it even more difficult to distinguish them in the fog. The video surveillance footage showed the International combination unit as it entered view from the right, squared off to the north/south roadway with its left turn indicator engaged, and came to a complete stop at the mouth of the intersection (Figure 4). The truck/semi-trailer remained stopped for approximately 4 seconds before it began to accelerate forward and turn left. Figure 5 shows the International/Wabash combined unit as it began the left turn. Approximately 5 seconds into the left turn, the Dodge entered the view from the left.

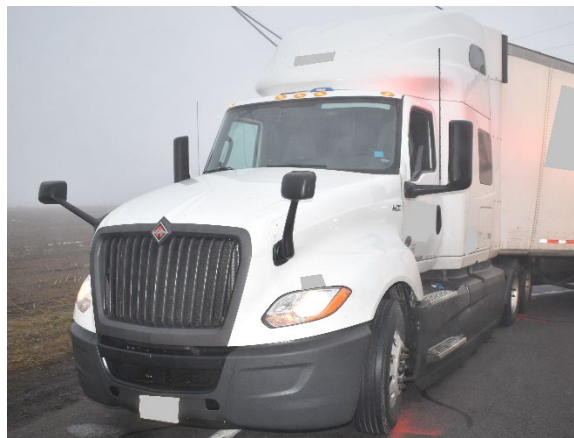
*Figure 10. Left front oblique view of the International tractor (on-scene law enforcement image)*

There was no damage to or involvement of the International tractor in the impact by the Dodge. Damage to the Wabash semi-trailer was observed in law enforcement images to the left plane and undercarriage, consisting of direct contact abrasions to the sidewall of the cargo body, minor deformation to the outer sill, direct contact to the aerodynamic side skirt, and deformation of the forward left axle assembly. On-scene images showed the side skirt was folded partially up and under the semi-trailer as a result of the impact and engagement of the Dodge beneath it. Contact damage to the skirt consisted of paint transfers, scuff marks, and abrasions; the panel itself did not appear fractured. Damage to the semi-trailer began immediately forward of the center of the

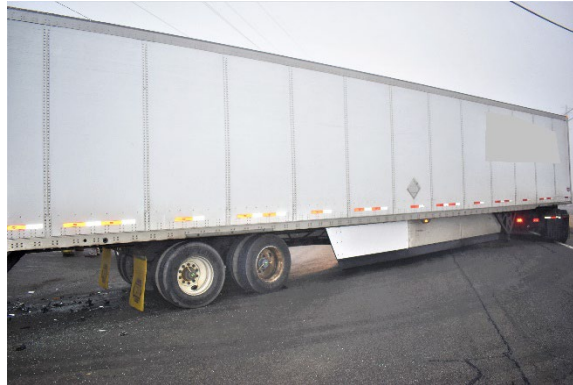
*Figure 11. Right plane view of the Wabash semi-trailer (on-scene law enforcement image)*

The trailer had a GVWR of 30,845 kg (68,000 lb), with gross axle weight ratings (GAWR) of 9,072 kg (20,000 lb). The trailer's axles were capable of being adjusted forward or rearward for loading/unloading and dependent on the load or its weight. The manufacturer's recommended tire size was 295/75R22.5 with 8.25x22.5 steel wheels, with recommended maximum cold tire pressure of 689 kPa (100 PSI). Specific tire data were not available. The forward rear axle was damaged during the crash; its mount was fractured on the left side. This caused the left rear tires to touch.

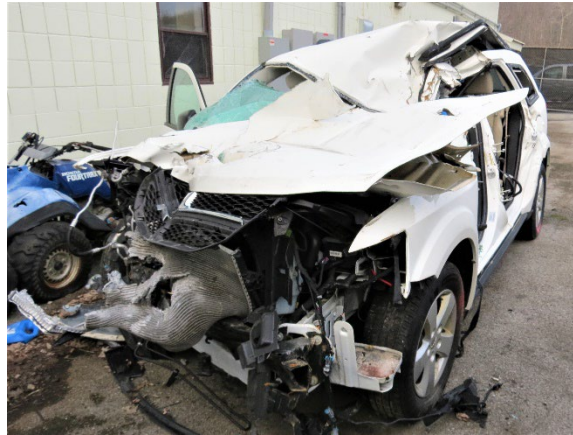
*Figure 14. Left front oblique view of the Dodge at the time of the SCI vehicle inspection*

Figure 14 shows the Dodge at the time of the SCI vehicle inspection. Standard features included electric power steering, power-assisted 4-wheel disc brakes with ABS, traction control, electronic stability control, a tire pressure monitoring system, and a post-collision safety system. The GVWR was 2,405 kg (5,300 lb), with GAWRs of 1,248 kg (2,750 lb) front and 1,339 kg (2,950 lb) rear. The vehicle manufacturer's recommended tire size was P225/65R17, with recommended cold tire pressures of 250 kPa (36 PSI) for all four axle positions.
