DOT HS 813 408

**Special Crash Investigations:  
On-Site Air Bag Non-Deployment  
Crash Investigation;  
Vehicle: 2008 Pontiac G6;  
Location: Ohio;  
Date: July 2020**

**Special Crash Investigations**  
**On-Site Air Bag Non-Deployment Crash Investigation**  
**Office of Defects Investigation**  
**Case Number: CR20034**  
**Vehicle: 2008 Pontiac G6**  
**Location: Ohio**  
**Crash Date: July 2020**

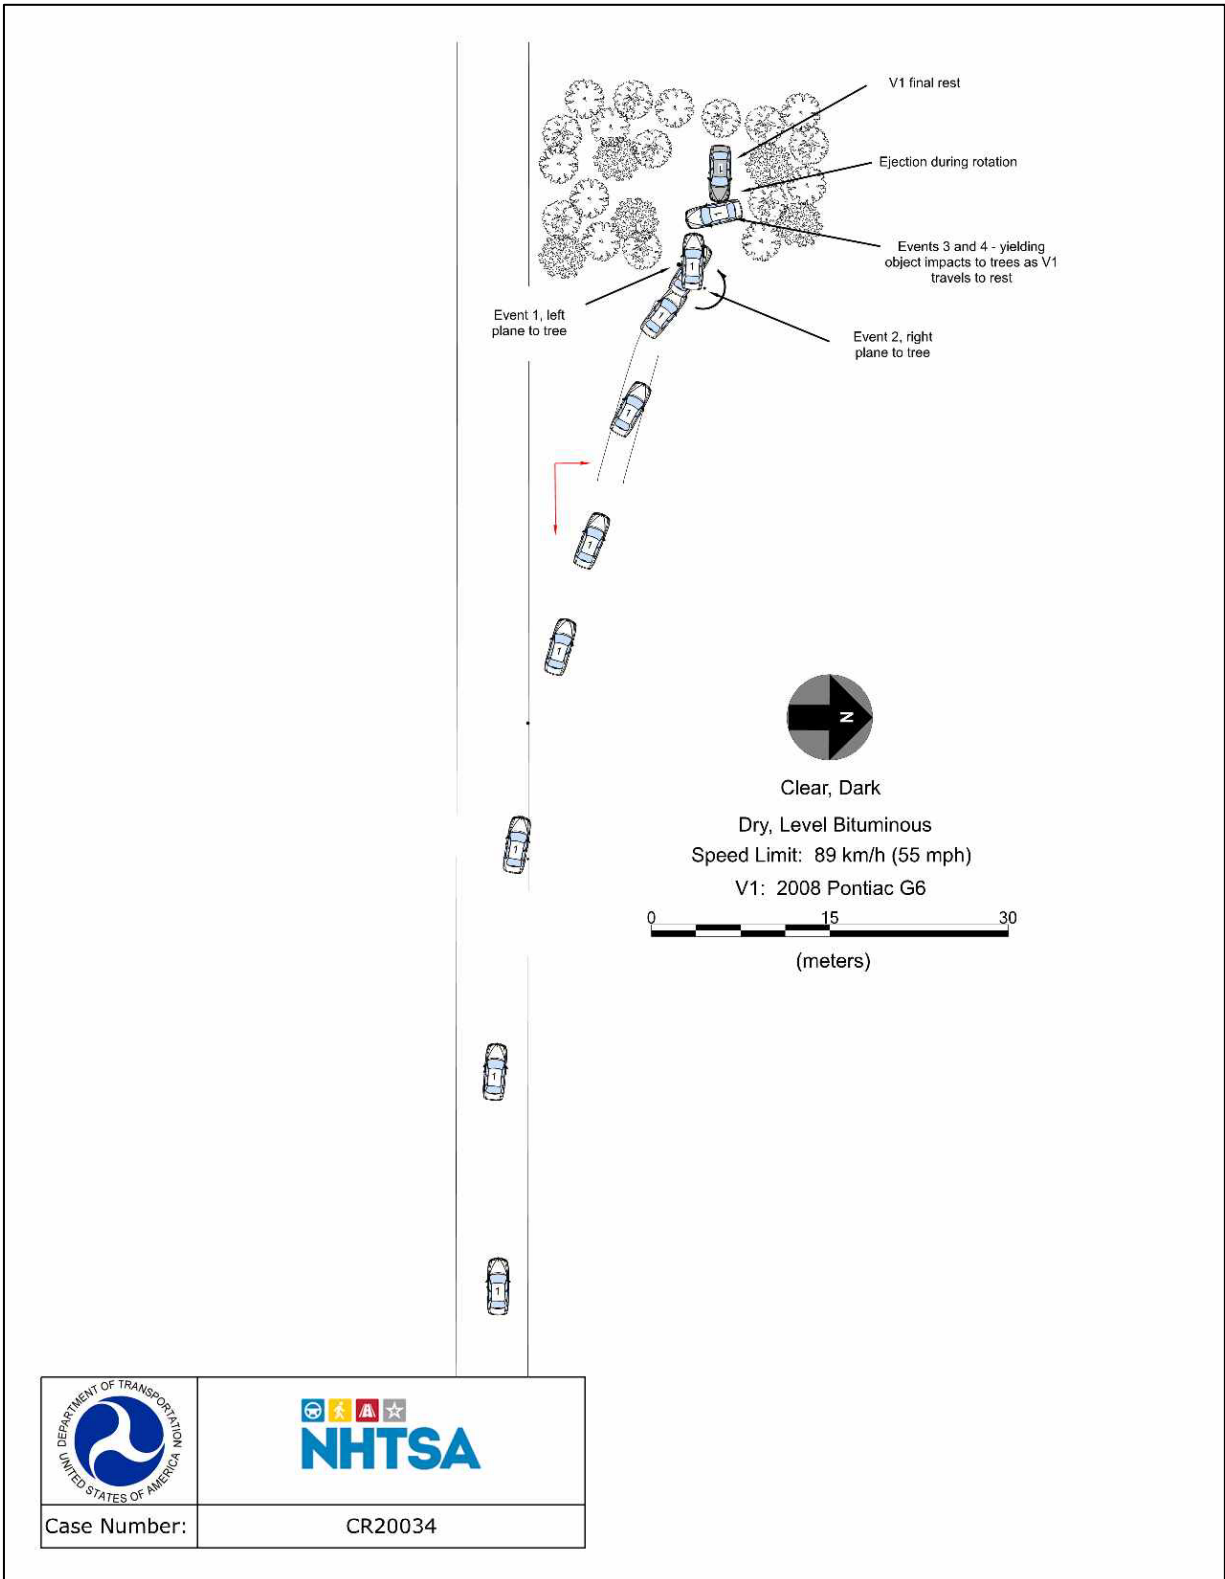
# Crash Diagram

As the Pontiac rotated counterclockwise about the first tree impact, its right rear corner struck the second tree and deformed. The infant responded to the 3 o'clock direction of force and the centripetal force of the rotation with a rightward and upward trajectory. He was ejected through the backlight opening and the infant struck the ground likely sustaining the identified injuries. His ejected location was not documented by the police. The infant was transported by helicopter to a regional trauma center and was pronounced deceased.
