DOT HS 813 418

**Special Crash Investigations:  
On-Site Move-Over-Law Crash  
Investigation;  
Vehicle: 2016 Dodge Challenger;  
Location: Texas;  
Crash Date: December 2020**

**Special Crash Investigations**  
**On-Site Move-Over-Law Crash Investigation**  
**Case Number: CR20039**  
**Vehicle: 2016 Dodge Challenger**  
**Location: Texas**  
**Crash Date: December 2020**

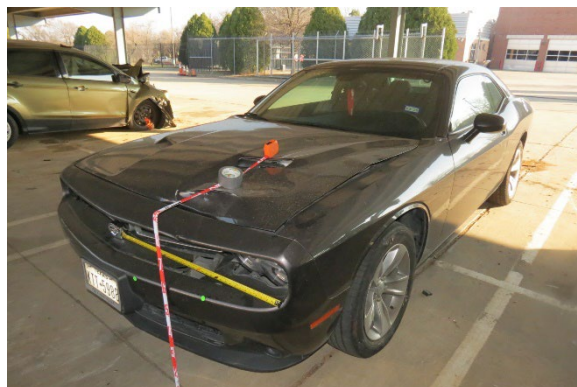
*Figure 1. 2016 Dodge Challenger*

The Dodge sustained damage to the front plane during the impact with the non-occupant. There was direct damage to the bumper fascia, upper and lower grilles, left head lamp assembly, and hood (See Figure 1 above). The direct damage started 24 cm (9.4 in) right of the left front bumper corner and extended 39 cm (15.4 in) to the right. There was no crush damage to the bumper but the non-occupant wrapped onto the hood (Figure 21). The contact to the hood extended approximately 70 cm (28 in) rearward and was 18 cm (7.1 in) wide. The maximum longitudinal crush to the front of the hood was approximately 5 cm (2 in), occurring 53 cm (22.0 in) left of the centerline. The collision deformation classification (CDC) for this impact was 12FYEN1. Scratching and dents were noted on the left side plane, but this damage occurred as police officers forced the vehicle to a stop and apprehended the driver.

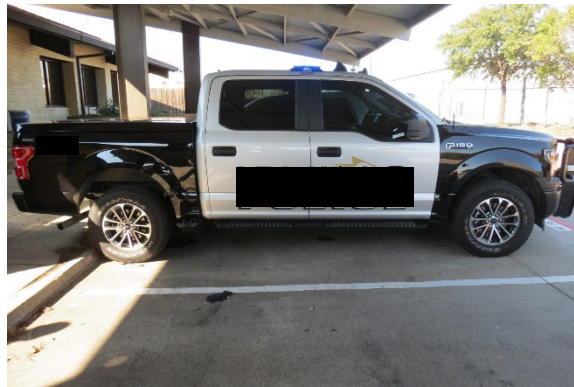
This was the only Ford police vehicle at the scene. It was also the only police or fire department vehicle that moved during the incident sequence. An officer moved this vehicle from the left lane to the shoulder, blocking the Dodge's movement eastward (see scene diagram at the end of this report). The Ford's front and back sections were painted black and the center section was light gray (Figure 5). The city name and "POLICE" were emblazoned across the doors in black and white, respectively, and "POLICE" was displayed across the front of the hood and on the tailgate in a tan color. All lettering was applied with reflective decals.

*Figure 5. Color scheme on police Ford F-150*

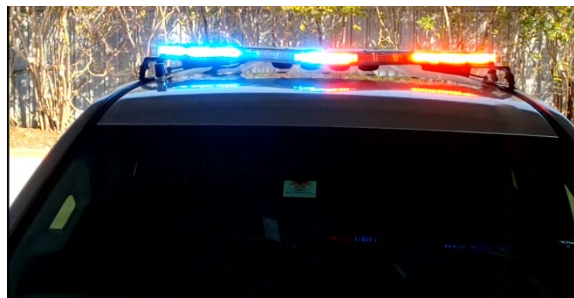
There were six Chevrolet Tahoe police vehicles at the scene. One was positioned at the far west end of the scene and the other five were at the east end. All were parked facing west, with their front plane lights facing the eastbound Dodge. The top plane was equipped with an LED light bar manufactured by Federal Signal. The right and left halves were illuminated with red and blue flashing LEDs. The center of the light bar jutted forward to form a triangular shape (Figure 8). This portion featured three blue and three red lights that were illuminated from the center in sequence, outward, then back to the center. This gave the illusion of lights shooting out to the sides and back again. The remainder of the LEDs were manufactured by Whelen. The push bar mounted on the front plane was equipped with eight small LEDs (Figure 9), arranged horizontally, that flashed red, blue, and white in four different patterns. The headlamps remained steadily illuminated but the high-beam lights would flash on and off quickly as did a thin light strip between the headlamp and the high-beam globes.

*Figure 8. Exemplar roof light equipment of exemplar Chevrolet*

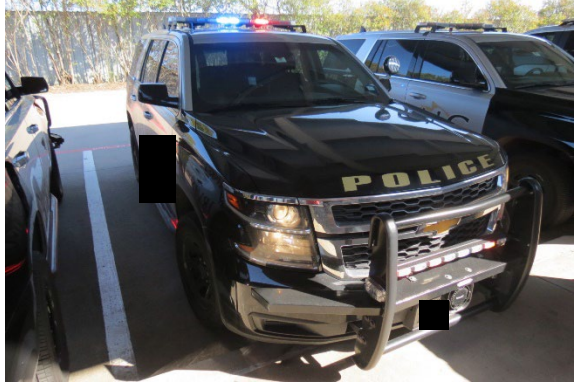
*Figure 9. Exemplar police Chevrolet, top and front warning lighting*

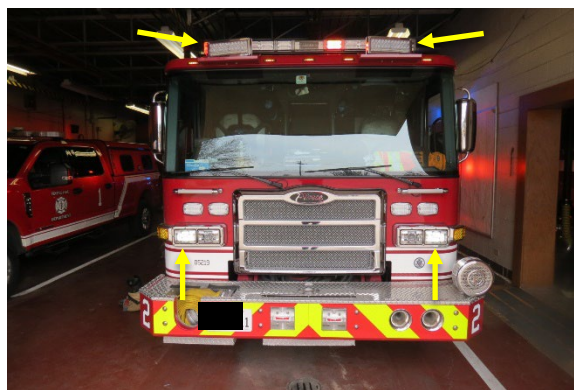
The fire department's Pierce engine unit was dispatched to the initial crash scene and was parked in the right lane, facing west, at the west end of the initial crash scene, an unknown distance east of one of the police vehicles. Emergency/warning lighting on the top and front planes (Figure 10) included the light bar atop the cab which featured six red LEDs on each side of the Opticon (a device that communicates with stop lights at intersections). For an unknown reason, the third and fifth LEDs on each side did not flash. Large, white LED non-flashing flood lights were mounted diagonally at both front roof corners. Three small red non-flashing LEDs were mounted horizontally at the windshield header and one more on the outboard side of each of the flood lights. There were two horizontally mounted LEDs on either side of the grille. Only the outside LEDs flashed white. The headlights, immediately below the LEDs, remained on.

*Figure 10. Front of the engine unit with arrows indicating flashing lights (some top bar lights are obscured by flood lights)*

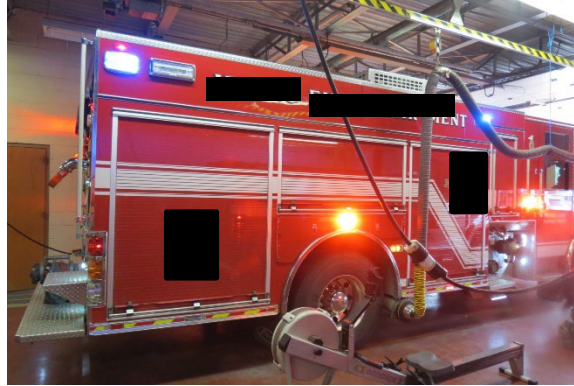
The side planes (Figure 11) were equipped with a flashing red LED at the front bumper level and turn lights on the front corners which remained continuously on. One small LED was mounted on the roof side rail directly below the top light bar that remained continuously illuminated. Blue and red LEDs were mounted at the upper level at the center and rear aspects of the truck, respectively. Red flashing LEDs were mounted above the pump controls at the center of the truck and above the back wheels. There were small red lights mounted forward of the rear wheel well and at the upper back corner. These two lights remained continuously on. Small red flashing LEDs were mounted at the sill level aft of the pump controls and aft of the back wheel well. There were also two flood light mounted on the side planes that could be illuminated if necessary.

*Figure 11. Right side of the engine unit*

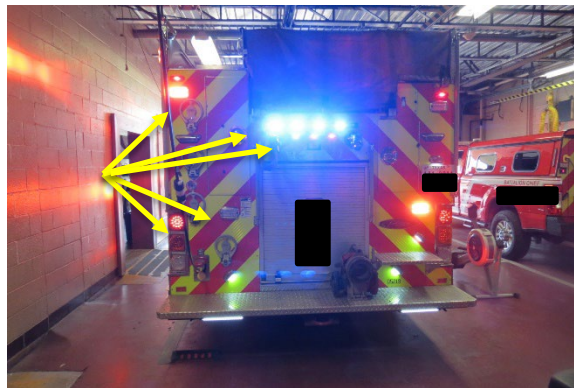
The back plane (Figure 12) was painted with red and yellow diagonal striping. All stripes emerged from the outboard edge and angled toward the centerline. Each outboard aspect of the back plane was equipped with a small light at the upper corner that remained continuously on and immediately below was an LED that flashed red. At the mid-level, flashing blue and red LEDs were mounted to the left and right sides, respectively, of the equipment door. Red brake

lights, also along the outboard edge, remained continuously on. Above the equipment door, three horizontally mounted red lights remained continuously on and mounted directly above was a horizontal array of eight small LEDs, alternating red and blue was mounted above the three lights at the top center. These flashed all one color, then the other in unison. In addition were several small white work lights.

*Figure 12. Back of the engine unit*

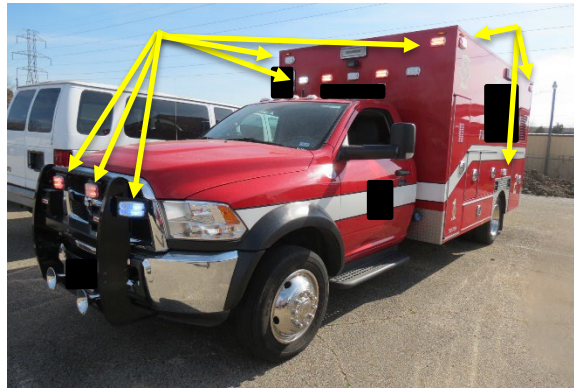
*Figure 13. Front and side plane lighting on the ambulance*

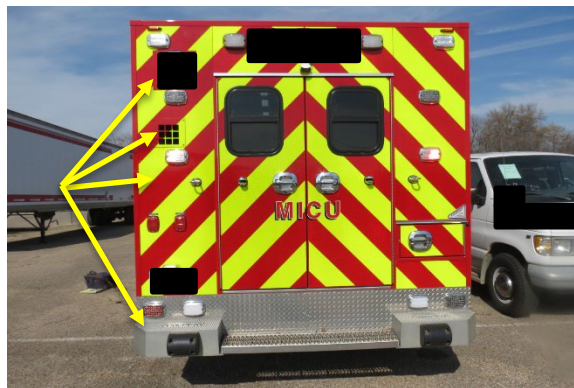
The back plane of the ambulance (Figure 14) featured an LED at each upper corner as well as mid-level on both sides of the doors. The upper LEDs flashed red only and the mid-level LEDs flashed half blue and half red. Brake lights were mounted to each outboard aspect, just above the bumper and below the upper corner LEDs. A white light was mounted above each door and would only illuminate when the doors were opened.

*Figure 14. Back plane of the ambulance*

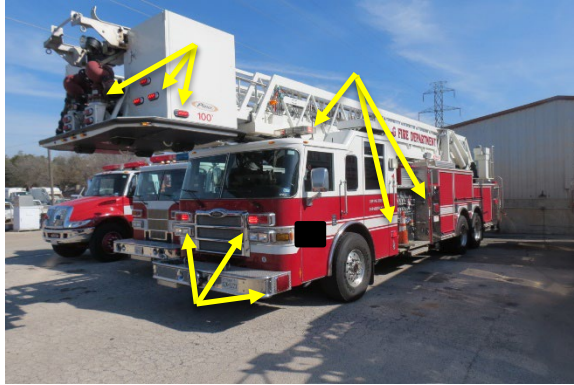
The fire department had one of its large Pierce ladder trucks (Figure 15) called a “blocker” dispatched to the initial crash scene. It was used to block the roadway, and to protect working emergency personnel. It was situated an unknown distance west of the blocker and was also parked at a diagonal, facing southwest. Ten small, red LEDs were mounted to the front side of the bucket and one LED was mounted to the lower front corner on each side. There were two red flashing lights, mounted horizontally, on either side of the grille and the low beam headlights remained continuously illuminated. Light bars were mounted on either side of the ladder on the cab roof. Each of the light bars had four red flashing LEDs, including one facing each side.

Figure 15. Left oblique view of the ladder truck

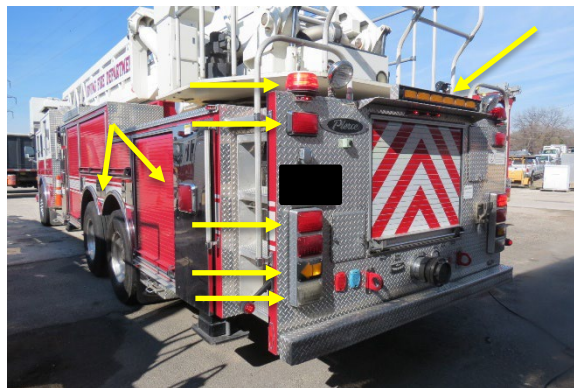
Each side of the ladder truck featured a blinking light on the side of the front bumper and a small flashing light at the top of the A-pillar. Three LEDs were mounted along each side of the truck as well as a small red LED between the wheel wells and a flood light at the top of the center section. The back plane of the ladder truck featured three red flashing lights, including a red flashing dome light at the top, and two other red flashing lights mounted at each outboard aspect (Figure 16). The turn signal light remained on continuously. There were three red lights mounted horizontally just above the rear equipment door. Immediately above those lights, a series of six red lights were mounted horizontally at the top center and these could be illuminated in different patterns, indicating the proper direction for following traffic. A red and white diagonal “A-shaped” pattern was painted on the rear equipment door of the truck.

Figure 16. Back of the ladder truck

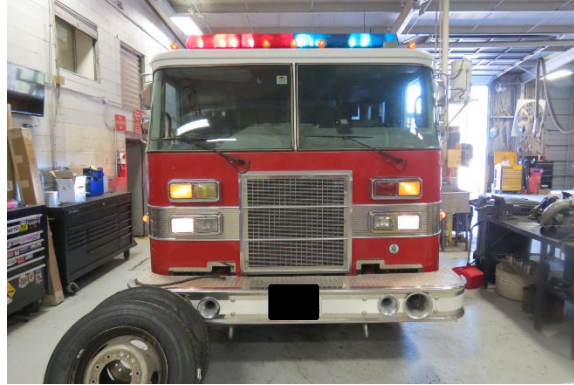
The fire department used retired fire trucks as “blockers,” which were parked at a diagonal across a roadway, blocking traffic that would be flowing toward the crash zone to be cleared. The blocker used in this incident (Figure 17) was a retired Pierce engine unit that was parked on the east end of the crash scene, facing southwest. All lighting on this vehicle was of incandescent bulbs unless otherwise indicated. The roof of the cab was equipped with a light bar manufactured by Public Safety Equipment. It was comprised of four red bulbs on the right and four blue bulbs on the left. Each bulb remained illuminated and a mirror circled around each bulb. The front of the cab featured two lights on either side of the grille, arranged horizontally. Each inboard light flashed white and the outboard light flashed red, each in a non-synchronous pattern.

*Figure 17. Front of the blocker engine unit*

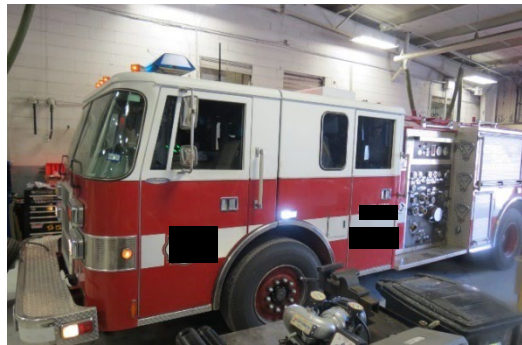
The right and left planes of the blocker were identical. There were red and white lights on the sides of the front bumper. The white lights remained on continuously and the red lights would periodically flash. Over each front wheel were LEDs (Figure 18), half flashing white and the other half red in no uniform pattern. LEDs were also mounted over the back wheels, constantly flashing red. A retrofitted “arrow board” was attached to the upper rear of each side of the truck (Figure 19). The board featured a 127 cm (50.0 in) horizontal light band and arrows at either end of the horizontal band which measured 38 cm (15.0 in) in height. All lighting was made of individual LED light packs, each 13 cm (5.1 in) in length. The arrow board could be illuminated and timed such that only the right or left or both arrows would flash, depending on which direction traffic was to be directed.

*Figure 18. Front and left planes of the blocker unit*

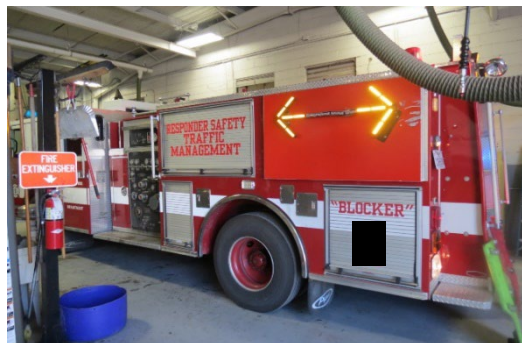
*Figure 19. "Blocker" engine unit, left arrow board*

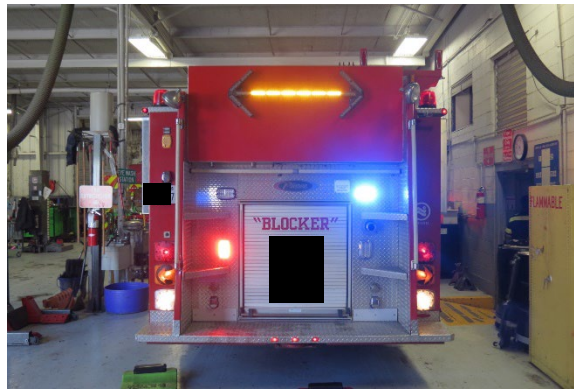
The back of the truck (Figure 20) featured red rotating mirror dome lights on each top corner. The arrow board was placed at the upper center and below it, LED units were mounted to the back bulkhead of the truck. The upper pair was mounted in horizontal fashion and would flash blue in an irregular, asynchronous manner. Below each of these lights were another set of LEDs that were mounted vertically. These flashed back and forth in red. Each outboard aspect of the back plane also had brake (red), turn (red), and reverse (white) lights that were continuously illuminated.

*Figure 20. Back of the blocker truck*
