DOT HS 813 511

**Special Crash Investigations:
On-Site Reported Unintended
Acceleration Crash Investigation;
Vehicle: 2009 Hyundai Santa Fe;
Location: Pennsylvania;
Crash Date: July 2017**

Special Crash Investigations
On-Site Reported Unintended Acceleration Crash Investigation
Office of Defects Investigation
Case No: CR20038
Vehicle: 2009 Hyundai Santa Fe
Location: Pennsylvania
Crash Date: July 2017

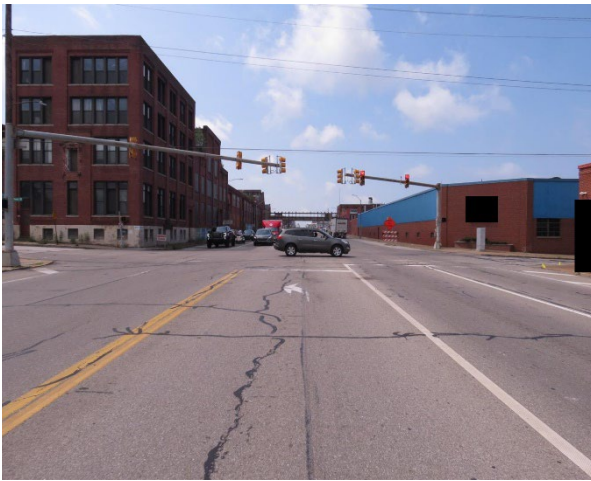
Figure 2. Viewing west of the crash scene, looking toward Event 1

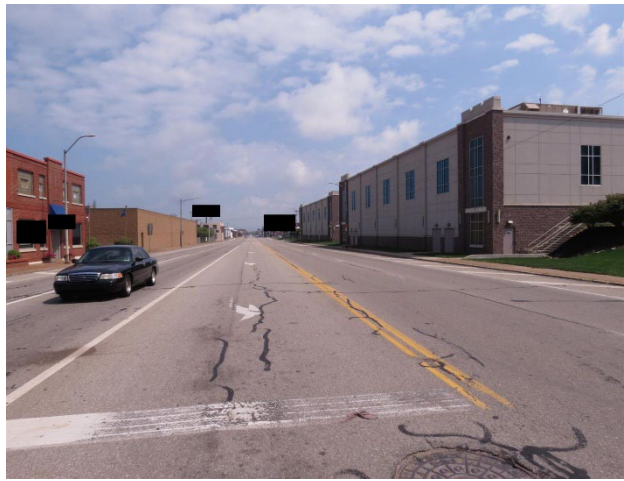
Figure 3. Viewing east of the crash scene, looking back

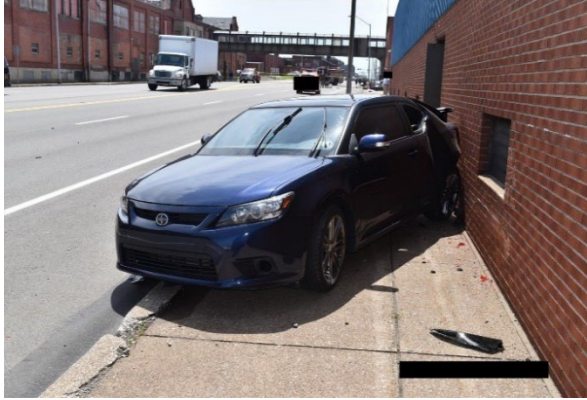
The Hyundai's greenhouse structures, above the beltline level, completely separated during the underride crash (Event 1). The Hyundai emerged from the other side of the trailer and then struck the back plane of the turning Scion (Event 2). The force of this impact displaced the Scion forward and to its right. It separated from the Hyundai with a clockwise rotation, sliding through the right westbound lane, mounting the sidewalk, and striking a building (Event 3) approximately 43 m (141 ft) from its initial point of impact (Figure 5).

Figure 5. Final rest of the Scion looking west (On-scene police image)

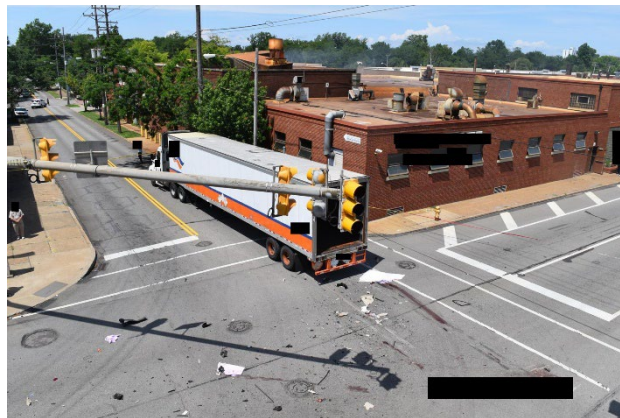
After the crash, the Freightliner crossed through the intersection and came to a controlled stop in the northbound lane (Figure 7).

Figure 7. Overview of the Freightliner looking northeast (On-scene police image)

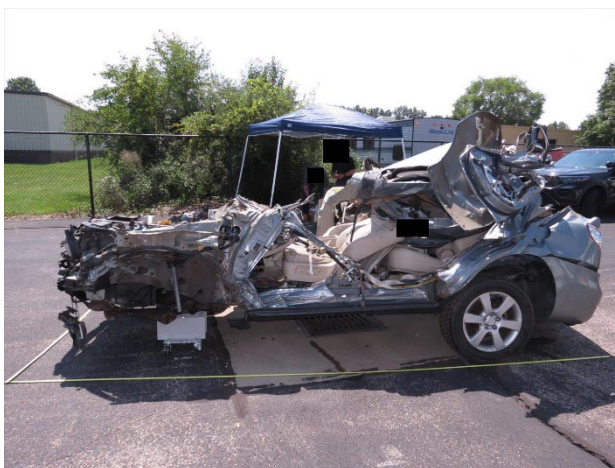
The 2009 Hyundai Santa Fe (Figure 8) was an SUV manufactured in November 2009 and identified by the Vehicle Identification Number (VIN) 5NMSH73E79Hxxxxxx. The Hyundai was an all-wheel-drive platform powered by a 3.3-liter, gasoline engine linked to an automatic transmission on a 270 cm (106.3 in) wheelbase. The gross vehicle weight rating was 2,400 kg (5,291 lb), with gross axle weight ratings of 1,368 kg (3,015 lb) front and 1,032 kg (2,275 lb) rear. The vehicle manufacturer's recommended tire size was P235/60R18 with recommended cold tire pressures of 207 kPa (30 psi) front and rear. At the time of the SCI inspection, the Hyundai had Mastercraft Courser HSX tires of the manufacturer's recommended size at all four axle positions. All four tires' treads were 6 mm (8/32 in) or greater.

Figure 8. Left side view of the Hyundai

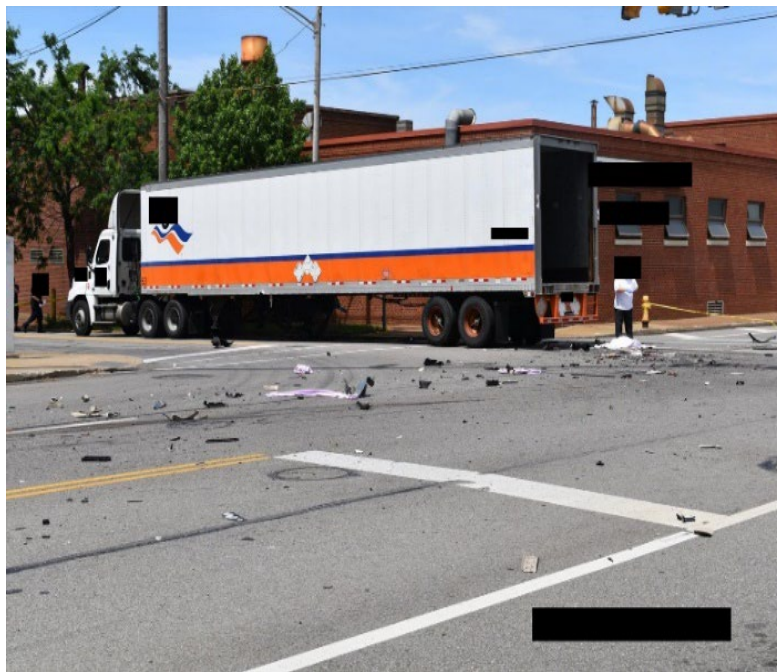
The Freightliner (Figure 19) was not available for inspection and all information was derived from the police report, VIN decoder, and on-scene photographs. The truck-tractor was identified by the VIN 3AKGGEDV0FSxxxxxx. It was powered by a 12.8-liter, I6 diesel, Detroit DD13 engine and had drum air brakes. The gross vehicle weight rating was 14,969 kg (33,001 lb) and above. The tractor was connected to a 4.1 m (13.4 ft) tall by 16.2 m (53.0 ft) long trailer that was transporting less than 2,268 kg (5,000 lb) of product.

Figure 19. Left-rear oblique view of the semi truck's final rest position looking northeast (On-scene police image)
