DOT HS 813 516

**Special Crash Investigations:
Remote Move-Over-Law Crash
Investigation;
Vehicle: 2017 Ford Explorer;
Location: Texas;
Date: January 2020**

**Special Crash Investigations
Remote Move-Over-Law Crash Investigation
Case Number: CR20006
Vehicle: 2017 Ford Explorer
Location: Texas
Crash Date: January 2020**

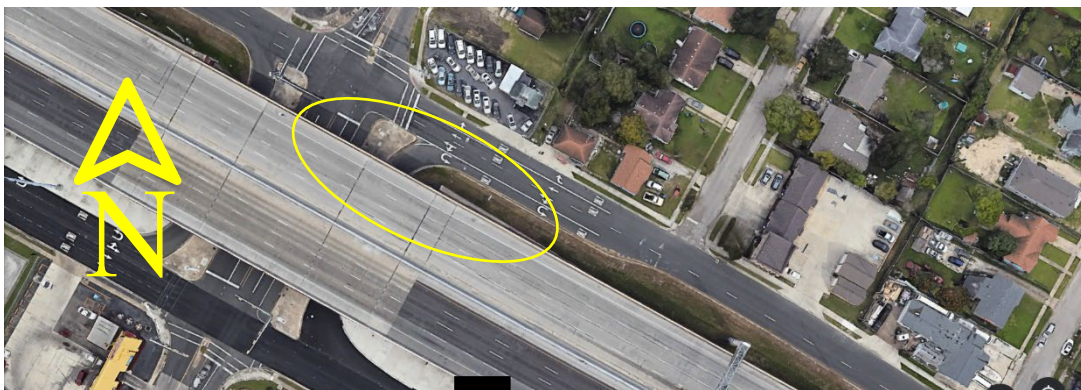
The Chevrolet Silverado (vehicle 5) was traveling northwest in the north westbound lanes (Figure 3) at an unknown speed. Court reports and witness accounts indicated that the Chevrolet driver was operating the vehicle erratically, moving over all lanes of traffic. Furthermore, the police crash report indicated the driver's blood alcohol concentration was .21 g/dL.

Figure 3. Overhead view of the crash area. Google Maps © 2022 Maxar Technologies, U.S. Geological Survey map data.

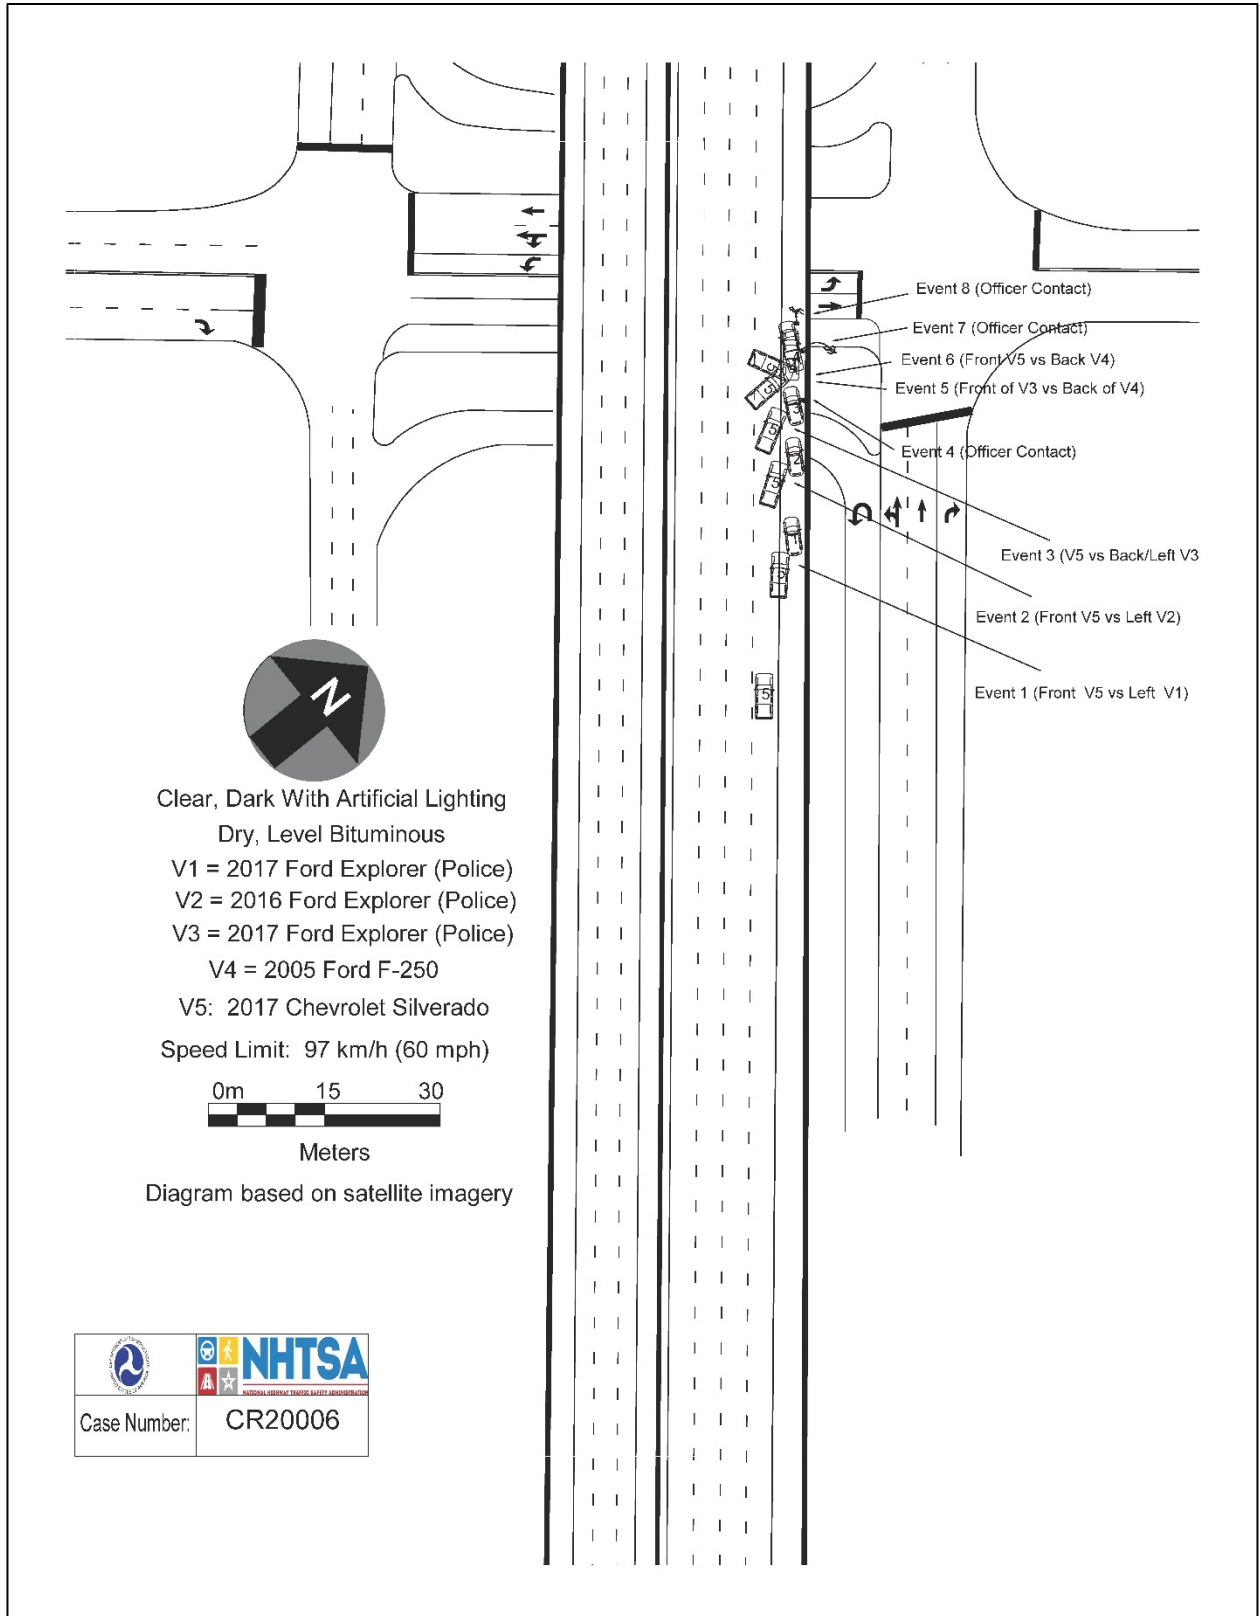
Crash Diagram

This crash occurred at night in artificially lighted conditions on the northbound shoulder of an elevated, urban, four-lane, physically divided State highway. Local weather reports indicated clear skies, no wind, and a temperature of 11 °C (51 °F). The bituminous roadway ran southeast/northwest with four northwest-bound through lanes that were separated from the three southeast-bound lanes by a concrete barrier. The travel lanes were approximately 3.7 m (12 ft) wide, and the right shoulder was approximately 3.4 m (11 ft) wide. Roadway markings consisted of a solid white edge line, dashed lane lines, and a solid yellow median line. All roadway measurements were scaled from satellite imagery. The speed limit was 97 km/h (60 mph). A crash diagram is included at the end of this report.
