DOT HS 813 541

Special Crash Investigations: On-Site Driver Air Bag Inflator Rupture Investigation; Vehicle: 2010 Ford Fusion; Location: Florida; Crash Date: June 2021

Special Crash Investigations
On-Site Driver Air Bag Inflator Rupture Crash Investigation
Office of Defects Investigation
Case No.: CR21018
Vehicle: 2010 Ford Fusion
Location: Florida
Crash Date: June 2021

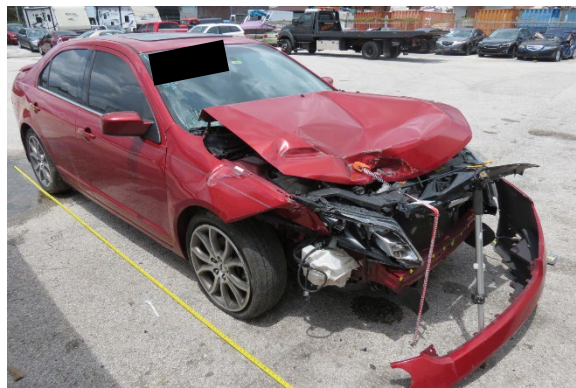
Figure 1. 2010 Ford Fusion

This report documents the on-site investigation of a crash involving a 2010 Ford Fusion (Figure 1) and a 2001 Dodge Ram in which the Ford driver's frontal air bag inflator ruptured, resulting in a severe laceration to the abdomen of the 23-year-old male driver. In July 2021 the National Highway Traffic Safety Administration initiated this crash investigation through notification from the Ford driver's legal counsel. The crash occurred in June 2021 and the investigation was assigned to the Special Crash Investigation (SCI) team at Crash Research & Analysis in July 2021. The Ford and crash scene were inspected in August 2021.

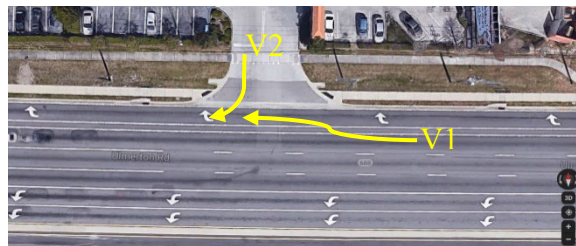
*Figure 2. Overhead view of crash site.
Image obtained from online mapping
service*

This crash occurred during the afternoon at the 3-leg intersection of a suburban 10-lane, State highway (Figure 2). The weather conditions were cloudy with 19 km/h (12 mph) winds from the southwest and a temperature of 30 °C (86 °F). The police crash report (PCR) listed the conditions as clear and dry. The Ford's trafficway traversed in an east/west compass direction with three westbound through lanes, two left turn lanes, and a right turn lane that were separated from the four eastbound lanes by a raised concrete median strip. The roadway traveled by the Dodge was a 12 m (39.3 ft) wide driveway that connected the State highway to a shopping plaza parking area. Both roadways were level and bituminous. Roadway markings for the Ford consisted of a solid white edge line, solid white right and left turn lane lines, dashed lane lines, and a solid yellow median line. The speed limit for the Ford was 72 km/h (45 mph). A crash diagram is included at the end of this report.

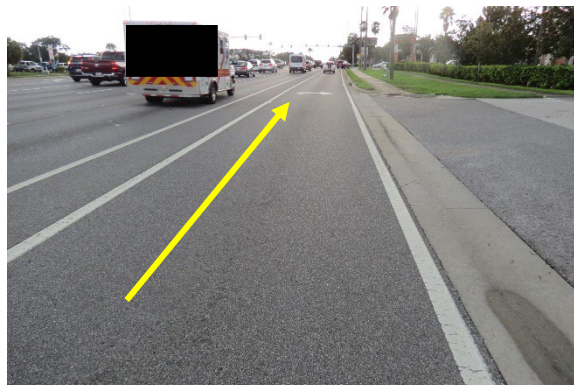
*Figure 3. West view of the Ford's
approach to impact area*

The Ford was traveling west in the right lane (Figure 3) at an EDR-reported speed of 64 km/h (39.8 mph) 5.0-seconds prior to algorithm enable (AE). At 3.5 seconds prior to AE, the driver applied the service brake and the vehicle's speed reduced to 54 km/h (33.6 mph) at AE. He stated to the police that he was changing lanes prior to the crash, from left to right. The EDR data showed that the driver gradually steered to the right to change lanes then braked quickly and steered left in an attempt to avoid the collision.

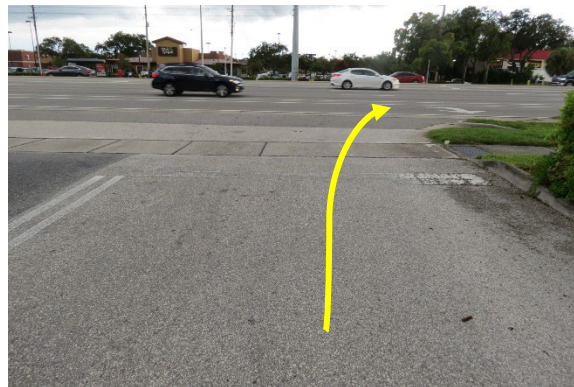
Figure 4. South view of Dodge's travel path

The Dodge initially headed south on the driveway (Figure 4) from the shopping plaza and its driver intended to turn right onto the westbound roadway.

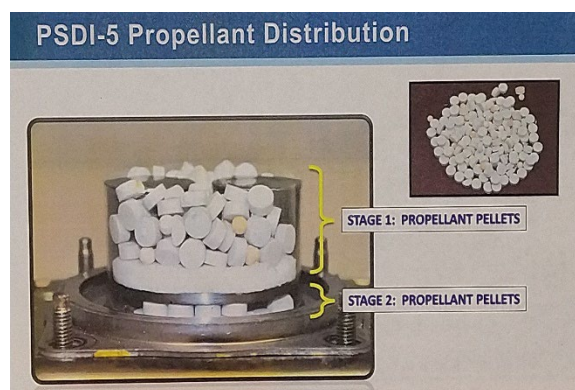
Figure 9. Cross section of PSDI-5 air bag inflator (image used with permission)

The report pertaining to the description of the Takata air bag inflator defect stated "Takata is submitting this defect information report (DIR) to address concerns shown in PSDI-5 PSAN air bag inflators that use calcium sulfate as a desiccant." A description of the cause of the defect stated "The propellant tablets in some of the subject inflators may experience an alteration over time, which could potentially lead to over-aggressive combustion in the event of an air bag deployment. Depending on the circumstances, this potential condition could create excessive

internal pressure when the air bag is deployed, which could result in the body of the inflator rupturing on deployment. Based upon Takata's investigation to date, the potential for such ruptures may occur in some of the subject inflators after several years of exposure to persistent conditions of high absolute humidity. The potential for rupture may also be influenced by other factors, including manufacturing variability or vehicle type."

The driver frontal air bag inflator was manufactured by Takata and according to a Takata representative present at the vehicle inspection, was original equipment (Figure 8). The inflator was housed in the hub of the steering wheel and was divided into two sections for Stage 1 and Stage 2 deployment (Figure 9). Both sections contained a majority of ammonium nitrate pellets (propellant) mixed with small darker colored balls of a calcium sulfate desiccant (drying agent). The two sections were encased in a metal mesh filter and each section was separated by two horizontal metal dividers that fit against the perimeter of the inflator and around the vertical squibs. The inflator was mounted in the steering wheel hub, in line with the steering column, with the stage 2 side facing the instrument panel. The stage 1 side faced the driver. The inflator was 7.5 cm (3.0 in) in diameter and 4.5 cm (1.8 in) in height. The original height of the inflator was 3.4 cm (1.3 in) but the detonation of the propellant caused both the top and bottom to bulge (Figure 10).
