DOT HS 813 571

**Special Crash Investigations:
Remote Move-Over-Law Crash
Investigation;
Vehicle: 2006 GMC TC6500
Wrecker/Nonmotorists;
Location: Montana;
Crash Date: October 2020**

Special Crash Investigations
Remote Move-Over-Law Crash Investigation
Case Number: DS21007
Vehicle: 2006 GMC TC6500 Rollback Wrecker/Nonmotorists
Location: Montana
Crash Date: October 2020

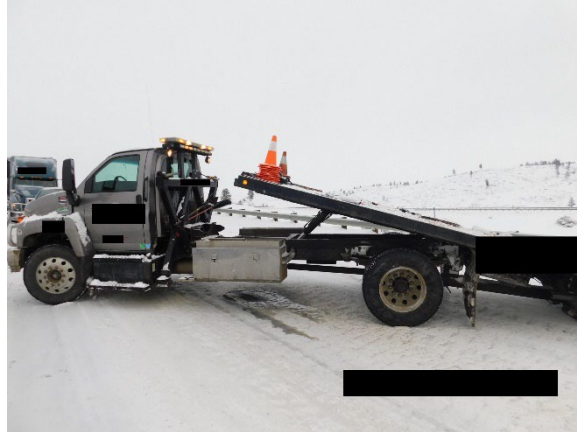
The struck subject vehicle was a 2006 GMC TC6500 medium/heavy truck configured as a rollback wrecker (Figure 1). The GMC wrecker was in the second lane from the right in front of the U-Haul trailer. The deck was tilted, and the operator was near the right side of the tow bed and was in the process of loading the trailer. The second tow truck was east of the GMC wrecker in the same lane. The Ford pickup from the previous crash was already secured to the tow truck for travel. The 28-year-old and 37-year-old male tow truck operators (nonmotorists) were on the roadway near the rollback wrecker. Both wore reflective clothing.

Figure 1. Struck subject vehicle, 2006 GMC TC6500 rollback wrecker (police photo)

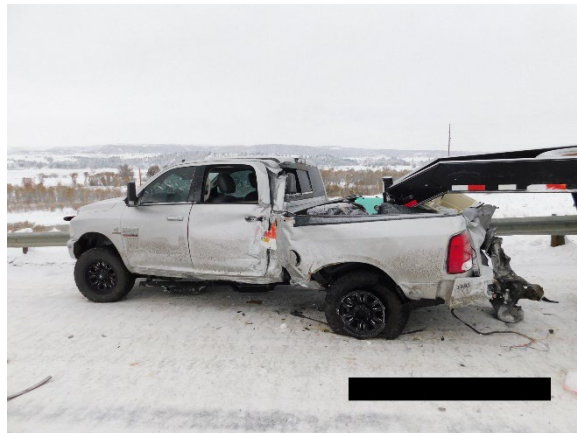
Figure 2. Striking vehicle, 2016 Ram 3500 with trailer (police photo)

The striking vehicle was a 2016 Ram pickup (Figure 2) driven by a belted 18-year-old male. A belted 13-year-old male was seated in the front right passenger seat. The Ram was in the first lane from right and was pulling a 12 m (40 ft) gooseneck trailer. The other involved vehicle was a 2016 Volvo VLN tractor that was driven by a 57-year-old male and was pulling a 2019 East 16 m (53 ft) trailer. It was traveling ahead of the Ram in the same lane. The Volvo driver saw the “Wrecker Ahead” sign and began slowing.

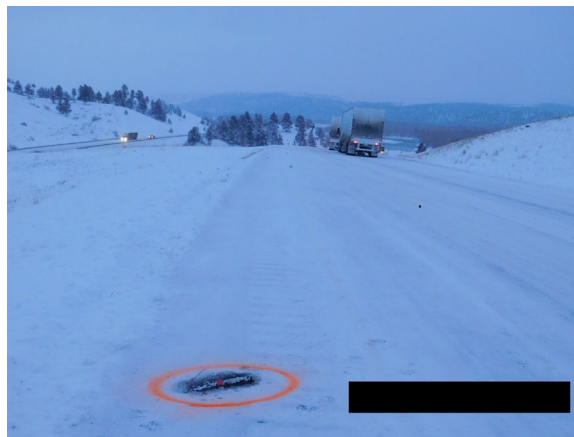
The crash site was in the eastbound lanes of a two-lane divided interstate highway (Figure 3). The travel lanes were approximately 3.6 m (12 ft) wide and were separated by dashed white painted lines. The roadway was bordered on the left edge by a solid yellow painted fog line, a paved shoulder with a rumble strip, and a metal guardrail. The roadway was bordered on the right edge by a solid white painted fog line, a paved shoulder with a rumble strip, and a metal guardrail. Leading up to the crash site was a sweeping right curve with a negative grade. Directly before the crash site the roadway straightened out but continued downhill. At the time of the crash all the pavement markings were covered by snow and ice. The coefficient of friction was extremely low due to snow and ice conditions. It was dark at the time of the crash with no artificial illumination. The weather according to the nearest weather station was reported as -15 °C (5 °F), calm winds, 87 percent humidity, and snow showers. The speed limit was 128 km/h (80 mph) for vehicles and 112 km/h (70 mph) for commercial vehicles. A crash diagram and crash site satellite view are included at the end of this report.

Figure 3. Eastbound approach (police photo)

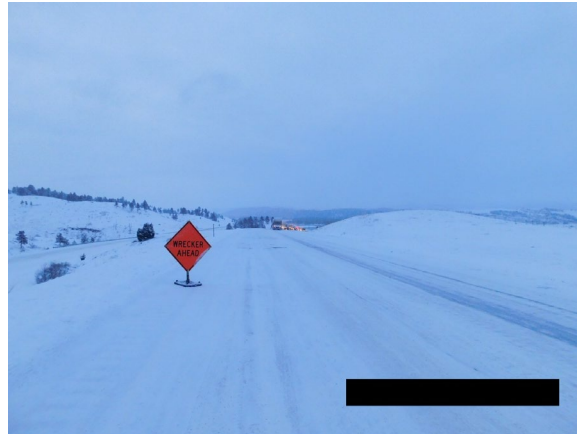
Two tow trucks were on-scene to recover the Ford and the trailer. A “Wrecker Ahead” sign had been placed on the roadside approximately 365 m (1,200 ft) west of the crash site (Figure 4). Several orange cones were on the roadway that appeared to be a part of a line of cones directing travel from the left lane to the right lane.

Figure 4. Eastbound approach “Wrecker Ahead” sign (police photo)

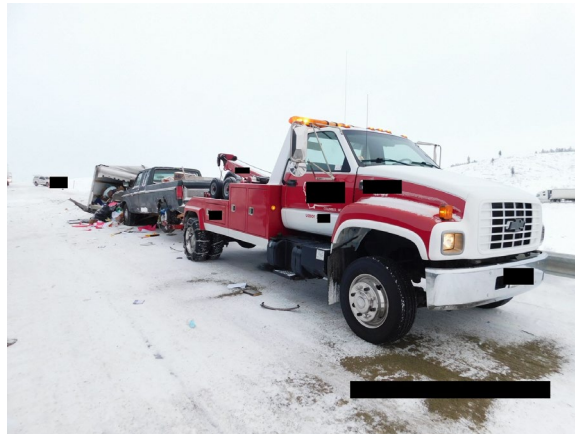
The 2002 Chevrolet C7 series medium truck (Figure 14) was identified using the VIN 1GBJ7H1C32Jxxxxxx. The manufacture date was unknown. The Chevrolet was a conventional cab-behind-engine incomplete chassis equipped with 7.2-liter, 6-cylinder, diesel engine, dual rear wheels, and a 6-speed manual transmission. It was a heavy-duty tow truck.

Figure 14. 2002 Chevrolet C7 with towed pickup, looking north (police photo)
