DOT HS 813 596

**Special Crash Investigations:
On-Site Reported Unintended
Acceleration Crash
Investigation;
Vehicle: 2011 Kia Sorento;
Location: Georgia;
Crash Date: July 2020**

Special Crash Investigations
On-Site Reported Unintended Acceleration Crash Investigation
Office of Defects Investigation
Case No: CR21029
Vehicle: 2011 Kia Sorento
Location: Georgia
Crash Date: July 2020

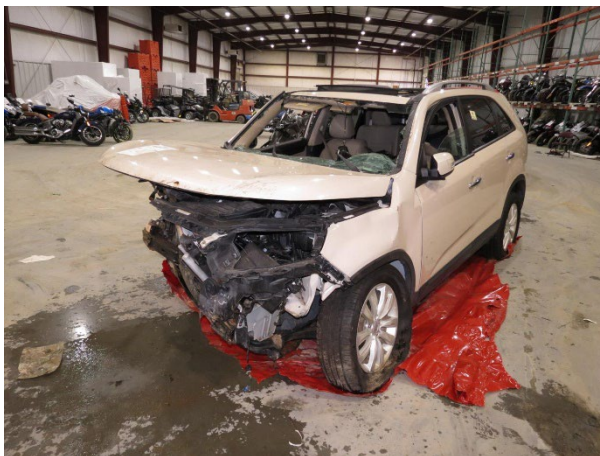
Figure 7. Left/front oblique view of the Kia

The Kia Sorento (Figure 7) was manufactured in October 2010 and was identified by the VIN 5XYKU4A29BGXXXXXX. The curb weight was 1,635 kg (3,605 lb.). The gross vehicle weight rating was 2,360 kg (5,203 lb.) with a front axle rating of 1,350 kg (2,976 lb.) and a rear axle rating of 1,450 kg (3,197 lb.). The 4-door, front-wheel drive, SUV was powered by a 3.5-liter 6-cylinder gasoline engine connected to an automatic transmission. The engine power was controlled by an electronic throttle control system. There was no mechanical linkage between the accelerator pedal and the throttle body. The service brakes were a four-wheel disk system combined with an antilock braking system (ABS). The vehicle manufacturer's recommended tire size was P235/60R18 front and rear with a recommended cold tire pressure of 230 kPa (33 psi). At the time of the SCI inspection, the Kia was equipped with Falken Pro G5 CVS model tires of the recommended size and mounted on OEM aluminum alloy wheels. The tire tread depth was 6 mm (7/32 in) or greater.

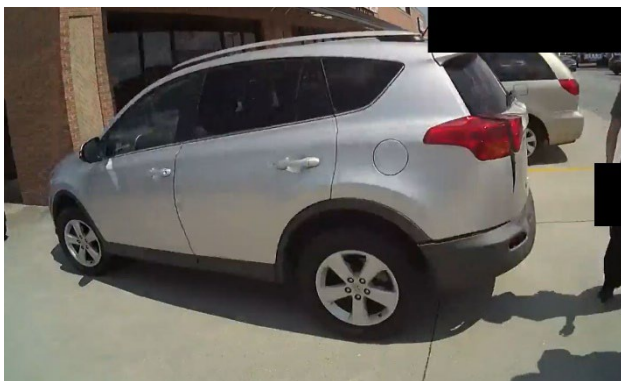
Figure 13. Police image of the Toyota

The Toyota (Figure 13) was identified by the VIN 2T3WFREV0EWXXXXXX. The 4-door SUV was powered by a 2.5 liter, inline 4-cylinder, gasoline engine connected to an automatic transmission with front-wheel drive. Although drivable, the owner was advised by police to have her vehicle towed to a local yard, where it was totaled by the insurance company and later sold off at an insurance vehicle salvage auction. This vehicle was not available for inspection. All vehicle information was derived from the VIN and on-scene and salvage yard pictures.

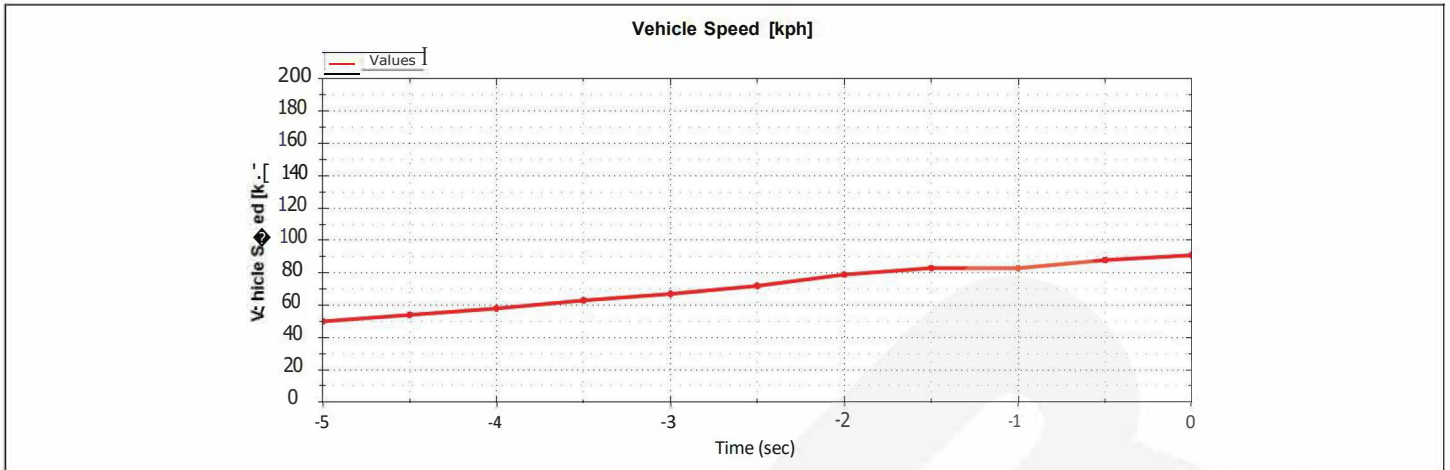
num	Time (sec)	Vehicle Speed [kph]
1	-5.0	50
2	-4.5	54
3	-4.0	58
4	-3.5	63
5	-3.0	67
6	-2.5	72
7	-2.0	79
8	-1.5	83
9	-1.0	83
10	-0.5	88
11	0.0	91

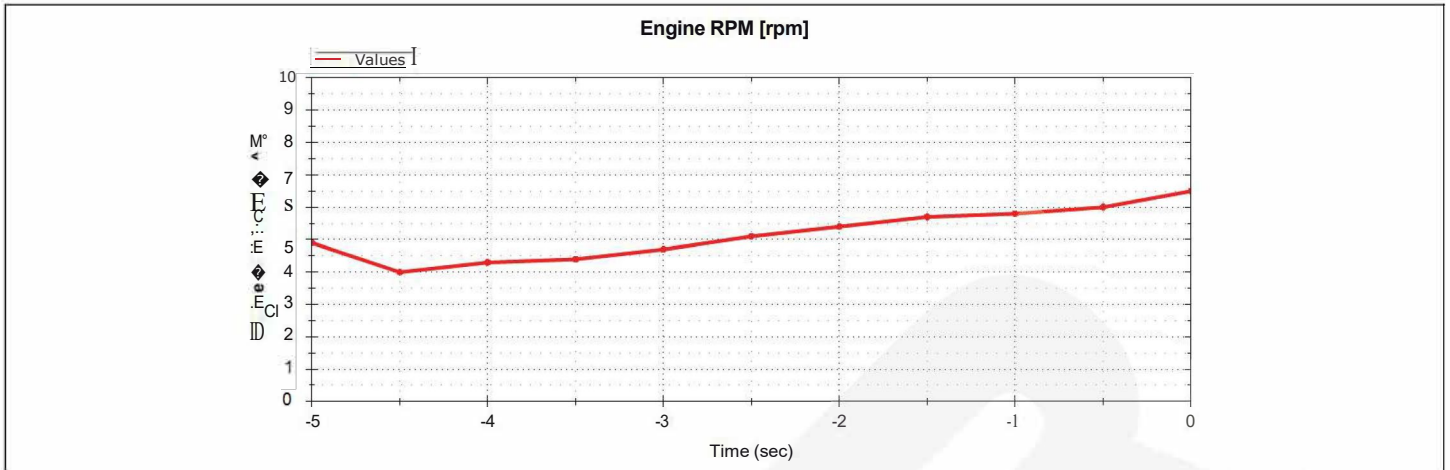
num	Time (sec)	Engine RPM [rpm]
1	-5_0	4900
2	-4.5	4000
3	-4_0	4300
4	-3.5	4400
5	-3.0	4700
6	-2.5	5100
7	-2.0	5400
8	-1.5	5700
9	-1.0	5800
10	-0.5	6000
11	0.0	6500

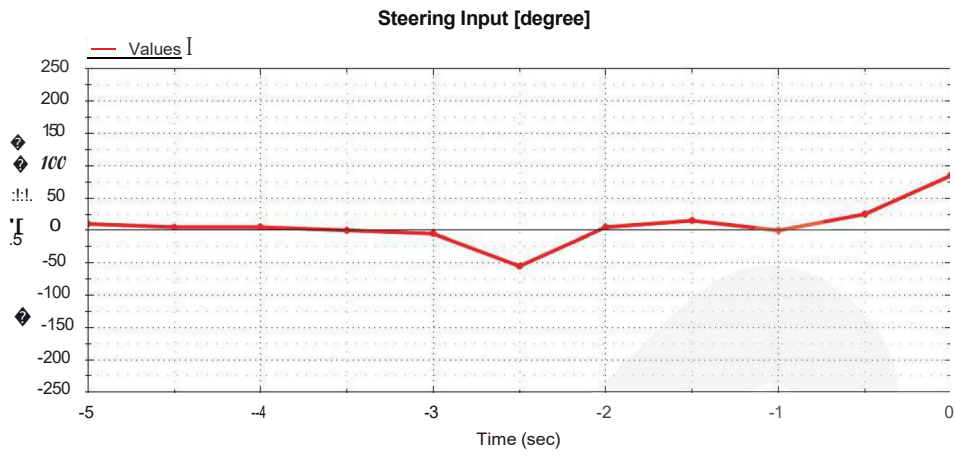
Steering Input

num	Time (sec)	Steering input [degree]
1	-5.0	10
2	-4.5	5
3	-4.0	5
4	-3.5	0
5	-3.0	-5
6	-2.5	-55
7	-2.0	5
8	-1.5	15
9	-1.0	0
10	-0.5	25
11	0.0	85

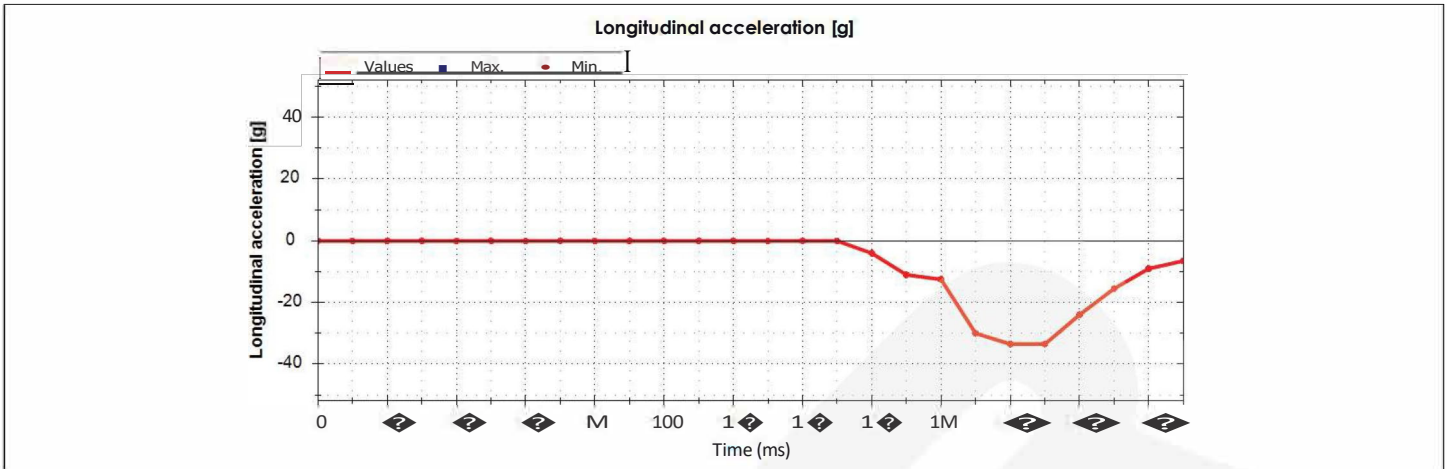
Longitudinal crash pulse acceleration Cg, 0 ,..., 250msec)

num	Time (ms)	Longitudinal acceleration [g]
1	0.0	0.0
2	10.0	0.0
3	20.0	0.0
4	30.0	0.0
5	40.0	0.0
6	50.0	0.0
7	60.0	0.0
8	70.0	0.0
9	80.0	0.0
10	90.0	0.0
11	100.0	0.0
12	110.0	0.0
13	120.0	0.0
14	130.0	0.0
15	140.0	0.0
16	150.0	0.0
17	160.0	-4.0
18	170.0	-11.0
19	180.0	-12.5
20	190.0	-30.0
21	200.0	-33.5
22	210.0	-33.5
23	220.0	-24.0
24	230.0	-15.5
25	240.0	-9.0
26	250.0	-6.5

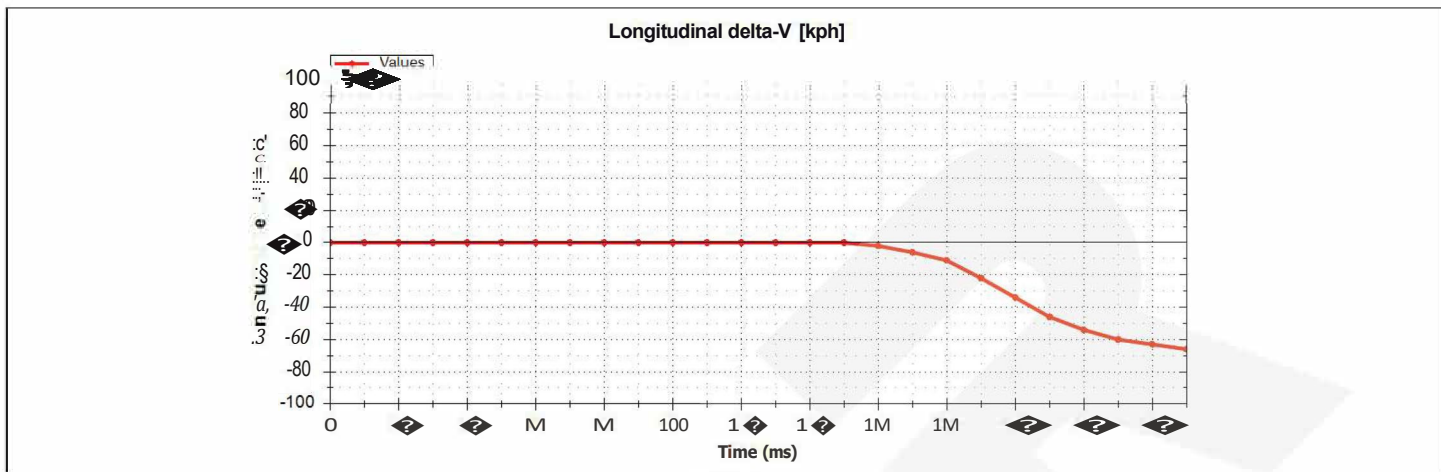
Longitudinal crash pulse delta-v (kph, 0 - 250msec)

Max. delta-V [kph]	-71
Time, Max. delta-V [msec]	297.5

num	Time (ms)	Longitudinal delta-V [kph]
1	0.0	0
2	10.0	0
3	20.0	0
4	30.0	0
5	40.0	0
6	50.0	0
7	60.0	0
8	70.0	0
9	80.0	0
10	90.0	0
11	100.0	0
12	110.0	0
13	120.0	0
14	130.0	0
15	140.0	0
16	150.0	0
17	160.0	-2
18	170.0	-6
19	180.0	-11
20	190.0	-22
21	200.0	-34
22	210.0	-46
23	220.0	-54
24	230.0	-60
25	240.0	-63
26	250.0	-66

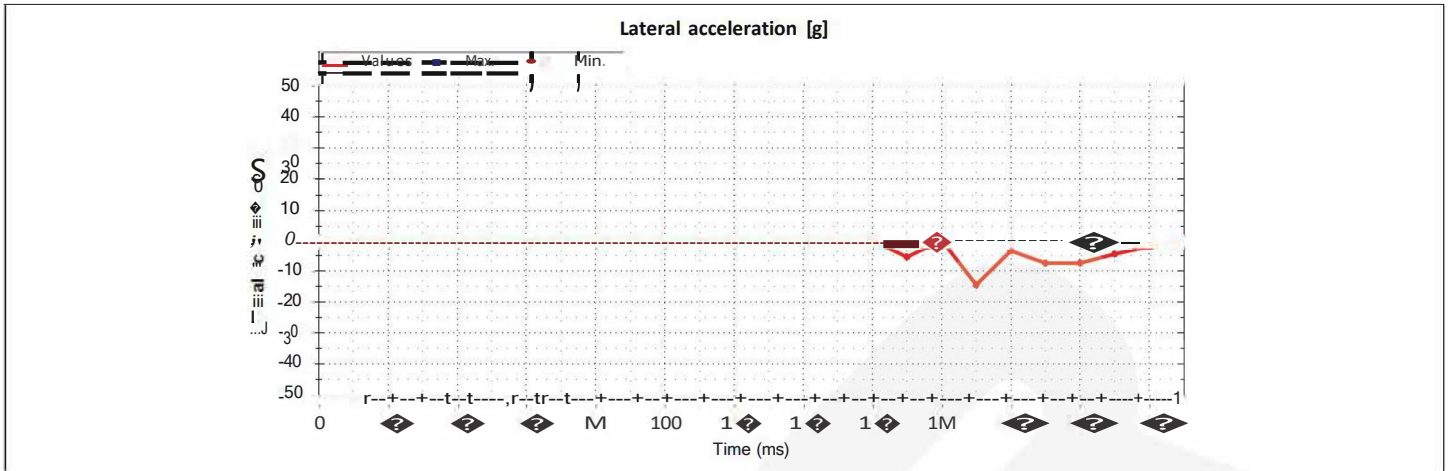
Lateral crash pulse acceleration Cg, 0 - 250msec)

num	Time (ms)	Lateral acceleration [g]
1	0.0	0.0
2	10.0	0.0
3	20.0	0.0
4	30.0	0.0
5	40.0	0.0
6	50.0	0.0
7	60.0	0.0
8	70.0	0.0
9	80.0	0.0
10	90.0	0.0
11	100.0	0.0
12	110.0	0.0
13	120.0	0.0
14	130.0	0.0
15	140.0	0.0
16	150.0	0.0
17	160.0	0.0
18	170.0	-5.5
19	180.0	0.0
20	190.0	-14.5
21	200.0	-3.5
22	210.0	-7.5
23	220.0	-7.5
24	230.0	-4.5
25	240.0	-2.0
26	250.0	0.0

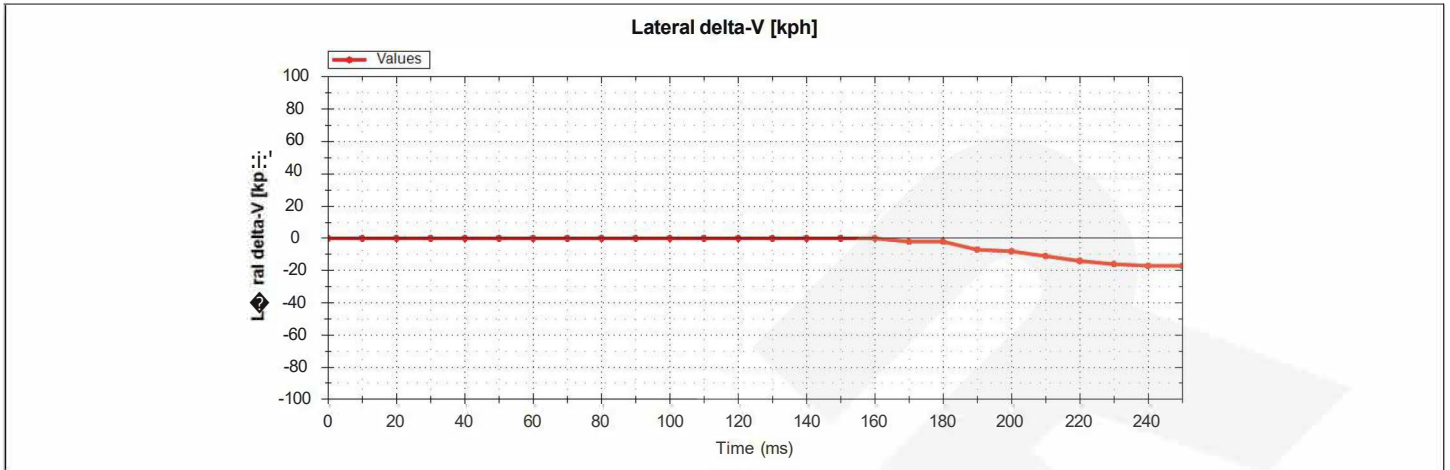
Lateral crash pulse delta-v (kph, 0 - 250msec)

Max. delta-V [kph]	-17
Time, Max. delta-V [msec]	260.0

num	Time (ms)	Lateral delta-V [kph]
1	0.0	0
2	10.0	0
3	20.0	0
4	30.0	0
5	40.0	0
6	50.0	0
7	60.0	0
8	70.0	0
9	80.0	0
10	90.0	0
11	100.0	0
12	110.0	0
13	120.0	0
14	130.0	0
15	140.0	0
16	150.0	0
17	160.0	0
18	170.0	-2
19	180.0	-2
20	190.0	-7
21	200.0	-8
22	210.0	-11
23	220.0	-14
24	230.0	-16
25	240.0	-17
26	250.0	-17

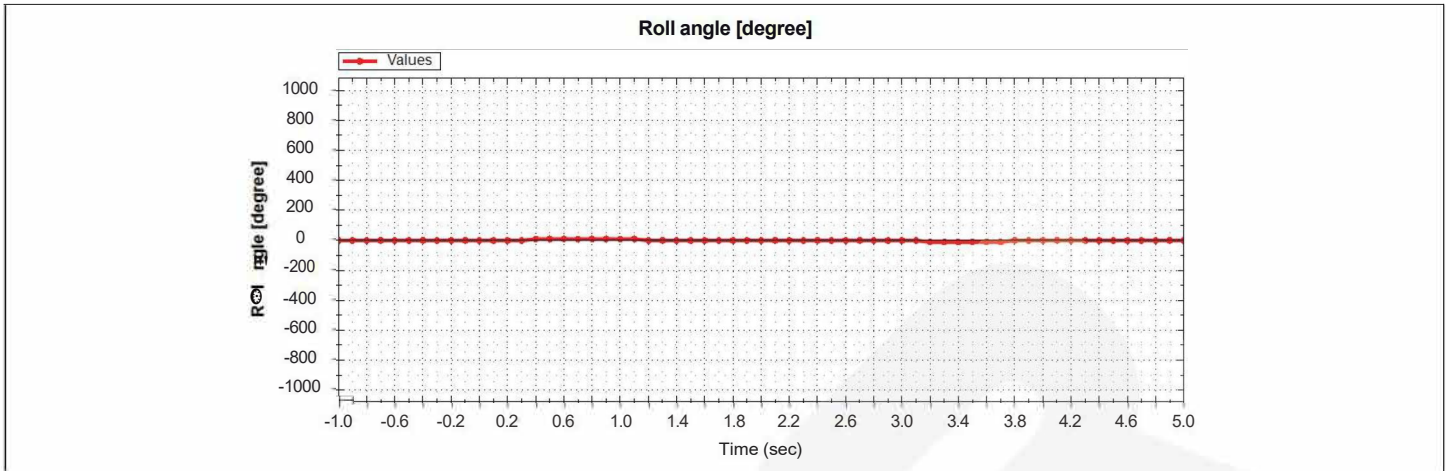
Roll angle (degree, -1 ~ 5sec)

num	Time (sec)	Roll angle [degree]
1	-1.0	0
2	-0.9	0
3	-0.8	0
4	-0.7	0
5	-0.6	0
6	-0.5	0
7	-0.4	0
8	-0.3	0
9	-0.2	0
10	-0.1	0
11	0.0	0
12	0.1	0
13	0.2	0
14	0.3	0
15	0.4	10
16	0.5	10
17	0.6	10
18	0.7	10
19	0.8	10
20	0.9	10
21	1.0	10
22	1.1	10
23	1.2	0
24	1.3	0
25	1.4	0
26	1.5	0
27	1.6	0
28	1.7	0
29	1.8	0
30	1.9	0
31	2.0	0

32	2.1	0
33	2.2	0
34	2.3	0
35	2.4	0
36	2.5	0
37	2.6	0
38	2.7	0
39	2.8	0
40	2.9	0
41	3.0	0
42	3.1	0
43	3.2	-10
44	3.3	-10
45	3.4	-10
46	3.5	-10
47	3.6	-10
48	3.	-10
49	3.8	0
50	3.9	0
51	4.0	0
52	4.1	0
53	4.2	0
54	4.3	0
55	4.4	0
56	4.5	0
57	4.6	0
58	4.7	0
59	4.8	0
60	4.9	0
61	5.0	0
