DOT HS 813 606

**Special Crash Investigations:
On-Site Child Safety Seat Crash
Investigation;
Vehicle: 2003 Toyota Camry;
Location: Virginia;
Crash Date: October 2021**

**Special Crash Investigations
On-Site Child Safety Seat Crash Investigation
SCI Case Number: CR21026
Vehicle: 2003 Toyota Camry
Location: Virginia
Crash Date: October 2021**

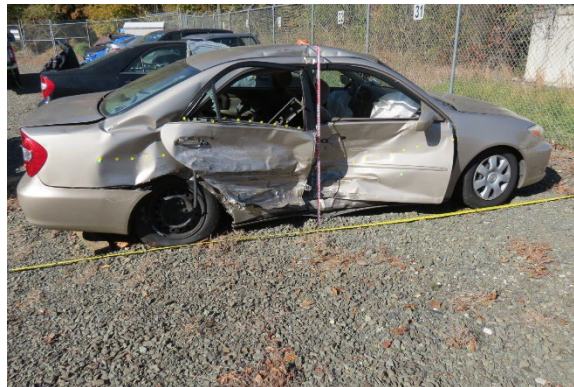
Figure 1. The 2003 Toyota Camry

This on-site investigation documented the crash of a 2003 Toyota Camry (Figure 1) and a 2005 Subaru Forester that resulted in fatal injuries to the Toyota's second-row middle passenger, a belted 7-year-old female who was seated in a backless booster seat (Figure 2). The National Highway Traffic Safety Administration received notification in October 2021 and the investigation was assigned to the Special Crash Investigations (SCI) team at Crash Research & Analysis in the same month. The investigating police agency was contacted in October 2021 and a written request was required to obtain information. The police agency responded in November 2021. Inspections of both vehicles, the crash scene, and the Toyota driver interview were completed in November 2021.

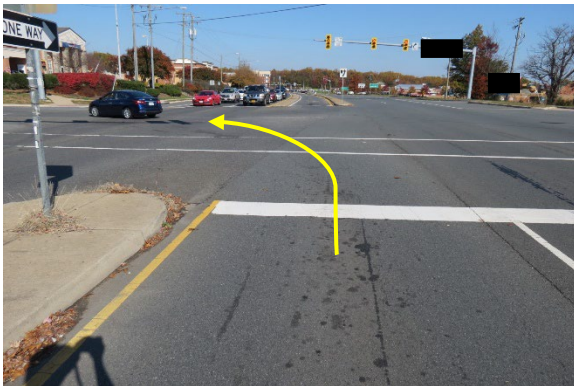
Figure 3. Northeast view, the Toyota's travel path to impact

The Toyota was traveling northeast in the left turn lane, approaching the intersection. The Toyota driver stated she observed the overhead traffic signal transition from a green signal phase to yellow as she entered the intersection and initiated the left turn (Figure 3) to proceed northwest. The Subaru was traveling southwest in the left-through lane (Figure 4) and was proceeding through the intersection. The Subaru driver also stated to the police that she entered the intersection on a yellow traffic signal phase.

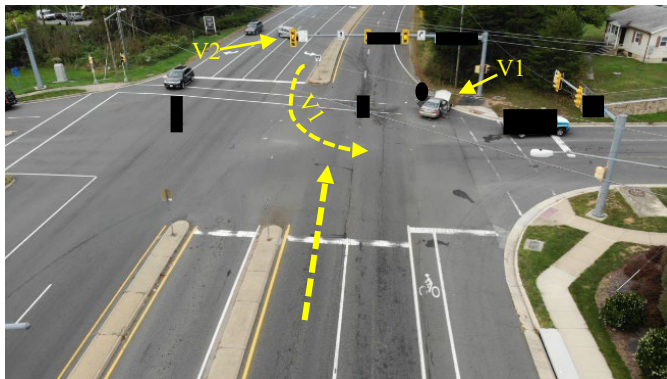
Figure 5. Police image, southwest/overhead view of travel paths, impact area, and final rest locations

The Toyota was redirected to the northwest corner of the intersection, approximately 10 m (33 ft) from the area of impact. The vehicle rotated clockwise approximately 450° and came to final rest at the northwest corner of the intersection, facing west. The Subaru continued forward and passed through the intersection after the crash. It rotated clockwise approximately 180° and traveled over the center median. The Subaru traveled approximately 47 m (154 ft) from the impact area and came to final rest facing north, straddling the two-northeast bound through lanes. Figure 5 shows the travel paths, impact area, and the final rest of both vehicles.

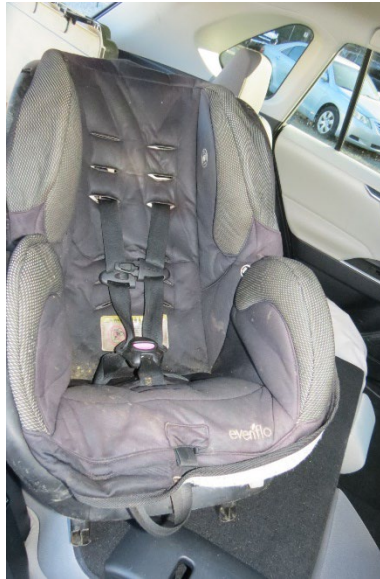
*Figure 9. Evenflo
SureRide/Titan 65
convertible CRS (LR
Passenger)*

The 2-year-old child passenger was seated in a forward-facing EvenFlo SureRide/Titan 65 convertible seat (Figure 9) with model number 37111623. It was manufactured in November 2014 and its expiration date was November 2020. The CRS was made with a one-piece plastic shell with an attached, pull-out “foot” (leveler) on the bottom. The head area of the CRS was lined with a 1 to 2 cm (0.4 to 0.8 in) Styrofoam insert and the front of the CRS was covered with a 1 cm (0.4 in) thick padded cover. The LATCH system was present at this position for the CRS.

secure the child were in good working order and the shoulder straps were routed through the lowest slots in the upper set of three. The Toyota driver stated in the SCI interview that the retainer clip was not used during the crash. The police crash report said that the vehicle's seat belt alone secured the CRS, the belt webbing was twisted, and the lower anchor straps and connectors were not used. Inspection of the CRS revealed minor stress marks on the right-side interior of the CRS but there was no damage.

The police crash report also stated the bottom of the seat was displaced at a near 45° angle (Figure 10) with the upper portion canted toward the direction of force (approximately 60°). The CRS was not firmly secured by the vehicle's seat belt. Also, the Styrofoam on the left side of the CRS' head area was fractured, though it is unknown if this was from previous damage.

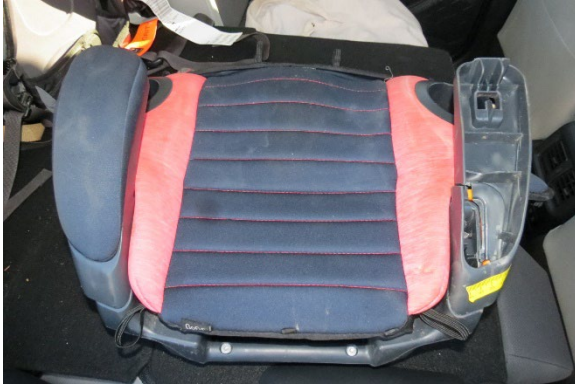
Figure 11. Top of the booster seat

The 7-year-old child passenger was seated in a Chicco Gofit booster seat (Figure 11) with model number: 050 79751 810 070. It was manufactured in September 2020 and the expiration date was September 2028. The booster seat was 42 cm wide (16.5 in) wide and 12 cm (4.7 in) high and was constructed with a two-piece seating base with a 1 to 2 cm (0.4 to 0.8 in) padded cover. The booster was recommended for children 4 years and older that weighed 18 to 50 kg (40 to 110 lb) and were between 97 to 145 cm (38 to 57 in) tall.

Inspection of the booster seat revealed a separation of the bottom portion from the top, a stress mark, and tearing of the plastic at the front of the seat (Figure 12). Stress marks were also noted on the left and right sides of the seat (Figure 13). There were no load marks on the belt guides of the booster seat. The top half of the right armrest was fractured and separated, and the remaining portion was cracked. This breakage probably occurred as the 7-year-old was displaced right and forward as a result of the crash.

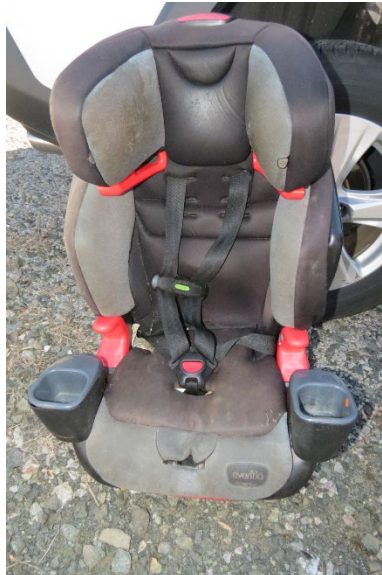
*Figure 14. Second-row right
CRS*

The 6-year-old passenger was seated in a forward-facing Evenflo Evolve forward-facing combination booster seat (Figure 14). The CRS model number was 34411770 and manufactured in December 2017 with an expiration date of February 2025. The CRS was constructed of multiple plastic and metal components, a lightly padded cloth cover, and dual armrests with integrated cup holders. The adjustable headrest was lined with a 1 to 3 cm (0.4 to 1.2 in) collar of Styrofoam. This CRS could be used as a forward-facing CRS, a high-backed booster, and a backless booster if the back was removed. When used with the 5-point internal harness, the vehicle's seat belt or the tether and lower anchor straps and connectors (not used in this crash) could be used to secure the CRS. When used as a booster seat, the vehicle's seat belt would be used to secure the child. The back could also be removed, and the unit could be used as a backless booster, with the vehicle's seat belt used to restrain the child.

Based on information from the police crash report and evidence within the vehicle, the CRS was secured by the vehicle's 3-point lap and shoulder seat belt during this crash. According to the police, the seatbelt was routed correctly through the proper channels on the back of the CRS in ELR mode and not switched into locking ALR mode. An examination of the vehicle's seat belt showed load marks on the belt webbing and latch plate belt guide as well as the seat belt routing ports on the back of the CRS.

Inspection of the CRS revealed the buckles, hardware, and retainer clip to be undamaged and in good working order and the shoulder straps were routed through the top slots in the cover and the slots below the top level on the back rest. Stress marks were noted on both sides of the top of the seat and a tear of the plastic was noted on the left front of the seat (Figure 15). Significant cracking and breakage was noted on the bottom of the plastic base (Figure 16), which became separated from the upper base panel on the left side. These were due to the intrusion from the right door and possibly lateral movement of the booster seat at the middle position. The collar of Styrofoam padding at the head area was fractured in two places.
