DOT HS 813 608

**Special Crash Investigations:
On-Site Reported Lane Keeping
Assist Issue/Air Bag Non-
Deployment Investigation;
Vehicle: 2020 Kia Niro;
Location: California;
Crash Date: November 2021**

Special Crash Investigations
On-Site Reported Lane Keeping Issue/Air Bag Non-Deployment Investigation
Office of Defects Investigation
Case Number: DS22004
Vehicle: 2020 Kia Niro
Location: California
Crash Date: November 2021

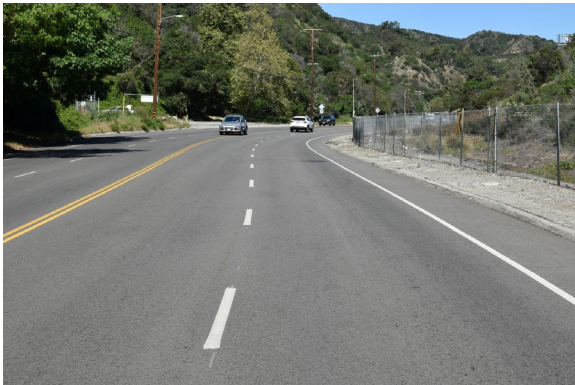
The Kia was initially traveling northbound in the right lane and was changing lanes to the left (Figure 5). The Subaru was traveling southbound in the left lane (Figure 6). A witness parked in a driveway north of the crash reported that he saw the Kia swerve into the southbound lane, then back into the northbound lane and then back into the southbound lane. The driver of the Subaru stated that she steered to the left to avoid the Kia but remained in her lane.

Figure 5. Northbound approach

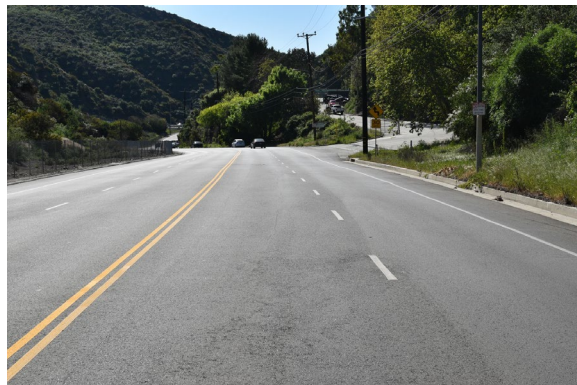
Figure 6. Southbound approach

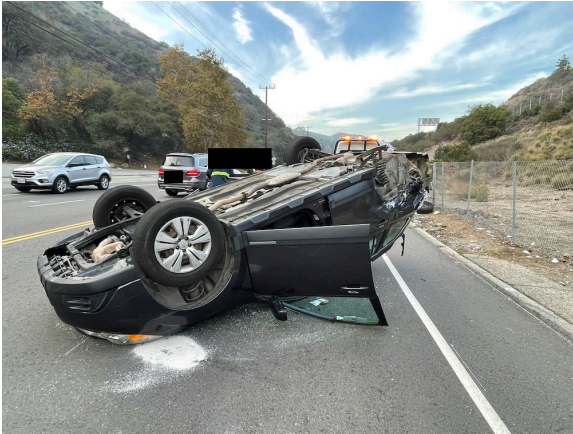
The Subaru went into a clockwise rotation, tripped and began a left-side-leading rollover (Event 2). The Subaru rolled two-quarter turns and came to rest on its roof in the right northbound lane (Figure 7). The Kia was re-directed in a clockwise direction and departed the roadway to the right where it struck a no parking signpost (Event 3) and a chain link fence (Event 4). The vehicle came to rest off-road in contact with the fence (Figure 8).

Figure 7. Final rest, 2012 Subaru Outback, looking north (police photo)

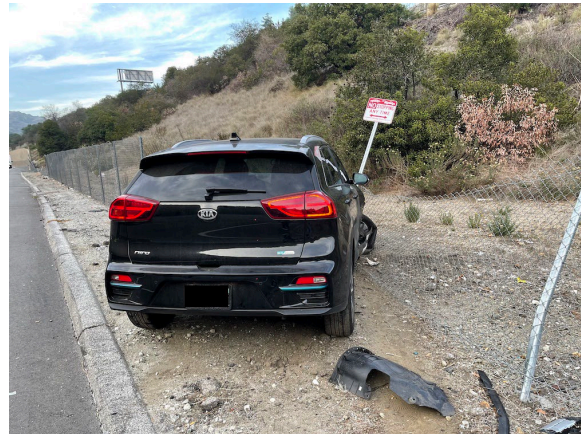
Figure 8. Final rest, 2020 Kia Niro, looking north (police photo)

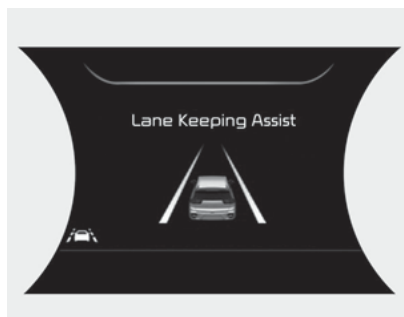
Display (Figure 11): White (sensor does not detect the lane marker or vehicle speed is less than 60 km/h (37 mph). Green (sensor detects the lane marker and the system is able to control the steering).

*Figure 11. Cluster display,
2020 Kia Niro*

It should be noted that the vehicle had been inspected prior to the SCI inspection by a mechanic hired by the owner and it is unknown what functions may have been activated or deactivated during that inspection. Kia representatives said that LKA was not activated at the time of the SCI vehicle inspection. This was based on observations of the various menu settings at the time of the inspection. Based on the earlier inspection activities, the Kia representatives could not determine if the LKA was turned on at the time of the crash.

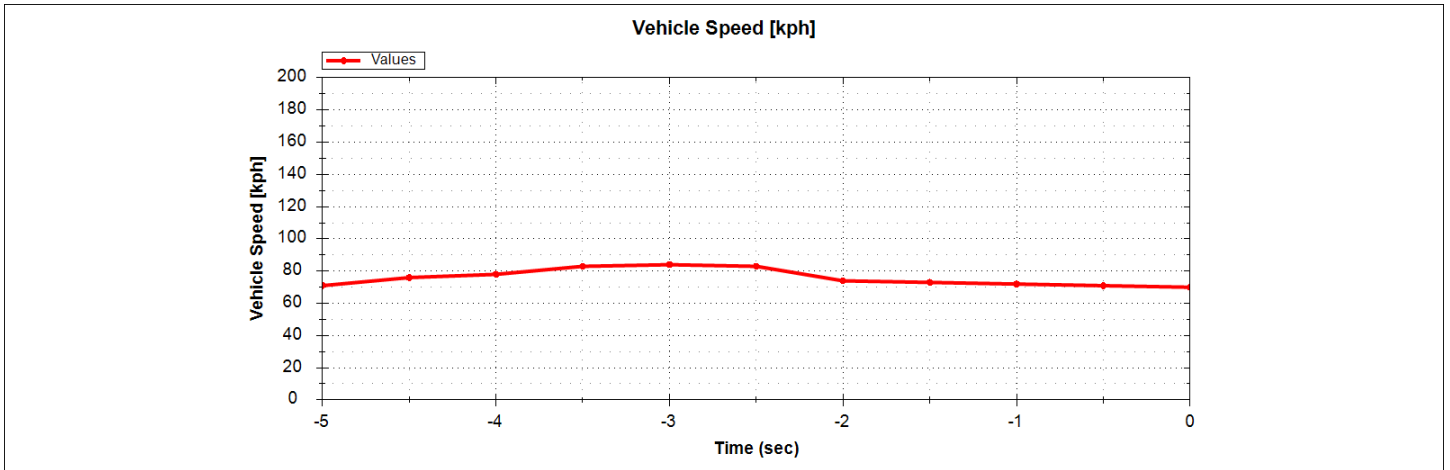
Num	Time (sec)	Vehicle Speed [kph]
1	-5.0	71
2	-4.5	76
3	-4.0	78
4	-3.5	83
5	-3.0	84
6	-2.5	83
7	-2.0	74
8	-1.5	73
9	-1.0	72
10	-0.5	71
11	0.0	70

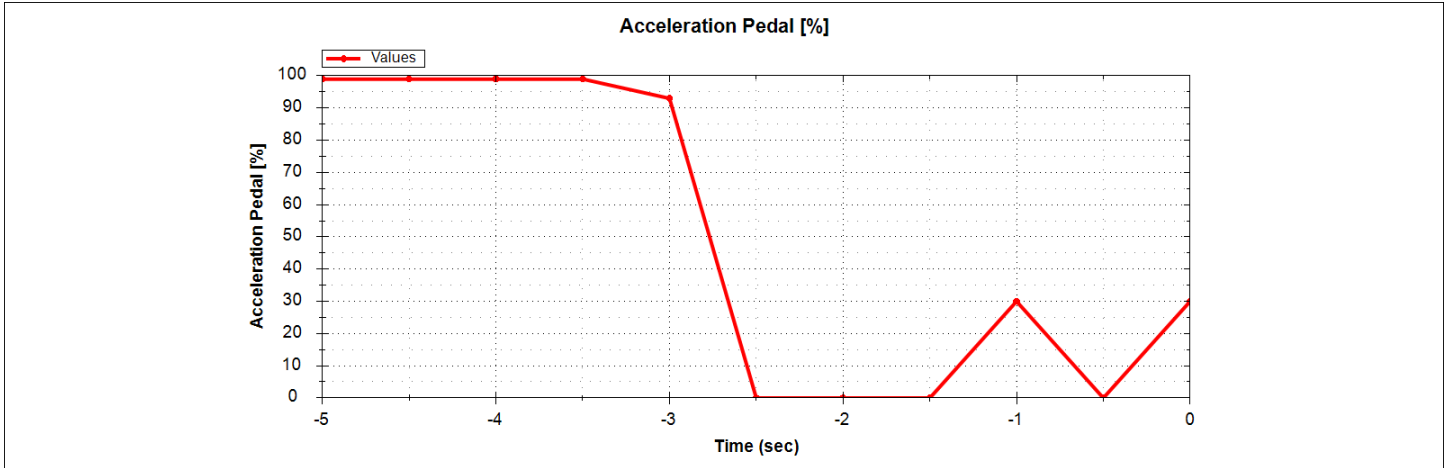
Num	Time (sec)	Acceleration Pedal [%]
1	-5.0	99
2	-4.5	99
3	-4.0	99
4	-3.5	99
5	-3.0	93
6	-2.5	0
7	-2.0	0
8	-1.5	0
9	-1.0	30
10	-0.5	0
11	0.0	30

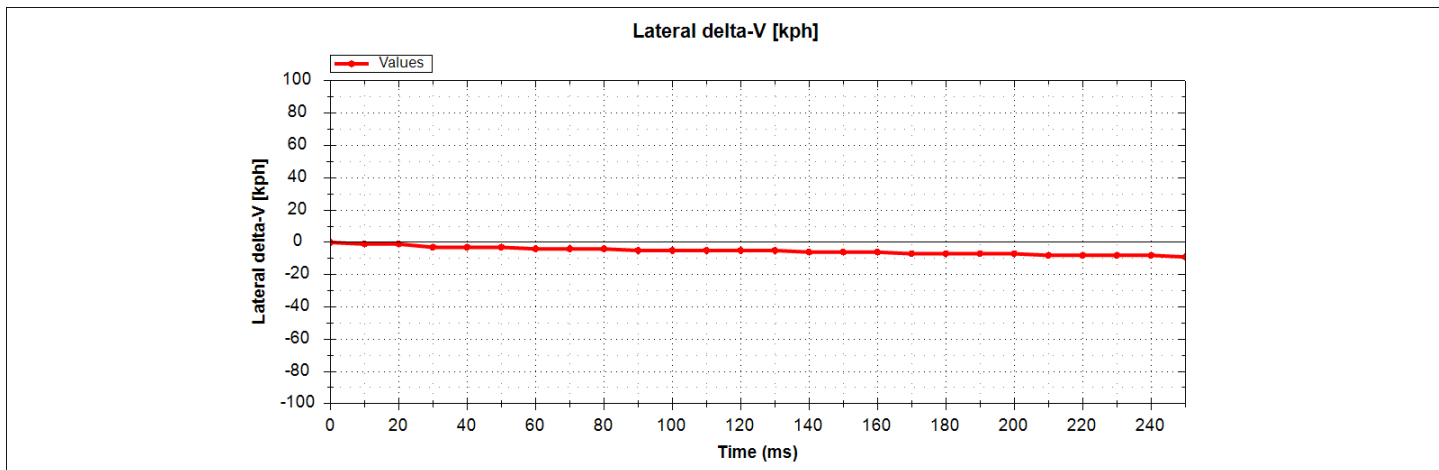
Lateral crash pulse_delta-v (kph, 0 ~ 250msec)

Max. delta-V [kph]	-10
Time, Max. delta-V [msec]	297.5

Num	Time (ms)	Lateral delta-V [kph]
1	0.0	0
2	10.0	-1
3	20.0	-1
4	30.0	-3
5	40.0	-3
6	50.0	-3
7	60.0	-4
8	70.0	-4
9	80.0	-4
10	90.0	-5
11	100.0	-5
12	110.0	-5
13	120.0	-5
14	130.0	-5
15	140.0	-6
16	150.0	-6
17	160.0	-6
18	170.0	-7
19	180.0	-7
20	190.0	-7
21	200.0	-7
22	210.0	-8
23	220.0	-8
24	230.0	-8
25	240.0	-8
26	250.0	-9
