U.S. Department
of Transportation

**National Highway
Traffic Safety
Administration**

DOT HS 813 635

**Special Crash Investigations:
On-Site Ambulance Crash Investigation;
Vehicle: 2016 Mercedes-Benz Sprinter
Type II Ambulance;
Location: Texas;
Crash Date: April 2021**

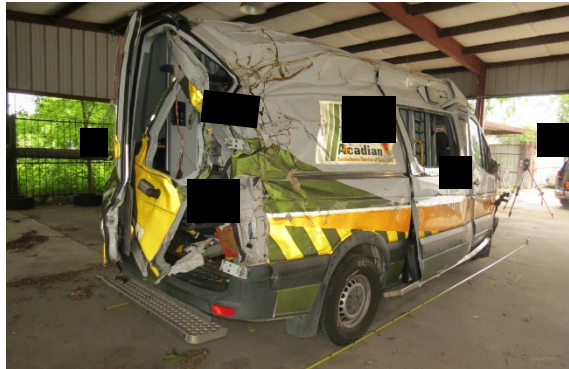
*Figure 1. The 2016 Mercedes Benz
Sprinter Type II ambulance*

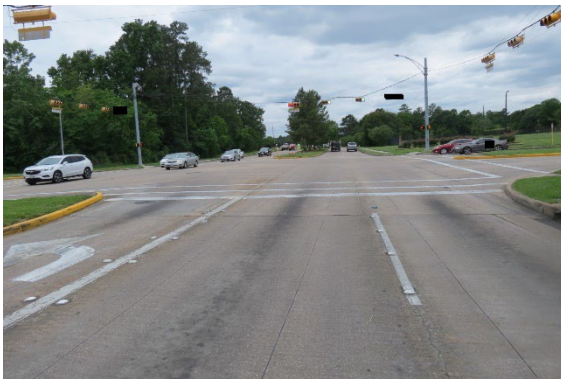
Figure 2. West view of the ambulance's approach

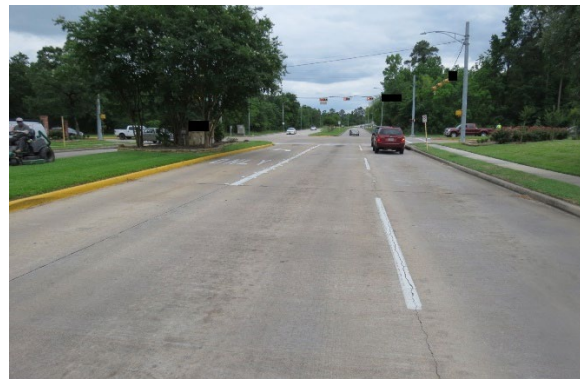
Figure 3. South view of the Toyota's approach

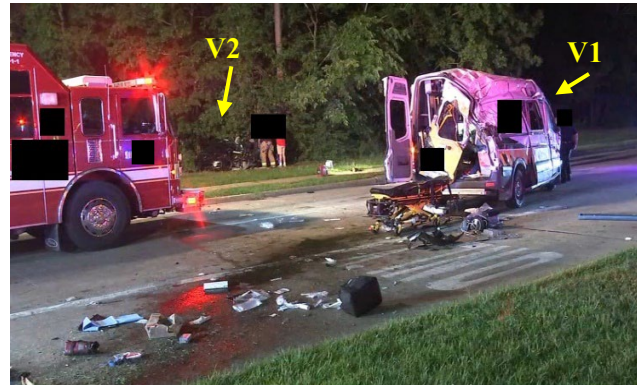
The front of the ambulance struck the left plane of the Toyota (Event 1). The force directions were in the 1 o'clock sector for the ambulance and the 11 o'clock sector for the Toyota. Both of the ambulance's frontal air bags deployed, as did the right outboard seat-mounted side impact and inflatable curtain (IC) air bags. Both Toyota frontal air bags deployed, as did the right IC air bag. The impact redirected both vehicles southwest and both rotated counterclockwise. The ambulance rolled over, right-side leading, one quarter-turn (Event 2). As the right side contacted the pavement, the right rear top of the ambulance struck the west median curb tip (Figure 4, Event 3) interrupting the rollover sequence and induced a clockwise rotation of approximately 180°. The rollover event initiation was classified as a "trip over" though its counterclockwise rotation was caused by the impact with the Toyota. The ambulance slid southwest on its right side, partially on the median/curb and on the roadway. The ambulance righted itself and came to rest in the westbound center lane (Figure 5), facing west, approximately 40 m (131 ft) from the initial impact.

The Toyota, also redirected southwest, rotated counterclockwise approximately 140° and crossed over all eastbound lanes. The vehicle departed the south roadside and the left plane sideswiped a vertical water standpipe (Event 4) as it was sliding rearward. The vehicle continued and the back end struck a tree (Event 5). The Toyota traveled approximately 45 m (148 ft) from the initial impact and came to rest facing northeast (Figure 5) with its back end against the tree.

Figure 5. Southwest view of vehicles at rest (Police on-scene image, used with permission)

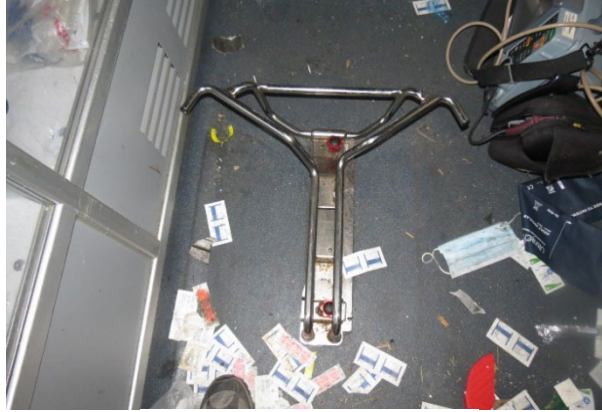
Prior to the crash, the patient cot was secured on the floor of the patient compartment via a Stryker Model 6371 cot fastener system. The system had a forward antler bracket and rear locking rail-clamp mechanism (Figures 13 and 14), and both were mounted to the floor of the patient compartment. The antler bracket cradled the forward portion of the cot's frame, while the vertically oriented locking clamp mechanism secured the locking pin, affixed to the lower frame rail of the cot.

Figure 14. Antler bracket

The antler bracket was secured to the floor of the patient compartment by two hand-tightened bolts that allowed the crew members to adjust and align the bracket to fit different cots if necessary. The rear locking rail-clamp was secured to the left side of the compartment via a bracket and four bolts. Combined, these two components were intended to restrict lateral and longitudinal movement of the cot in the ambulance during transit. The rail clamp and bolts were all intact and in good working order at the time of the SCI investigation in both the unlocked and locked position. The antler bracket was also intact and in good working order.

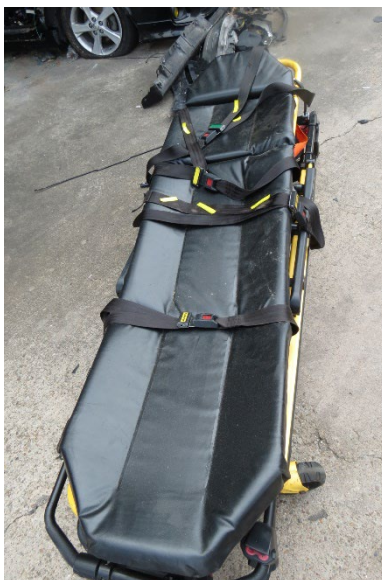
The Stryker Power-Pro XT Model 6500 wheeled ambulance cot was manufactured in June 2011 with serial number 11063XXXX. The cot (Figure 15) had a tubular aluminum frame with circumferential weld joints and steel hardware fasteners. The X-frame supporting the mattress platform featured power lift capabilities with variable height positions between a minimum of 36 cm (14.2 in) and a maximum of 105 cm (41.3 in). The mattress platform featured 0 to 73° of positive backrest angular adjustment via a manually controlled gas-pressure cylinder. In a similar fashion, the leg portion featured 15° of positive angular adjustment. Overall dimensions of the cot were 58 cm (22.8 in) wide and 206 cm (81.1 in) long. A placard declared that the loaded capacity limit of the cot 317 kg (700 lb). Electrical power was supplied by a removable 24-v nickel-cadmium direct current battery. The cot had a multi-point harness system for manual restraint of its occupant. This system had a lateral lower extremity strap, lateral lap/thigh strap, and an upper torso harness that incorporated two shoulder straps, each crossing over the patient's chest to the opposite shoulder. All the straps were fixed-length webbing that included locking latch plates and sewn buckles. During the SCI inspection, all straps were intact and historical wear was present. The specific use and placement of the straps could not be definitively determined.

Figure 15. Stryker Power-Pro XT 6500 patient cot

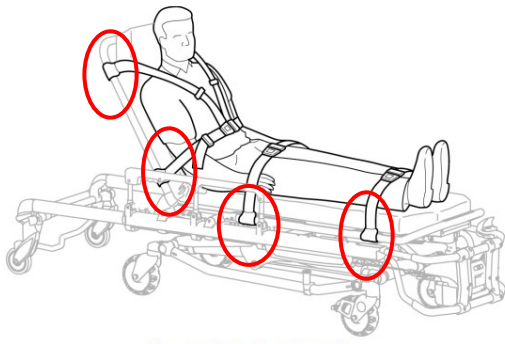
Inspection of the patient cot revealed that all restraint straps were anchored to the mattress platform (Figure 16). The owner's manual stated that proper restraint strap anchor points were on the actual cot frame (Figure 17). Furthermore, the lower leg restraints were anchored closer to the center of the cot than the proper location shown in the owner's manual. Further inspection revealed the left side of the middle section of the platform was pulled from its mounting during the crash sequence (Figure 18).

Figure 17. Owner's manual diagram of the proper restraint anchor points (on cot frame)
