DOT HS 813 636

**Special Crash Investigations:
On-Site Rollover Crash
Investigation;
Vehicle: 2021 Hyundai Santa Fe;
Location: North Carolina;
Date: March 2022**

Special Crash Investigations
On-Site Rollover Crash Investigation
Case Number: CR22008
Vehicle: 2021 Hyundai Santa Fe
Location: North Carolina
Crash Date: March 2022

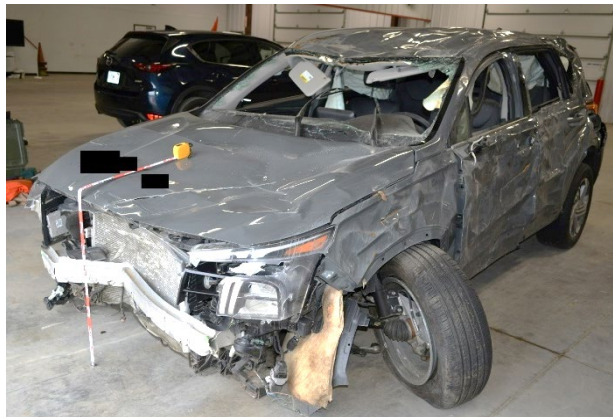
Figure 1. Left front oblique of the Hyundai

This report documents the on-site investigation of the roadway departure/rollover crash of a 2021 Hyundai Santa Fe (Figure 1). The crash was identified through the National Highway Traffic Safety Administration's Crash Research Sampling System in March 2022. The Special Crash Investigations (SCI) team at Crash Research & Analysis, Inc., was notified of the crash and conducted an on-site investigation in May 2022. The SCI team contacted the insurance adjuster who had custody of the vehicle. An inspection of the Hyundai was conducted to measure exterior deformation, interior damage and intrusion, documentation of interior occupant contact, and assessment of the manual and supplemental restraint systems. The Hyundai had an event data recorder (EDR) that was imaged by the SCI investigator during the inspection with the Global Information Technologies Hyundai EDR tool. The crash site was also photographed, documented, and measured by a Nikon total station. The driver was contacted but refused an interview.

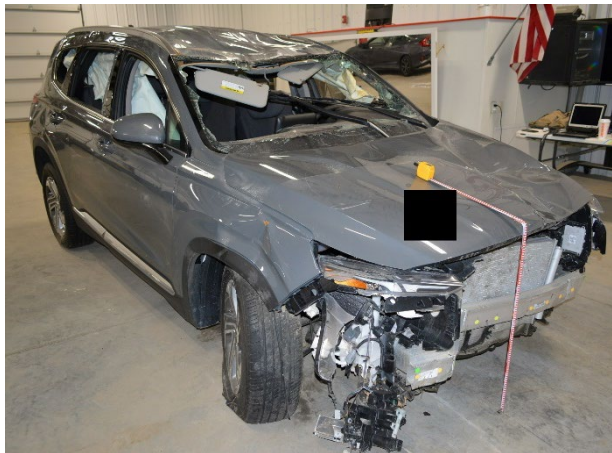
Figure 7. Right front oblique of the Hyundai

The 2021 Hyundai Santa Fe was a 4-door SUV (Figure 7) manufactured in May 2021, identified by Vehicle Identification Number 5NMS2DAJ6MHxxxxxx. It had a 277 cm (109.1 in) wheelbase and powered by a 2.5-liter, inline 4-cylinder gasoline engine linked to an 8-speed automatic transmission with all-wheel drive. The service brakes were a power-assisted 4-wheel disc system. Steering was a speed-sensitive electric rack and pinion system. It had an antilock braking system, electronic stability control, traction control, automatic crash notification, crash imminent braking, forward collision warning, pedestrian automatic emergency braking, blind spot detection, lane departure warning, lane keeping assistance, lane centering assistance, daytime running lights, and adaptive cruise control. The status of the lane systems is unknown.

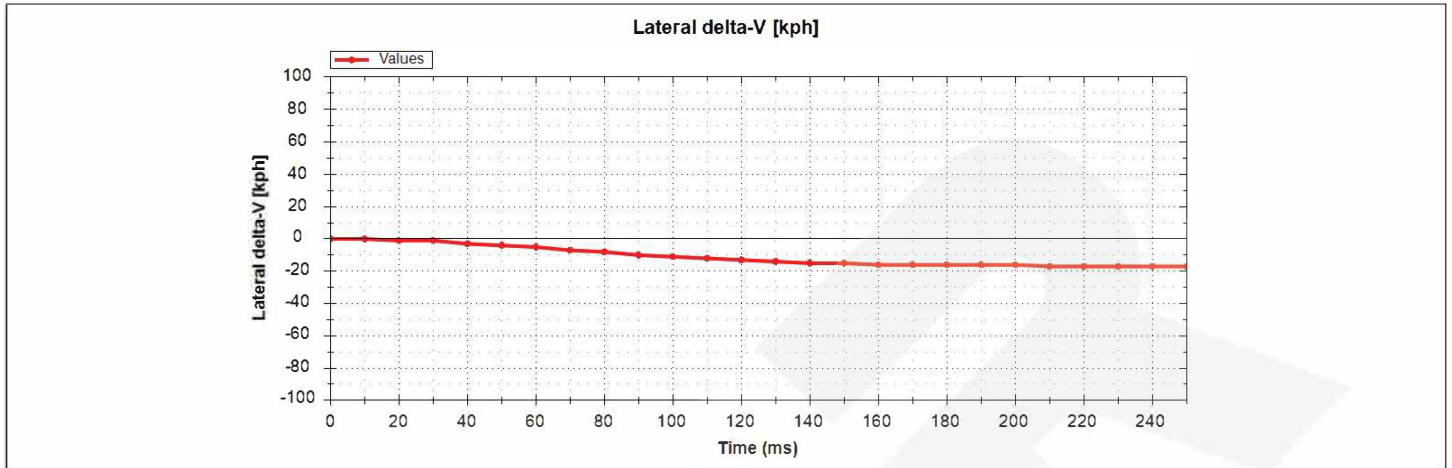
Lateral crash pulse_delta-v (kph, 0 ~ 250msec)

Max. delta-V [kph]	-18
Time, Max. delta-V [msec]	300.0

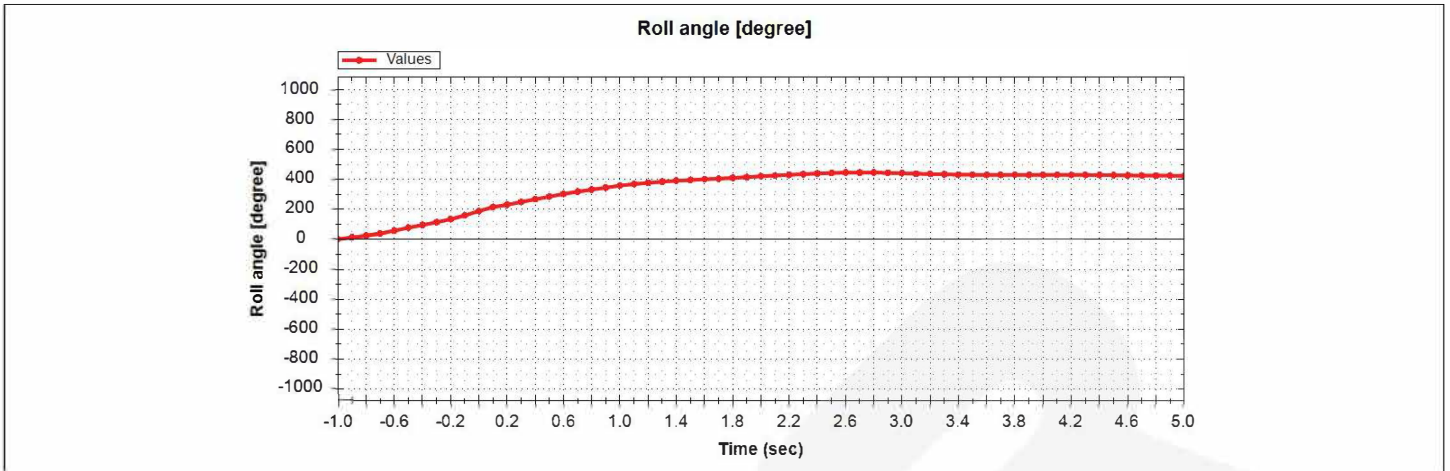
Roll angle (degree, -1 ~ 5sec)

This EDR record was consistent with the rollover (Event 4) that occurred approximately 2 seconds after the guardrail impact. The recorded data showed a rollover to the right (positive roll angle). However, it was noted that the reported roll angle was in excess of three-quarter-turns. Table 2 represents the roll angle of the Hyundai for EDR Event 2 in half-second intervals.
