DOT HS 813 685

**Special Crash Investigations:  
On-Site Rollover Crash  
Investigation;  
Vehicle: 2018 Jeep Grand  
Cherokee;  
Location: Illinois;  
Crash Date: March 2022**

**Special Crash Investigations**  
**On-Site Rollover Crash Investigation**  
**Case Number: CR22009**  
**Vehicle: 2018 Jeep Grand Cherokee**  
**Location: Illinois**  
**Crash Date: March 2022**

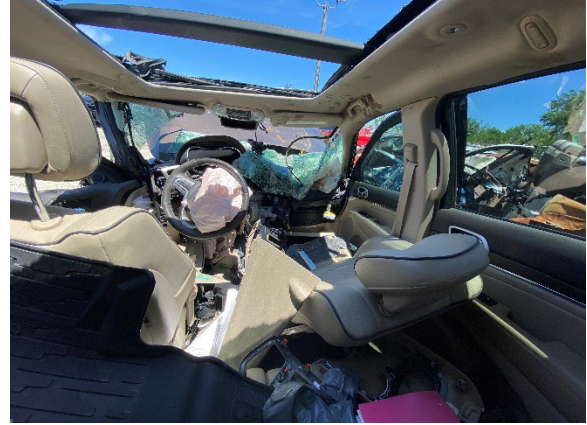
*Figure 9. Overall view of the Jeep's instrument panel and front-row seating positions*

Local law enforcement restricted access to the interior due to pending litigation; therefore, a complete interior inspection could not be obtained. The investigating officer requested the interior components not be manipulated or disturbed. However, images were obtained to assist with the investigation. The Jeep's interior sustained damage (Figures 8 and 9) and intrusion attributed to the frontal impact. The left A-pillar, steering wheel, and left instrument panel all intruded longitudinally an estimated 30 cm (12 in) due to the impact with the Ford. The lower instrument panel/knee bolster intruded to the forward edge of the driver seat cushion. The left A-pillar laterally intruded a visually estimated 25 cm (10 in). Two areas of dried blood were noted at the right sun visor and the right grab handle.
