DOT HS 813 696

# **Special Crash Investigations: On-Site Rollover Crash Investigation; Vehicle: 2008 Cadillac Escalade; Location: California; Crash Date: August 2022**

**Special Crash Investigations  
On-Site Rollover Crash Investigation  
Case Number: DS22020  
Vehicle: 2008 Cadillac Escalade  
Location: California  
Crash Date: August 2022**

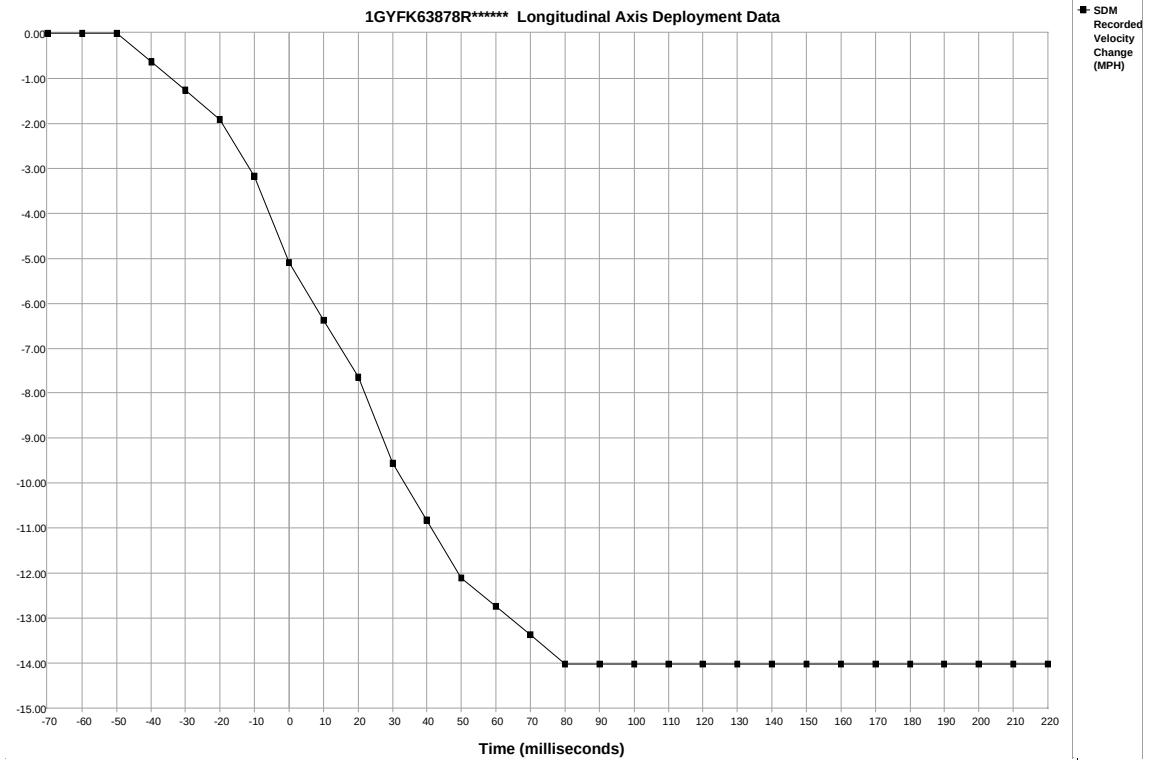
| SDM Longitudinal Axis Recorded Velocity Change (MPH) | 0.00 | 0.00 | 0.00 | -0.64 | -1.27 | -1.91 | -3.18 | -5.09 | -6.37 | -7.64 | -9.55 | -10.82 | -12.10 | -12.73 | -13.37 |
| SDM Longitudinal Axis Recorded Velocity Change (MPH) | -14.01 | -14.01 | -14.01 | -14.01 | -14.01 | -14.01 | -14.01 | -14.01 | -14.01 | -14.01 | -14.01 | -14.01 | -14.01 | -14.01 | -14.01 |

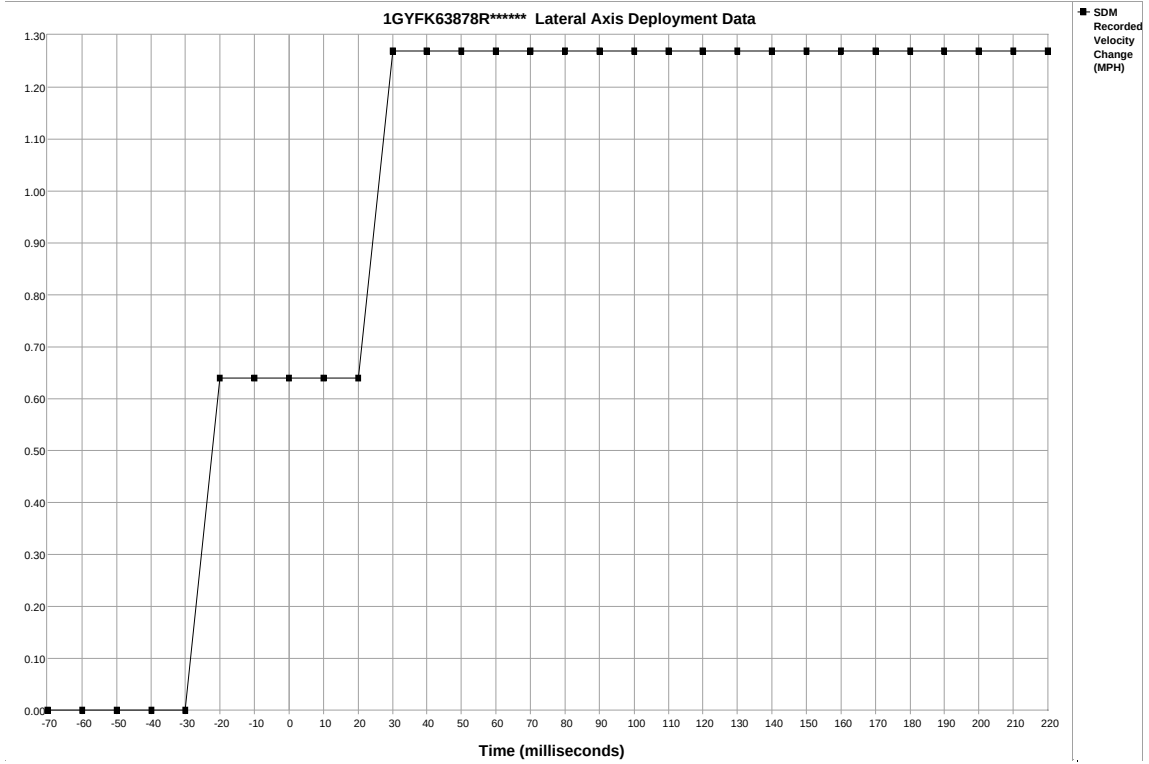
| SDM Lateral Axis Recorded Velocity Change (MPH) | 0.00 | 0.00 | 0.00 | 0.00 | 0.00 | 0.64 | 0.64 | 0.64 | 0.64 | 0.64 | 1.27 | 1.27 | 1.27 | 1.27 | 1.27 |

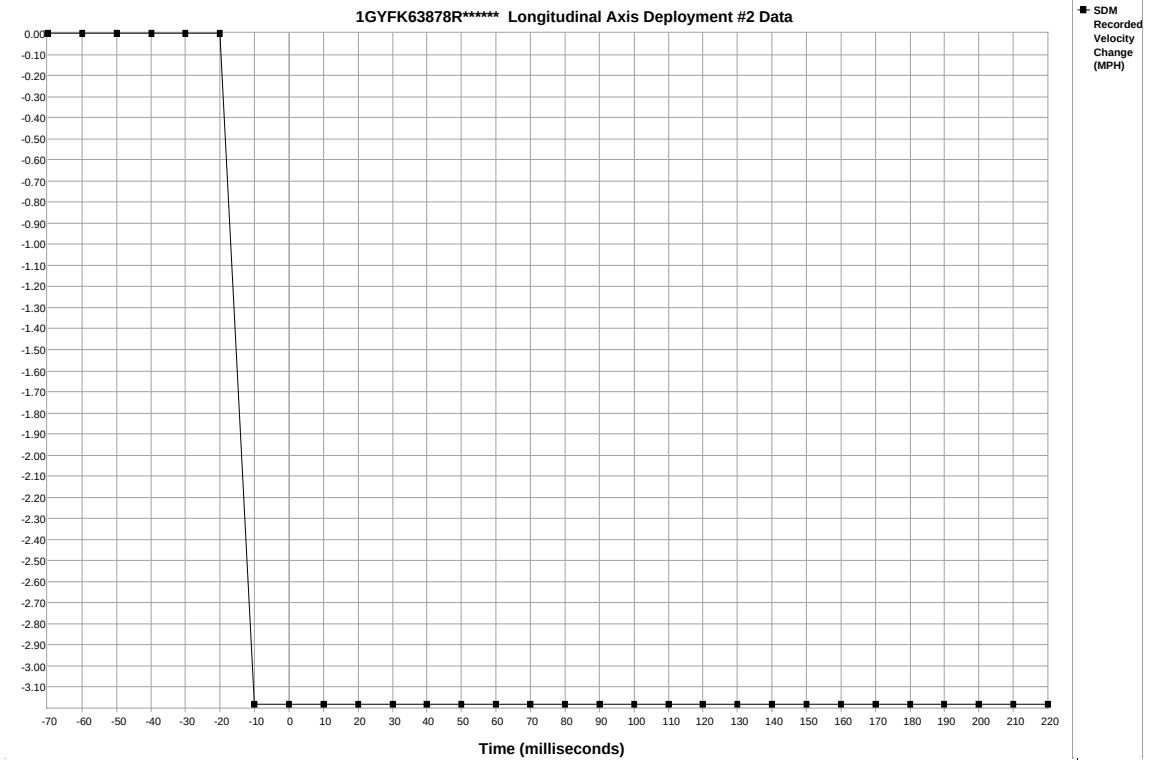
| SDM Longitudinal Axis Recorded Velocity Change (MPH) | 0.00 | 0.00 | 0.00 | 0.00 | 0.00 | 0.00 | -3.18 | -3.18 | -3.18 | -3.18 | -3.18 | -3.18 | -3.18 | -3.18 | -3.18 |
| SDM Longitudinal Axis Recorded Velocity Change (MPH) | -3.18 | -3.18 | -3.18 | -3.18 | -3.18 | -3.18 | -3.18 | -3.18 | -3.18 | -3.18 | -3.18 | -3.18 | -3.18 | -3.18 | -3.18 |

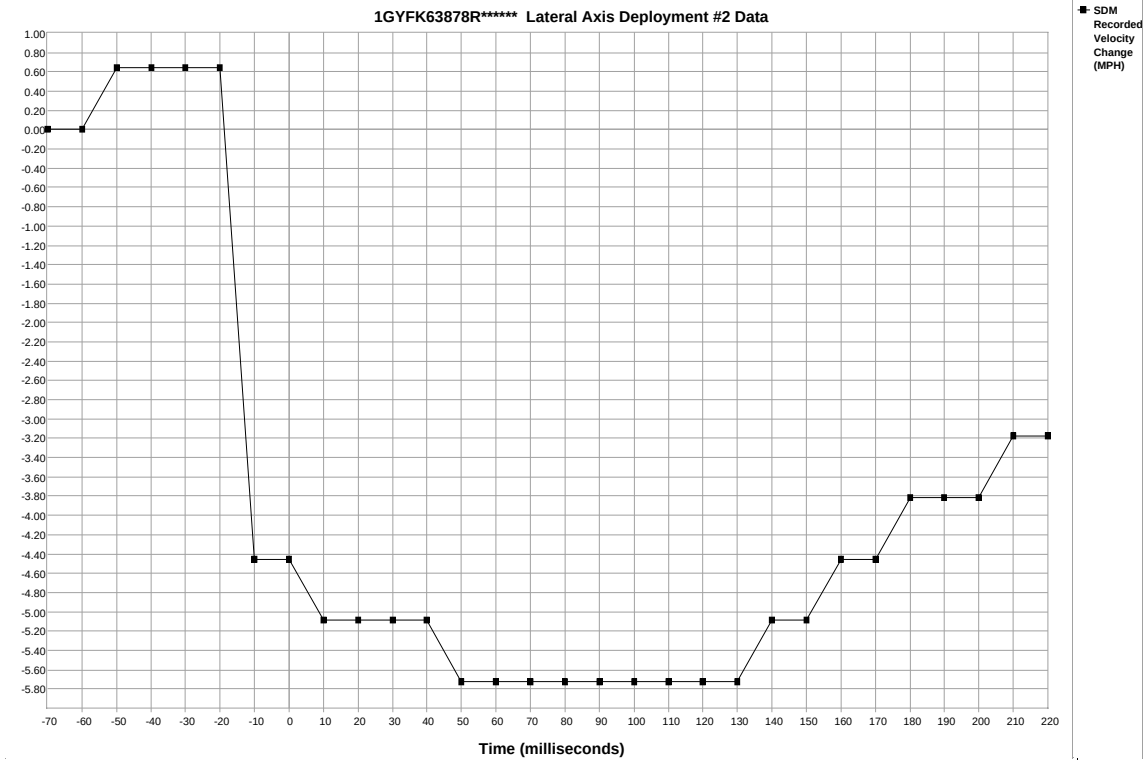
| SDM Lateral Axis Recorded Velocity Change (MPH) | 0.00 | 0.00 | 0.64 | 0.64 | 0.64 | 0.64 | -4.46 | -4.46 | -5.09 | -5.09 | -5.09 | -5.09 | -5.73 | -5.73 | -5.73 |
