DOT HS 813 718

**Special Crash Investigations:  
On-Site Ambulance Crash  
Investigation;  
Vehicle: 2014 Ford E-350 Type II  
Ambulance;  
Location: Arkansas;  
Crash Date: January 2023**

**Special Crash Investigations**  
**On-Site Ambulance Crash Investigation**  
**SCI Case No: CR23002**  
**Vehicle: 2014 Ford E-350 Type II Ambulance**  
**Location: Arkansas**  
**Crash Date: January 2023**

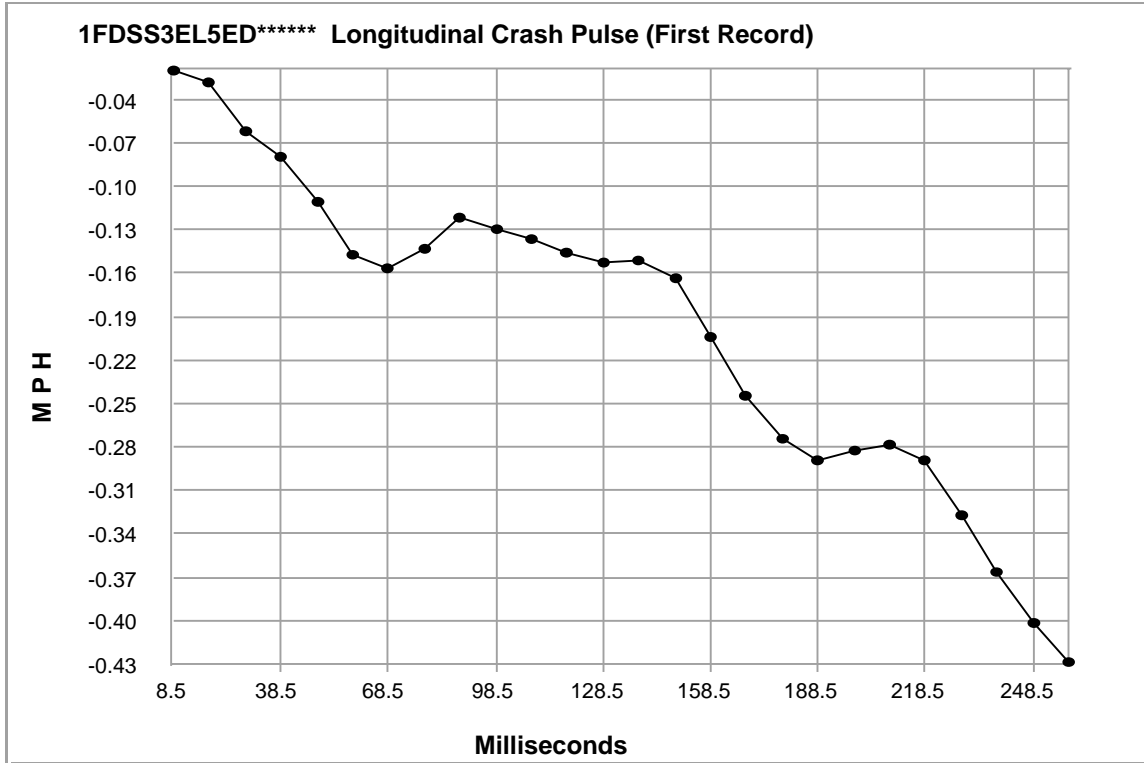
**Longitudinal Crash Pulse (First Record)**

The maximum longitudinal and lateral delta Vs were reported to be -1.25 km/h (-0.78 mph) and -0.41 km/h (-0.25 mph). It is the opinion of the SCI investigators that these values do not represent the impact damage sustained by the vehicle. The ambulance’s road departure was the source of the EDR’s AE and the recorded delta V was attributed to the velocity change of the ambulance’s travel over the uneven ground before the impact with the tree.
