DOT HS 813 725

**Special Crash Investigations:  
Remote Frontover Incident  
Investigation;  
Vehicle: 2022 Honda Civic;  
Location: California;  
Incident Date: March 2023**

**Special Crash Investigations**  
**Remote Frontover Incident Investigation**  
**Case Number: DS23009**  
**Vehicle: 2022 Honda Civic**  
**Location: California**  
**Incident Date: March 2023**

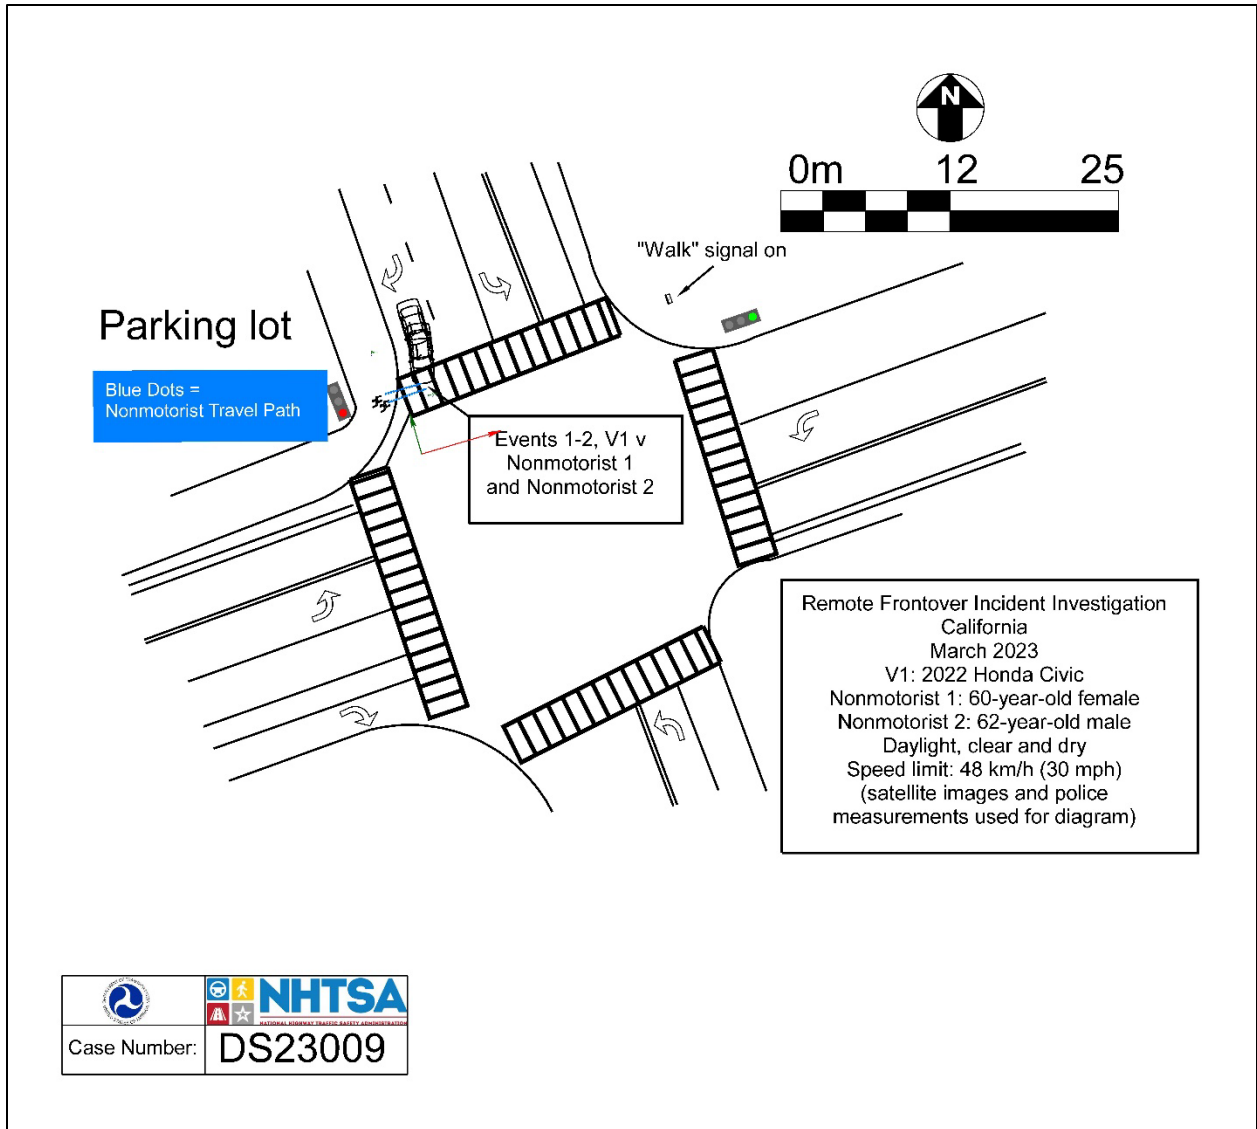
# Incident Diagram

The 62-year-old male nonmotorist was initially standing on the intersection's northwest sidewalk waiting for the "walk" crosswalk signal with his wife. Upon seeing the walk signal they entered the roadway walking east in the crosswalk. The Honda driver looked to his left at westbound traffic, saw it was clear, and began moving forward and struck the nonmotorist. According to the PCR, the male nonmotorist jumped onto the hood while being struck.
