DOT HS 813 168

Special Crash Investigations: On-Site Rollover Crash Investigation; Vehicle: 2016 Nissan Frontier; Location: Georgia; Crash Date: February 2018

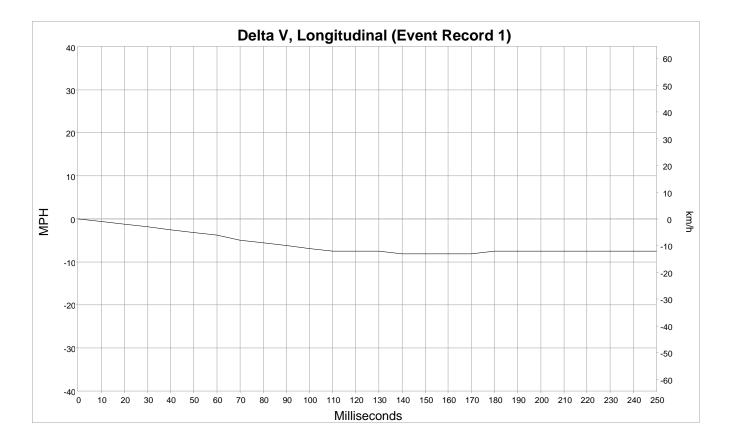
Longitudinal Delta V (Event Record 1)

Time (msec)	MPH [km/h]
0	0 [0]
10	-1 [-1]
20	-1 [-2]
30	-2 [-3]
40	-2 [-4]
50	-3 [-5]
60	-4 [-6]
70	-5 [-8]
80	-6 [-9]
90	-6 [-10]
100	-7 [-11]
110	-7 [-12]
120	-7 [-12]
130	-7 [-12]
140	-8 [-13]
150	-8 [-13]
160	-8 [-13]
170	-8 [-13]
180	-7 [-12]
190	-7 [-12]
200	-7 [-12]
210	-7 [-12]
220	-7 [-12]
230	-7 [-12]
240	-7 [-12]
250	-7 [-12]

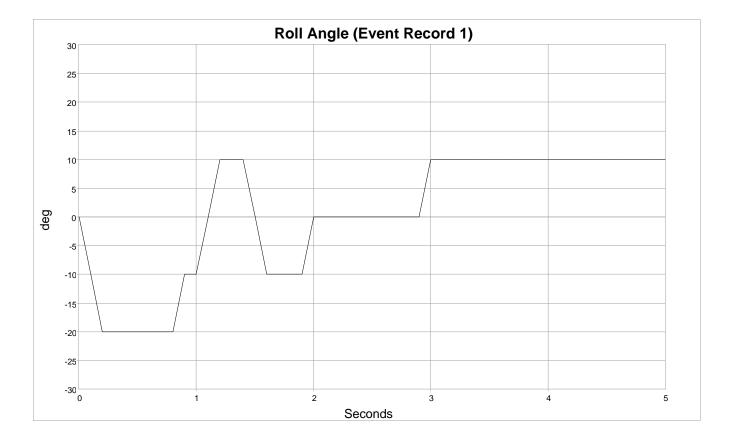
Roll Angle (Event Record 1)

Time (sec)	deg
0.0	0
0.1	-10
0.2	-20
0.3	-20
0.4	-20
0.5	-20
0.6	-20
0.7	-20
0.8	-20
0.9	-10
1.0	-10
1.1	0
1.2 1.3	10
1.3	10
1.4	10
1.5	0
1.6	-10
1.7	-10
1.8	-10
1.9	-10
2.0	-10 0
2.1	0
2.2	0
2.3	0
2.4	0
2.5	0
2.6	0
2.7	0

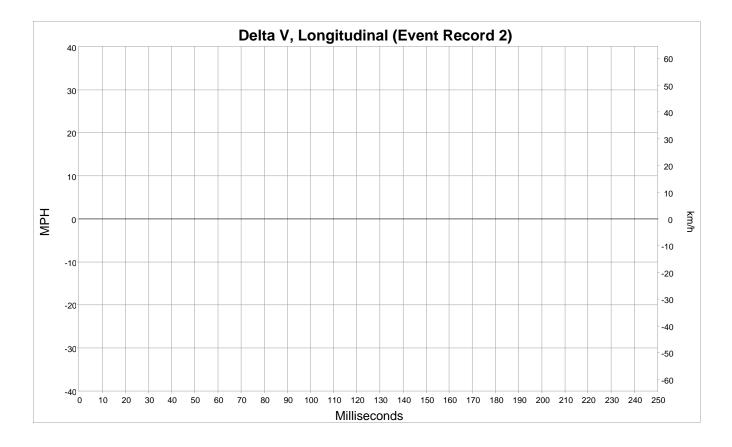
Longitudinal Delta V (Event Record 2)

Time (msec)	MPH [km/h]
0	0 [0]
10	0 [0]
20	0 [0]
30	0 [0]
40	0 [0]
50	0 [0]
60	0 [0]
70	0 [0]
80	0 [0]
90	0 [0]
100	0 [0]
110	0 [0]
120	0 [0]
130	0 [0]
140	0 [0]
150	0 [0]
160	0 [0]
170	0 [0]
180	0 [0]
190	0 [0]
200	0 [0]
210	0 [0]
220	0 [0]
230	0 [0]
240	0 [0]
250	0 [0]

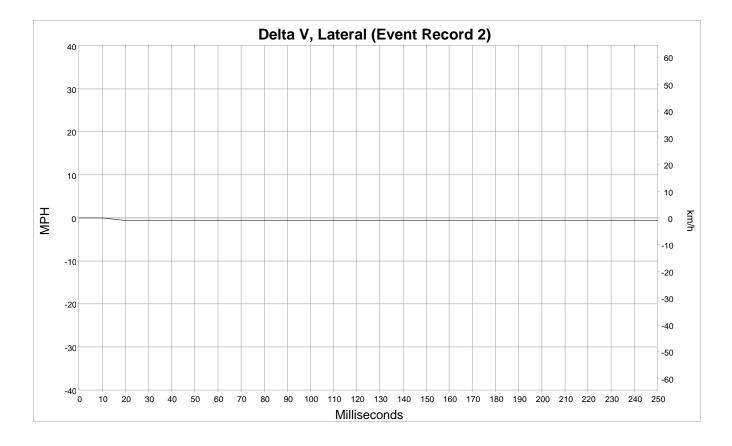
Lateral Delta V (Event Record 2)

MPH [km/h]
0 [0]
0 [0]
-1 [-1]
-1 [-1]
-1 [-1]
-1 [-1]
-1 [-1]
-1 [-1]
-1 [-1]
-1 [-1]
-1 [-1]
-1 [-1]
-1 [-1]
-1 [-1]
-1 [-1]
-1 [-1]
-1 [-1]
-1 [-1]
-1 [-1]
-1 [-1]
-1 [-1]
-1 [-1]
-1 [-1]
-1 [-1]
-1 [-1]
-1 [-1]

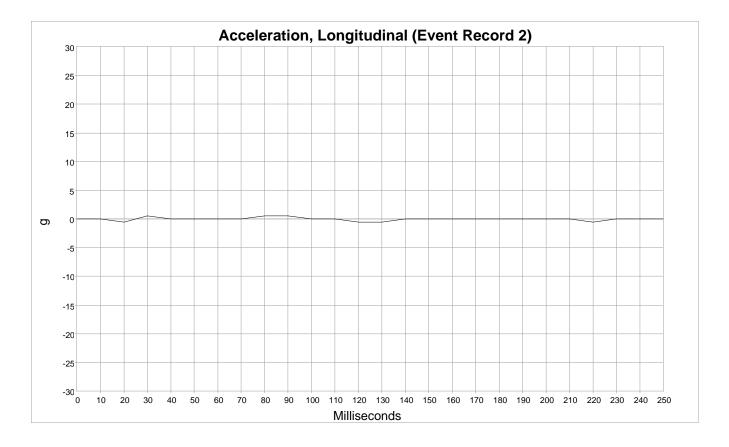
Longitudinal Acceleration (Event Record 2)

Time (msec)	g
0	0
10	0
20	5
30	.5
40	0
50	0
60	0
70	0
80	.5
90	.5
100	0
110	0
120	5
130	5
140	0
150	0
160	0
170	0
180	0
190	0
200	0
210	0
220	5
230	0
240	0
250	0

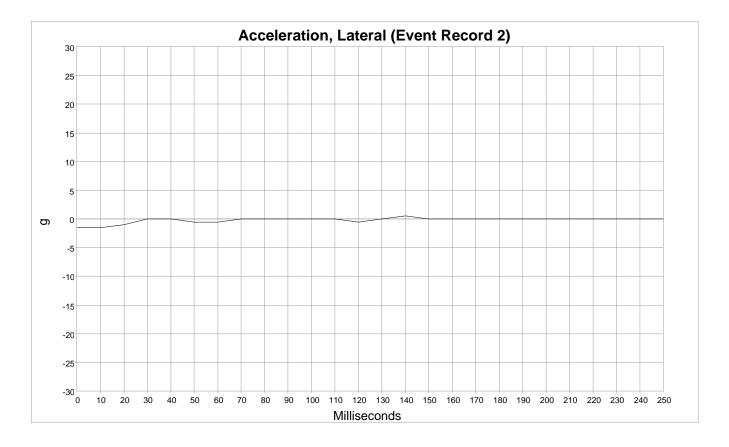
Lateral Acceleration (Event Record 2)

Time (msec)	g
0	-1.5
10	-1.5
20	-1
30	0
40	0
50	5
60	5
70	0
80	0
90	0
100	0
110	0
120	5
130	0
140	.5
150	0
160	0
170	0
180	0
190	0
200	0
210	0
220	0
230	0
240	0
250	0

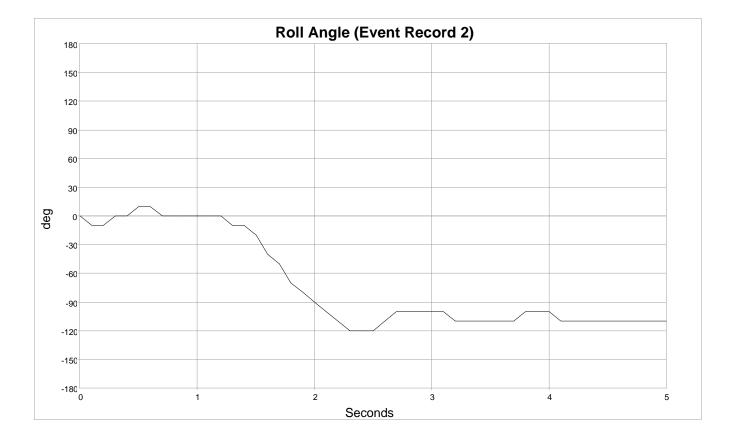
Roll Angle (Event Record 2)

Time (sec)	deg
0.0	0
0.1	-10
0.2	-10
0.3	0
0.4	0
0.5	10
0.6	10
0.7	0
0.8	0
0.9	0
1.0	0
1.1	0
1.2	0
1.3	-10
1.4	-10
1.5	-20
1.6	-40
1.7	-50
1.8	-70
1.9	-80
2.0	-90
2.1	-100
2.2	-110
2.3	-120
2.4	-120
2.5	-120
2.6	-110
2.7	-100

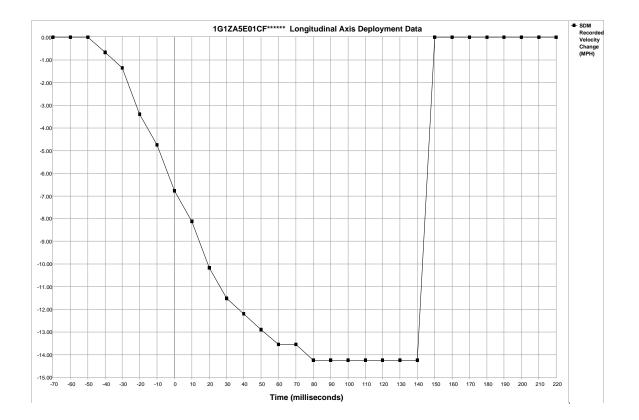
Time (milliseconds)	-70	-60	-50	-40	-30	-20	-10	0	10	20	30	40	50	60	70
SDM Longitudinal Axis Recorded Velocity Change (MPH)	0.00	0.00	0.00	-0.68	-1.36	-3.39	-4.74	-6.78	-8.13	-10.17	-11.52	-12.20	-12.88	-13.55	-13.55
Time (milliseconds)	80	90	100	110	120	130	140	150	160	170	180	190	200	210	220
SDM Longitudinal Axis Recorded Velocity Change (MPH)	-14.23	-14.23	-14.23	-14.23	-14.23	-14.23	-14.23	0.00	0.00	0.00	0.00	0.00	0.00	0.00	0.00

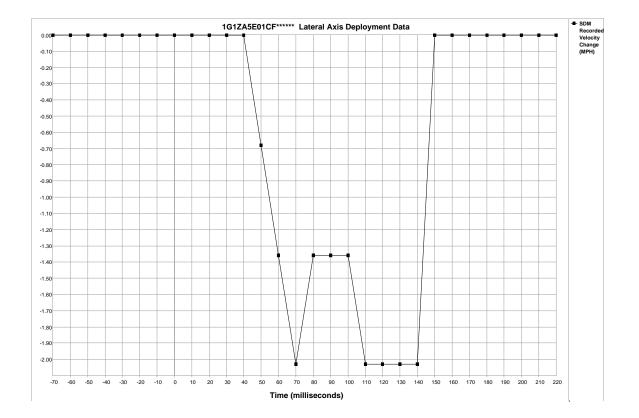
Time (milliseconds)	-70	-60	-50	-40	-30	-20	-10	0	10	20	30	40	50	60	70
SDM Lateral Axis Recorded Velocity Change (MPH)	0.00	0.00	0.00	0.00	0.00	0.00	0.00	0.00	0.00	0.00	0.00	0.00	-0.68	-1.36	-2.03
Time (milliseconds)	80	90	100	110	120	130	140	150	160	170	180	190	200	210	220
SDM Lateral Axis Recorded Velocity Change (MPH)	-1.36	-1.36	-1.36	-2.03	-2.03	-2.03	-2.03	0.00	0.00	0.00	0.00	0.00	0.00	0.00	0.00

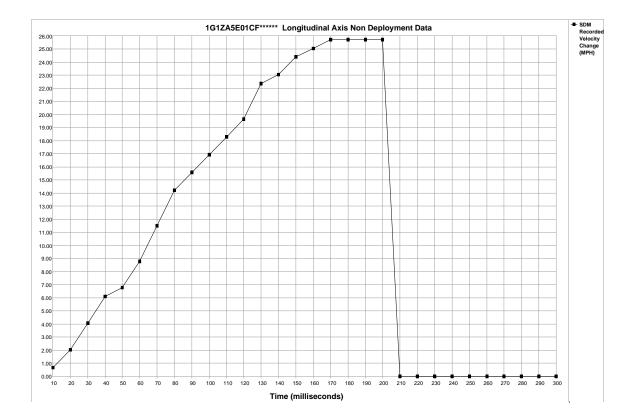
Time (milliseconds)	10	20	30	40	50	60	70	80	90	100	110	120	130	140	150
SDM Longitudinal Axis Recorded Velocity Change (MPH)	0.68	2.03	4.07	6.10	6.78	8.81	11.52	14.23	15.59	16.94	18.30	19.65	22.36	23.04	24.40
Time (milliseconds)	160	170	180	190	200	210	220	230	240	250	260	270	280	290	300
SDM Longitudinal Axis Recorded Velocity Change (MPH)	25.07	25.75	25.75	25.75	25.75	0.00	0.00	0.00	0.00	0.00	0.00	0.00	0.00	0.00	0.00

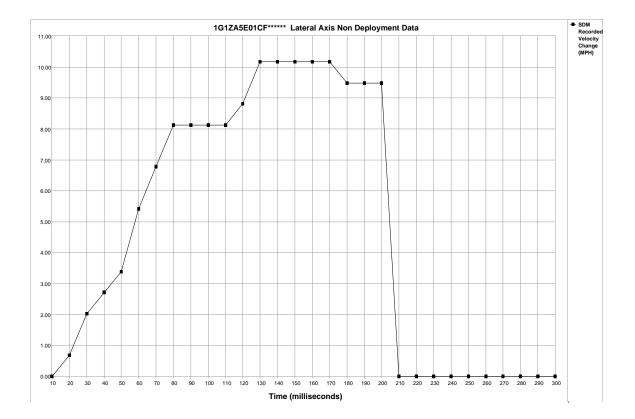
Time (milliseconds)	10	20	30	40	50	60	70	80	90	100	110	120	130	140	150
SDM Lateral Axis Recorded Velocity Change (MPH)	0.00	0.68	2.03	2.71	3.39	5.42	6.78	8.13	8.13	8.13	8.13	8.81	10.17	10.17	10.17
Time (milliseconds)	160	170	180	190	200	210	220	230	240	250	260	270	280	290	300
SDM Lateral Axis Recorded Velocity Change (MPH)	10.17	10.17	9.49	9.49	9.49	0.00	0.00	0.00	0.00	0.00	0.00	0.00	0.00	0.00	0.00
