U.S. Department of Transportation

National Highway Traffic Safety Administration

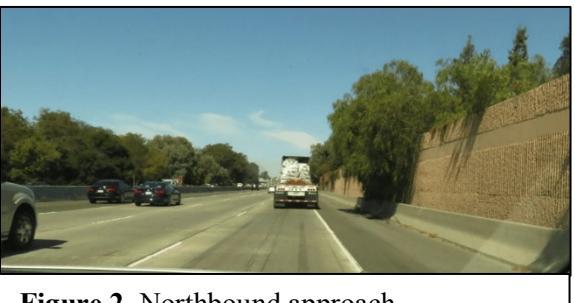
Figure 2. Northbound approach

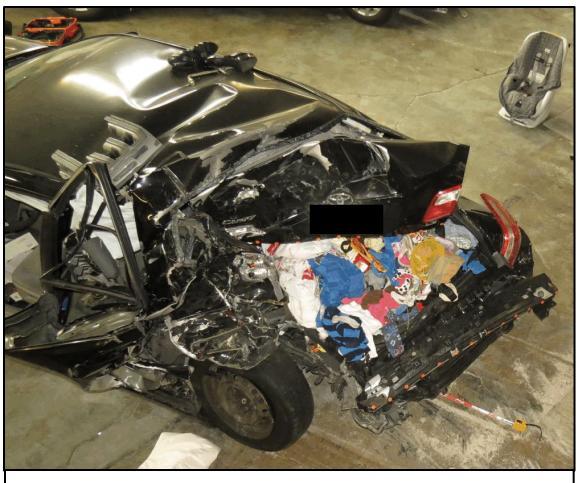
**Figure 4.** Rear plane damage, 2007 Toyota Camry

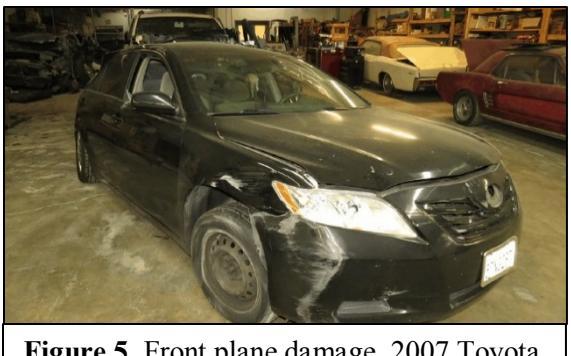
**Figure 5.** Front plane damage, 2007 Toyota Camry

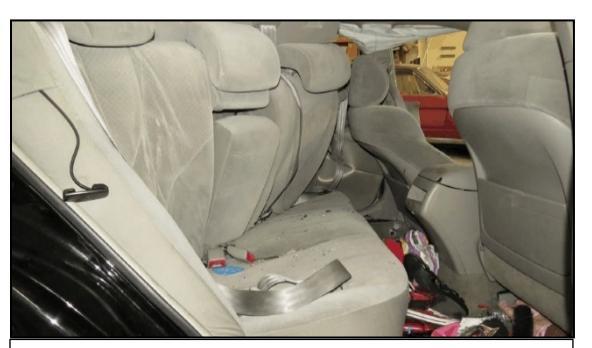
**Figure 6.** Second row intrusion, 2007 Toyota Camry

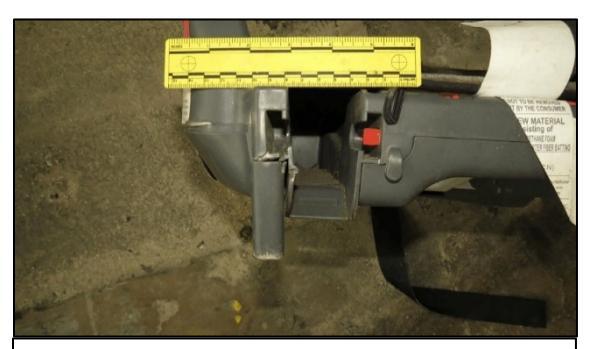
Figure 8. Graco Argos 70 CRS

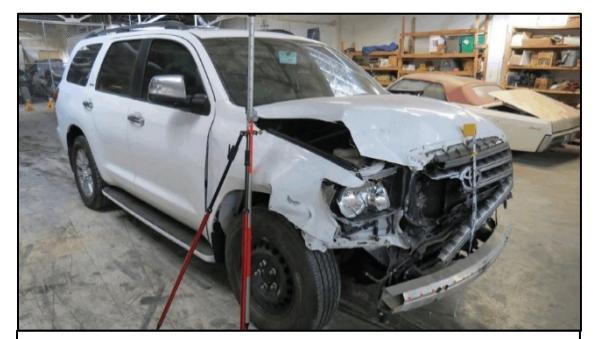
Figure 10. 2008 Toyota Sequoia
